AWS Field Report 2016-17

Field Team: Lee Welhouse, Carol Costanza, and Dave Mikolajczyk

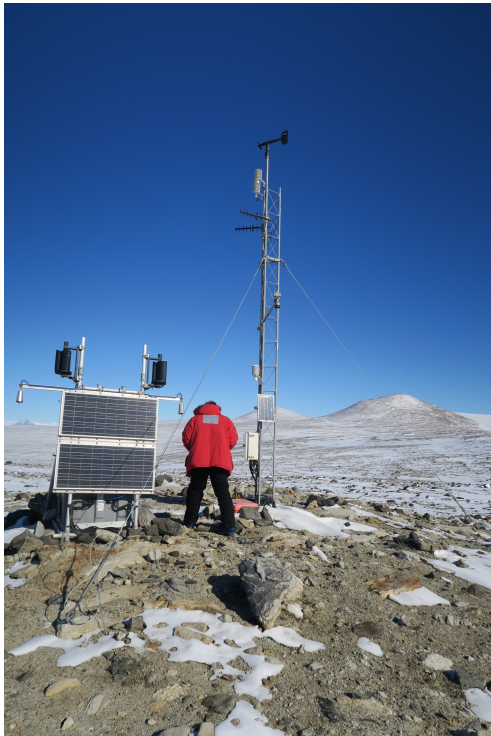
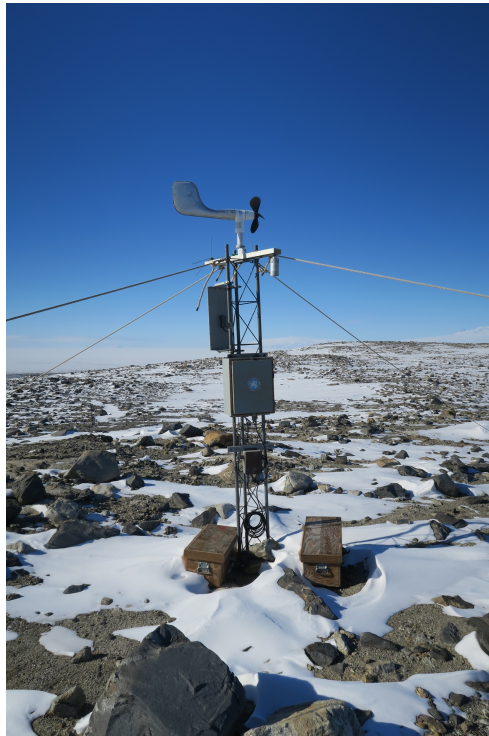
1442: Depart Helo Pad
1515: Arrive MPT
All parts of both AWS looked like they were still in great shape!
1555: Depart MPT
1632: Arrive Helo Pad

MP2 (left) and MPT (right) photos courtesy of Carol Costanza

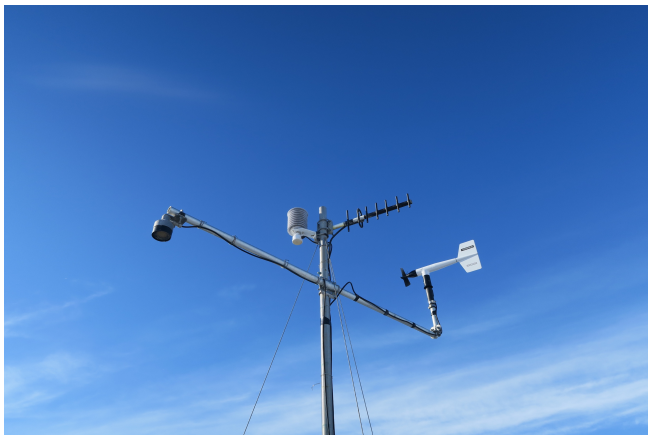
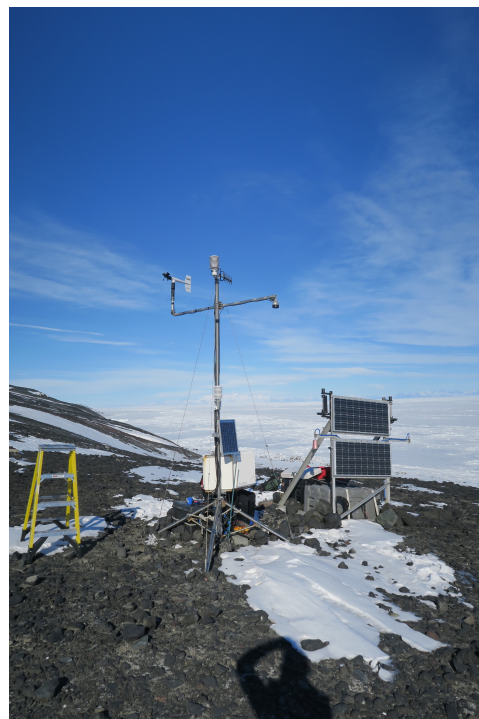
CBD boom (left) and CBD in full (right) photos courtesy of Carol Costanza

We replaced the aerovane, taped/wired the cabling, and checked the reading from the CR keypad. Lee noticed that the wind direction was backwards, so he had to change the wiring in the enclosure. The A red, wind wire was moved from VX2 to (ground) and the C yellow, wind wire was moved from (ground) to VX2, so the wires were switched in the enclosure. Then we wandered around the beach and waited for the helo for about 2 hours.

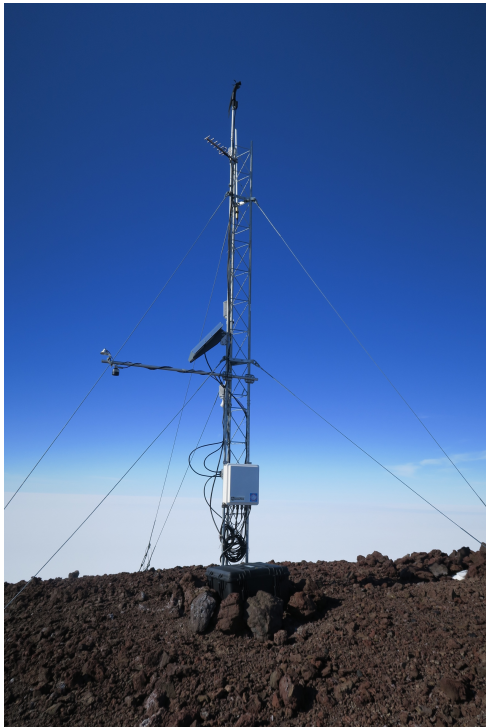
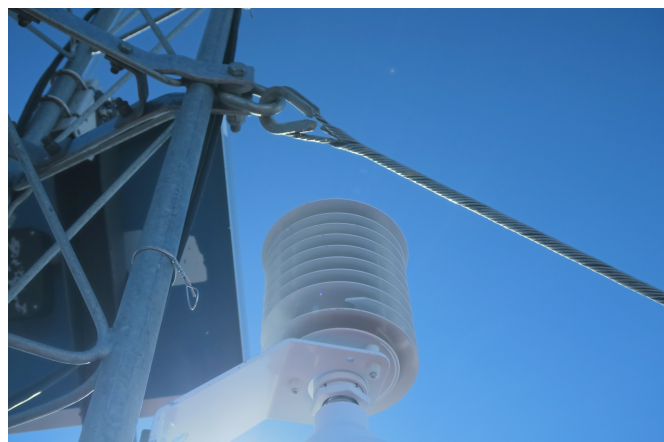
Tower, guy wires, and aerovane was inspected and looked correct. We did notice that the shields on both of the temperature sensors and the humidity sensors were chipped on the south side. It might be worth replacing the Gill shields at some point in the near future.

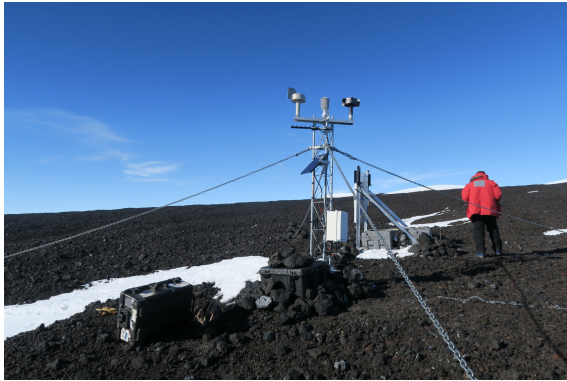
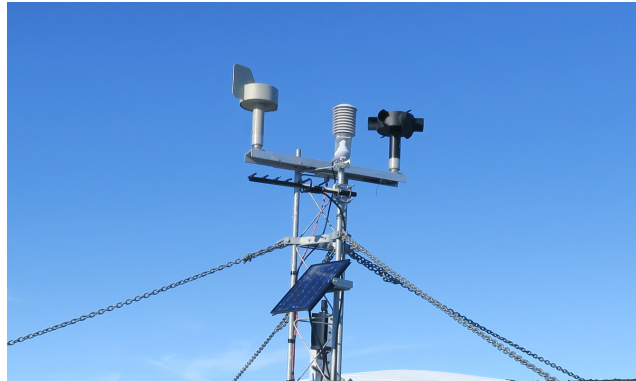
We replaced the high wind speed sensor because last year we noticed it wasn't spinning very fluidly. The wind direction sensor was not replaced because we noticed it was still working correctly. The correct high wind speed sensor was a 2-pin sensor.

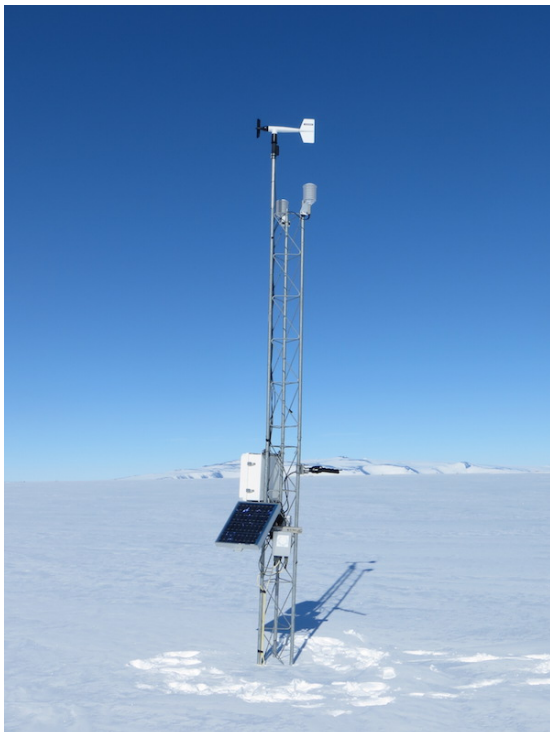
WFD upon arrival (Dave Mikolajczyk)

We dug down about 4 feet to try and recover the power system. Unfortunately, we hit many thick ice layers. We determined the old battery boxes were unrecoverable. We will be going back later in the season to re-install a new 3-battery power system because a battery box wasn't available at the time.

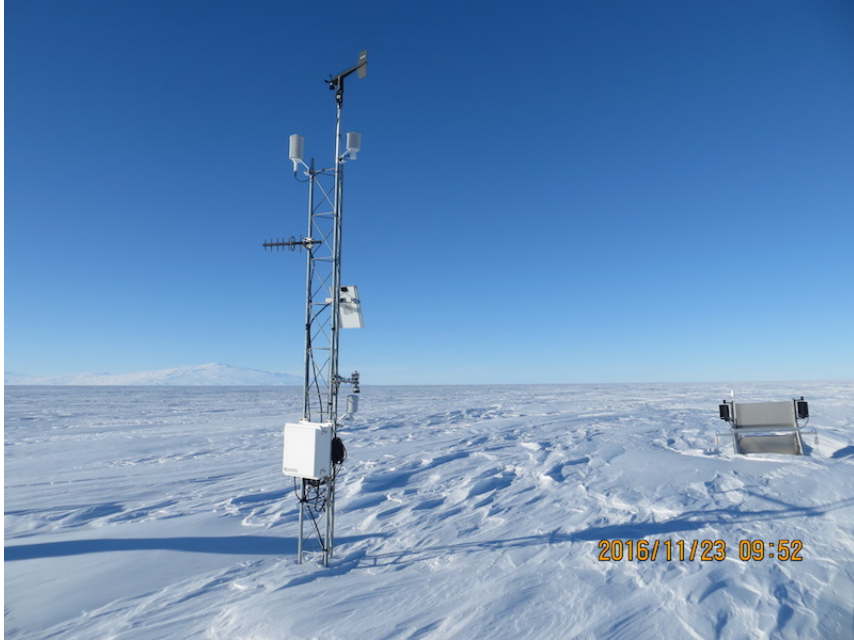
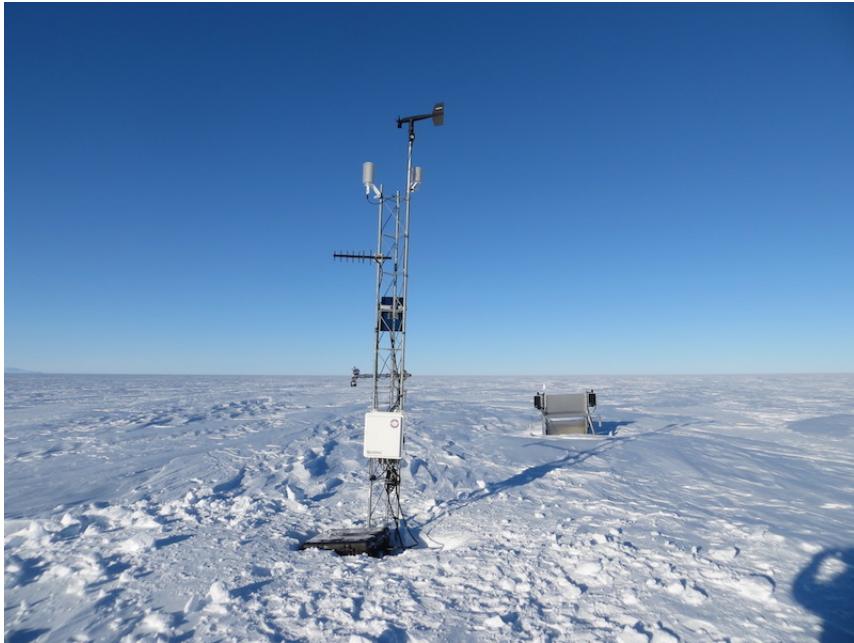
LOR before (top) and after (bottom) (photos courtesy of Dave Mikolajczyk)

NOTE: Upon checking the data from LOR back in McM, we noticed the wind was transmitting zeros and the RH was too low. It is thought that some wiring was undone on the datalogger, so we need to revisit LOR this season.

Replaced the solar panel. Swapped the existing pressure sensor and installed a Paroscientific SN 62187 pressure gauge. We checked the pressure values but noticed they were incorrect. Back in McMurdo, Lee noticed the calibration values were entered incorrectly. After remotely updating the program with the correct values, the pressure is transmitting nominally. Tightened down the nut on the propeller, as it was loose. Should be something to check in future visits.

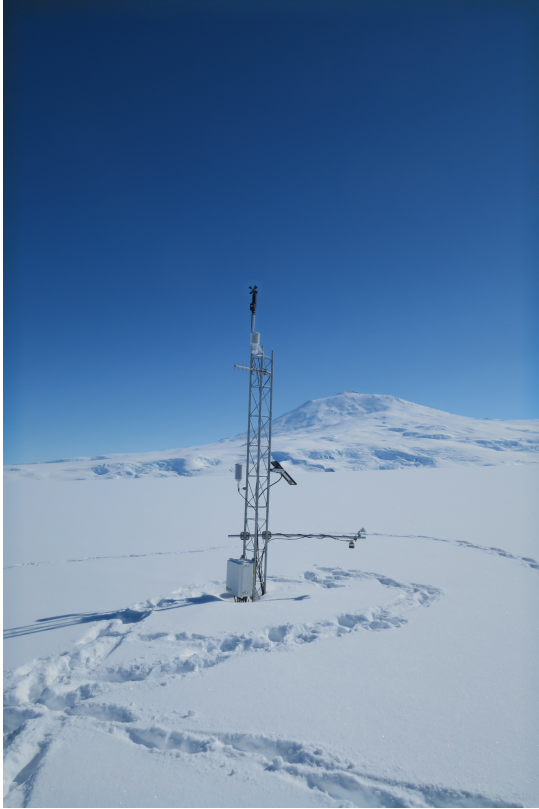
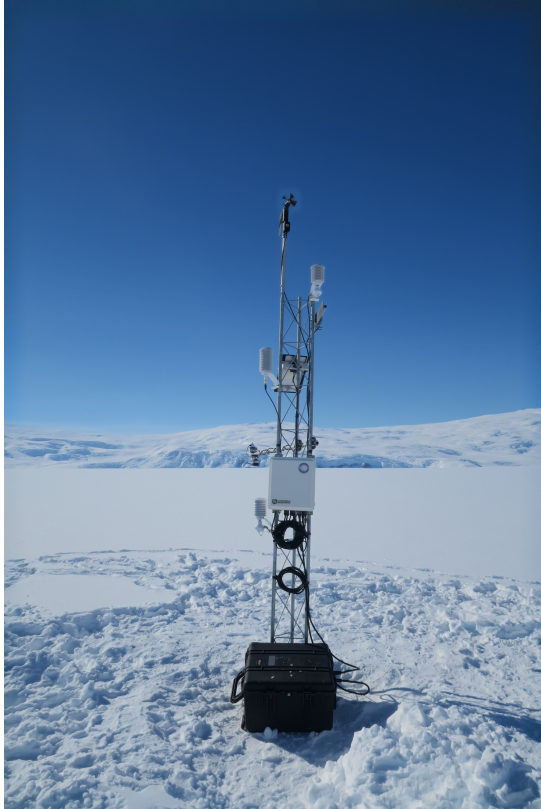
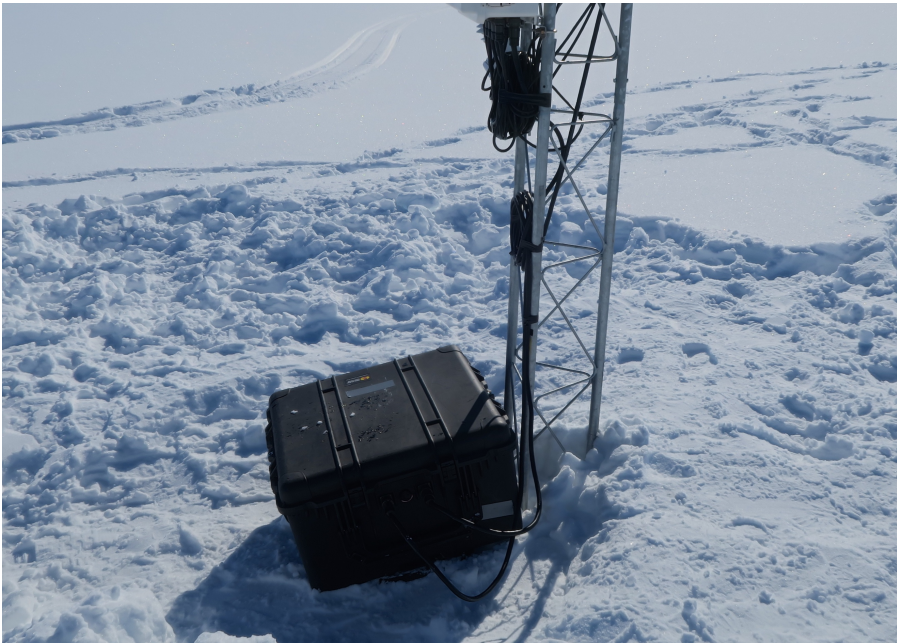
WDB before (left), WDB after (right), and WDB power system (bottom) photos courtesy of Carol Costanza

NOTE: The tower is tilting a fair amount. We should think about setting up a new tower next season. This would also be helpful because we can't remove the top pipe for the aerovane because the poles are cold welded. Finally, we might want to bring new quick connect wires for the power system. The third battery was directly wired without a plug.

An additional tower section was not needed. We first started to dig out the power system. It ended up being about 4 or 5 feet below surface after 2 years. The old 2-battery power system was returned to McMurdo, and the new 3-battery power system was installed. All of the instruments were raised except for the aerovane and the upper temperature sensor.

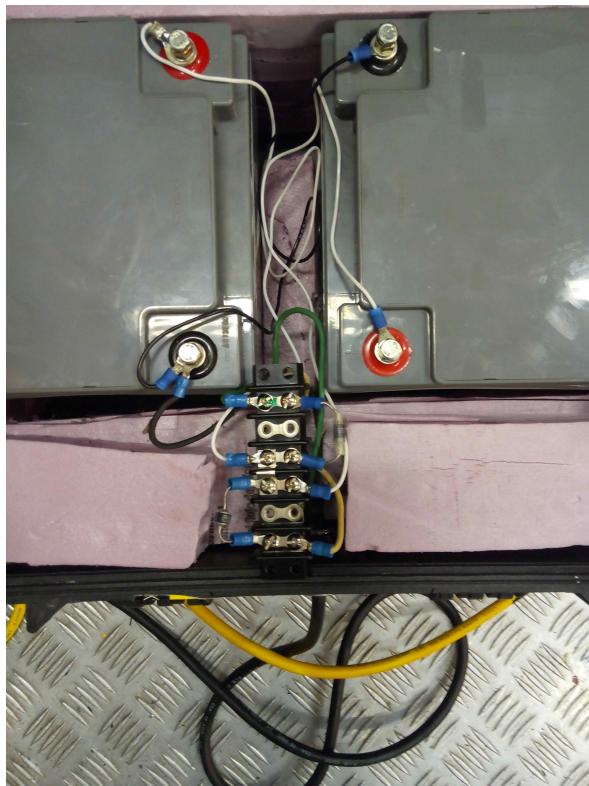
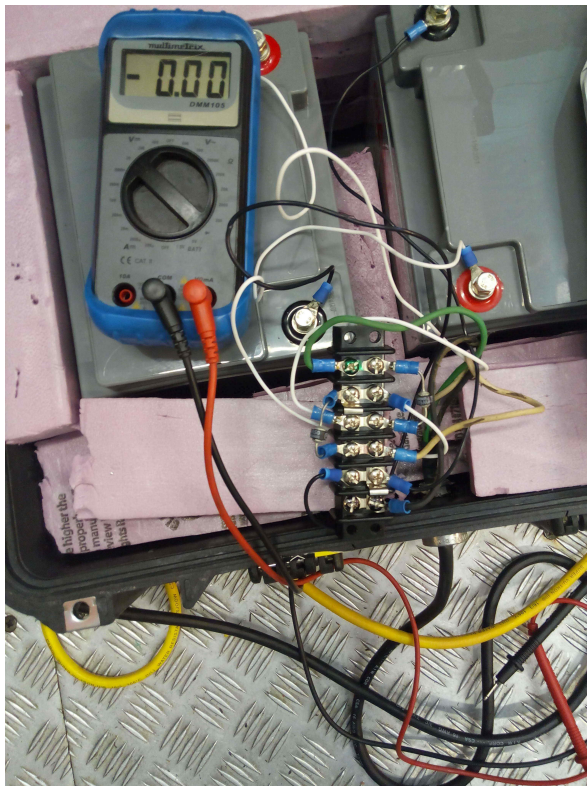
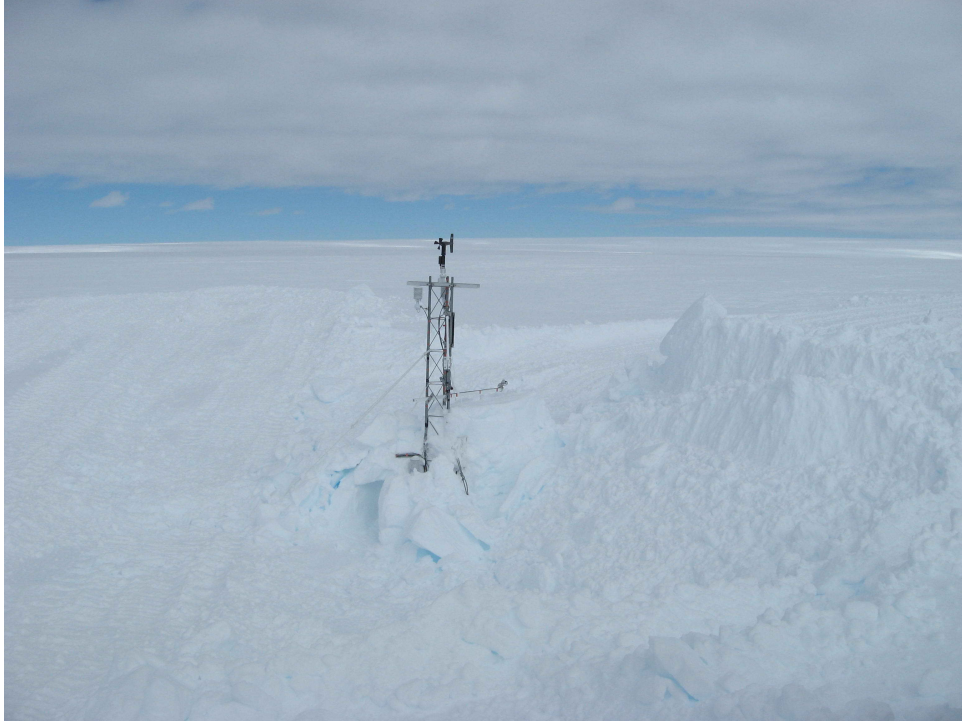
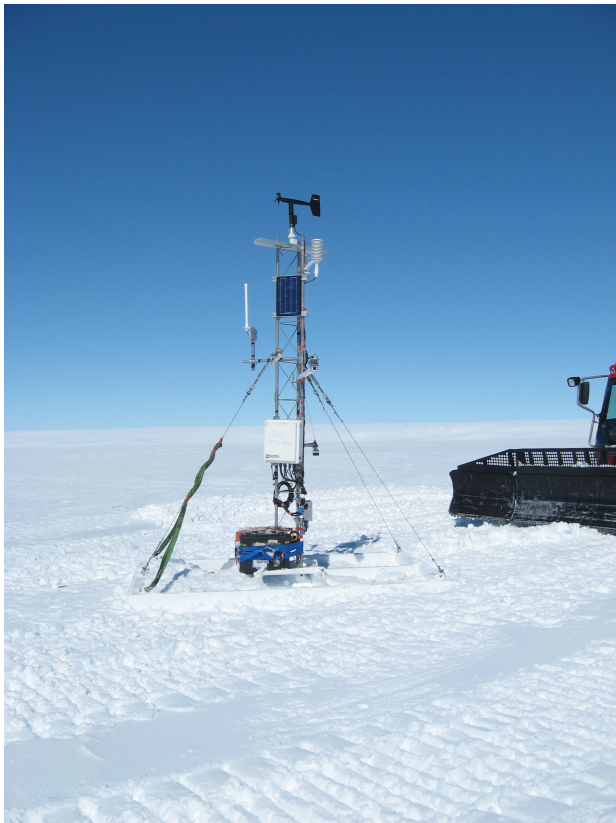
D-10 AWS photos courtesy of Philippe Dordhain

D10 station has been retrieved and installed on sled at D10 the 27 December 2016 05 UTC. One of the batteries case was incorrectly wired after inspection. The solar panel steering diode was mounted the wrong way.

D10 has been disconnected on the 23rd of December, transported to the station, installed on its sled as well as reconnected to its own batteries.

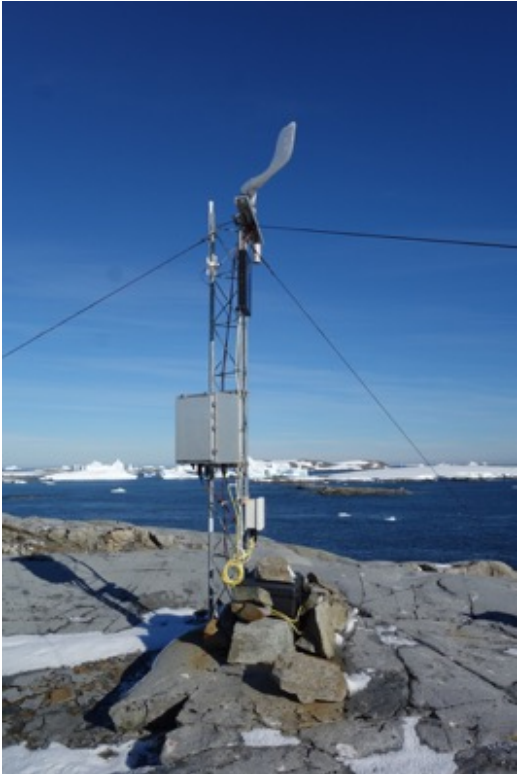
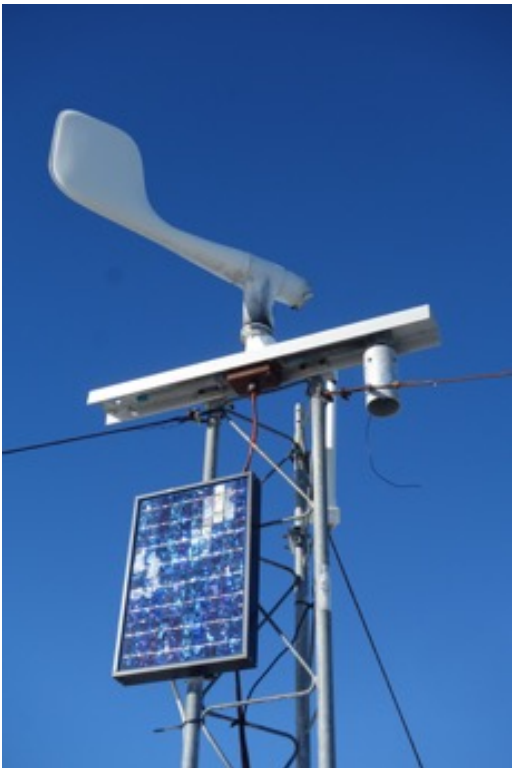
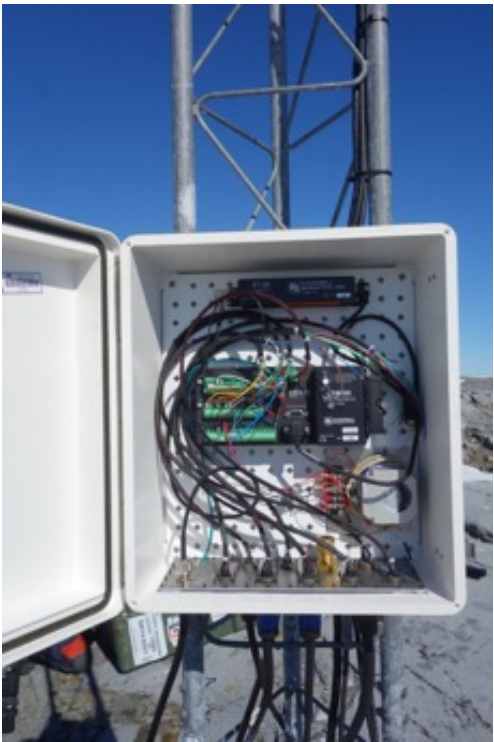
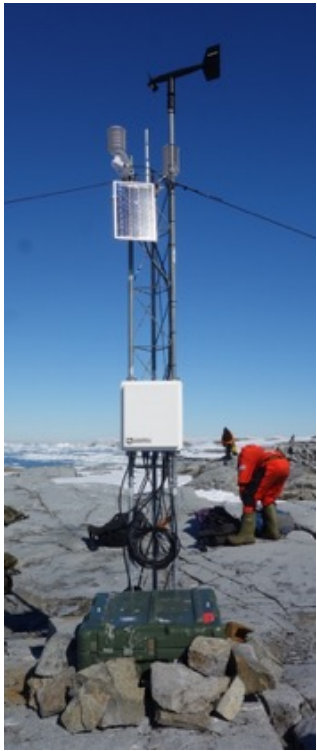
Dismal Photos Courtesy of Rosey Grant

Notes on arrival: The aerovane was missing its propeller. This was found in two pieces on the ground near the mast. Apart from the metal outer tube there was nothing left of the SR50. There were signs of corrosion and salt deposit on the logger box cable glands. All mast instrument attachments were very rusty. The battery box looked in good condition. The guys were rusty with some signs of damage but they were deemed safe. There was a redundant battery box left on the ground near the base of the mast. This was a wooden case with two very corroded batteries inside. (This was returned to Rothera where it was disposed of.)

The old instruments, solar panel, logger box and dump box were removed. All the U-bolts and attachments were severely rusted so they had to be cut (and bashed) to remove them from the mast. New instruments, ARGOS antenna, solar panel and logger box were attached, starting at the top and working down. The pipe supplied for mounting the propvane fitted over the leg of the mast but one of the bolts was too large for the hole so the pipe could only be secured with one bolt. Despite this, the mount felt secure.
