## **AWS Field Report 2025-26**

**Field Team: Matthew Lazzara, Lee Welhouse, Forbes Filip**

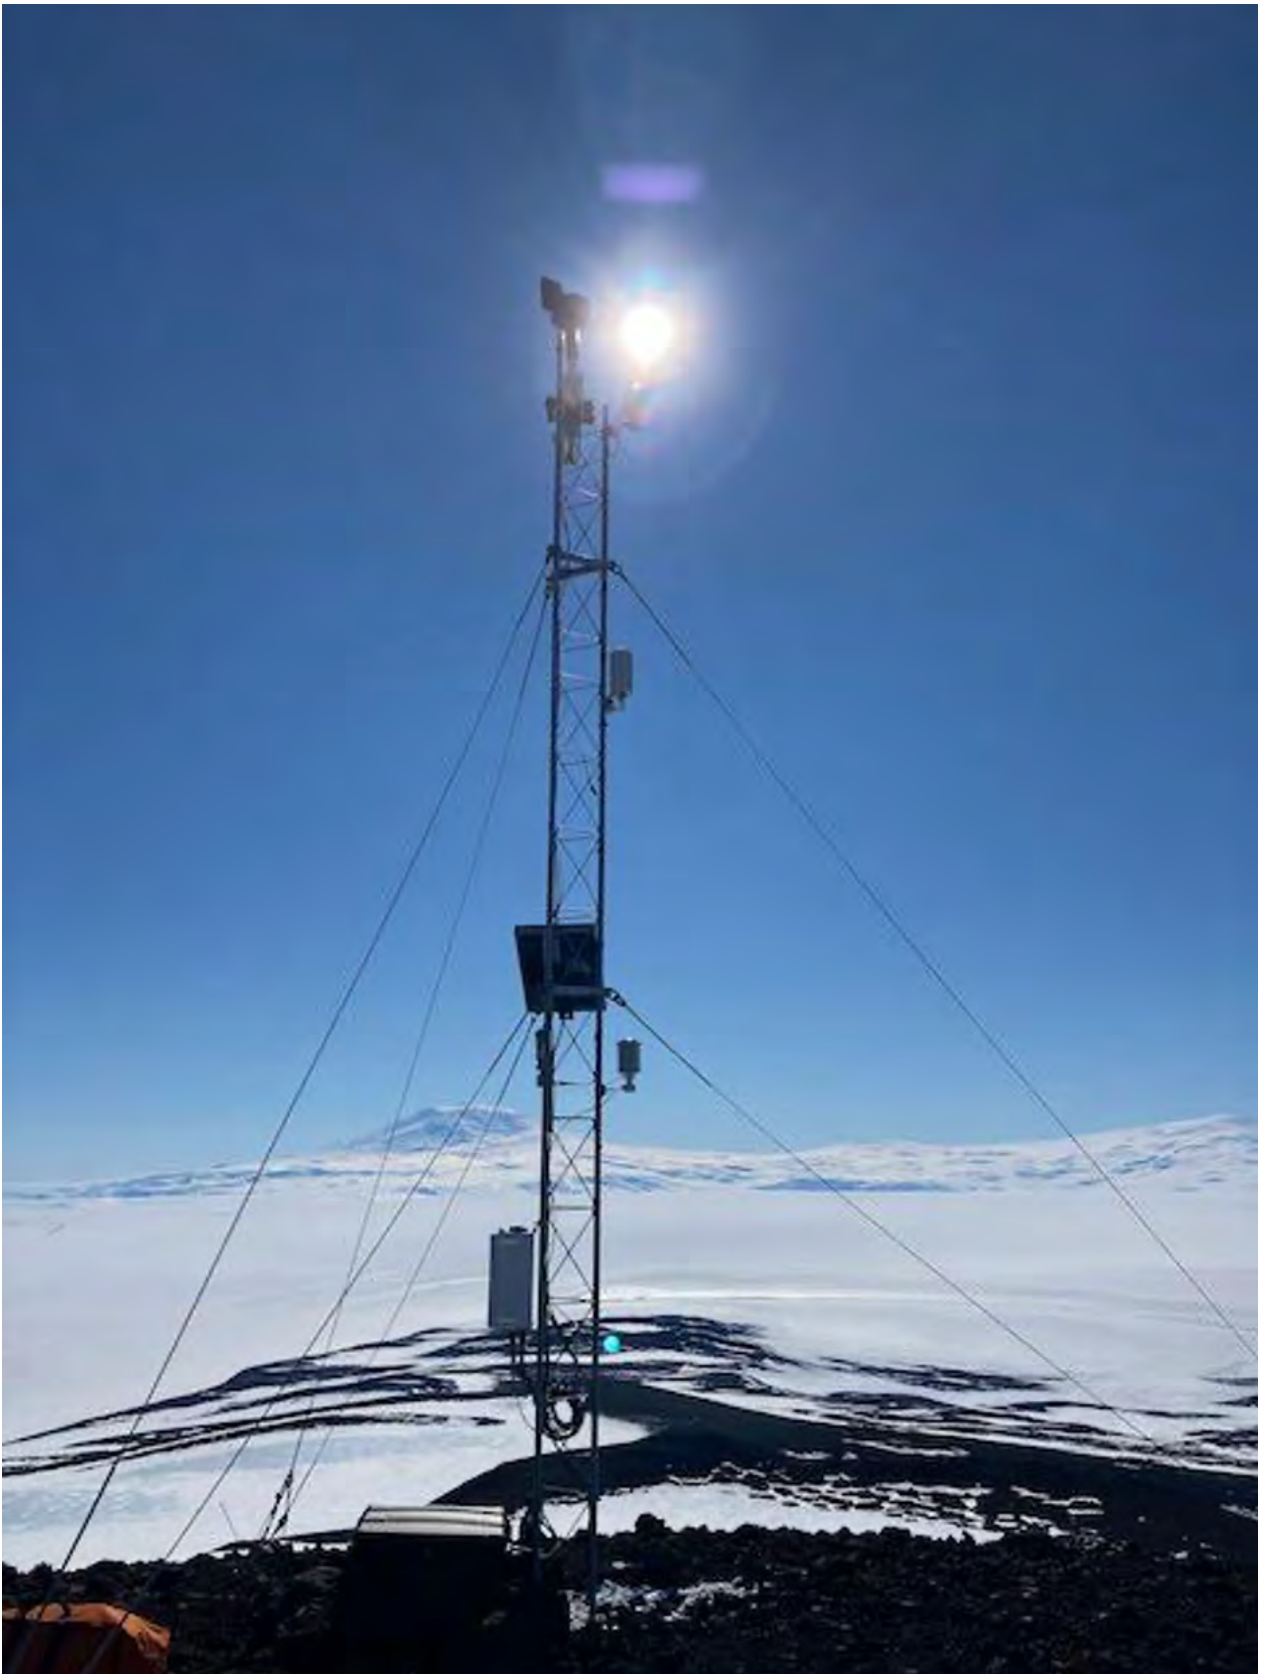
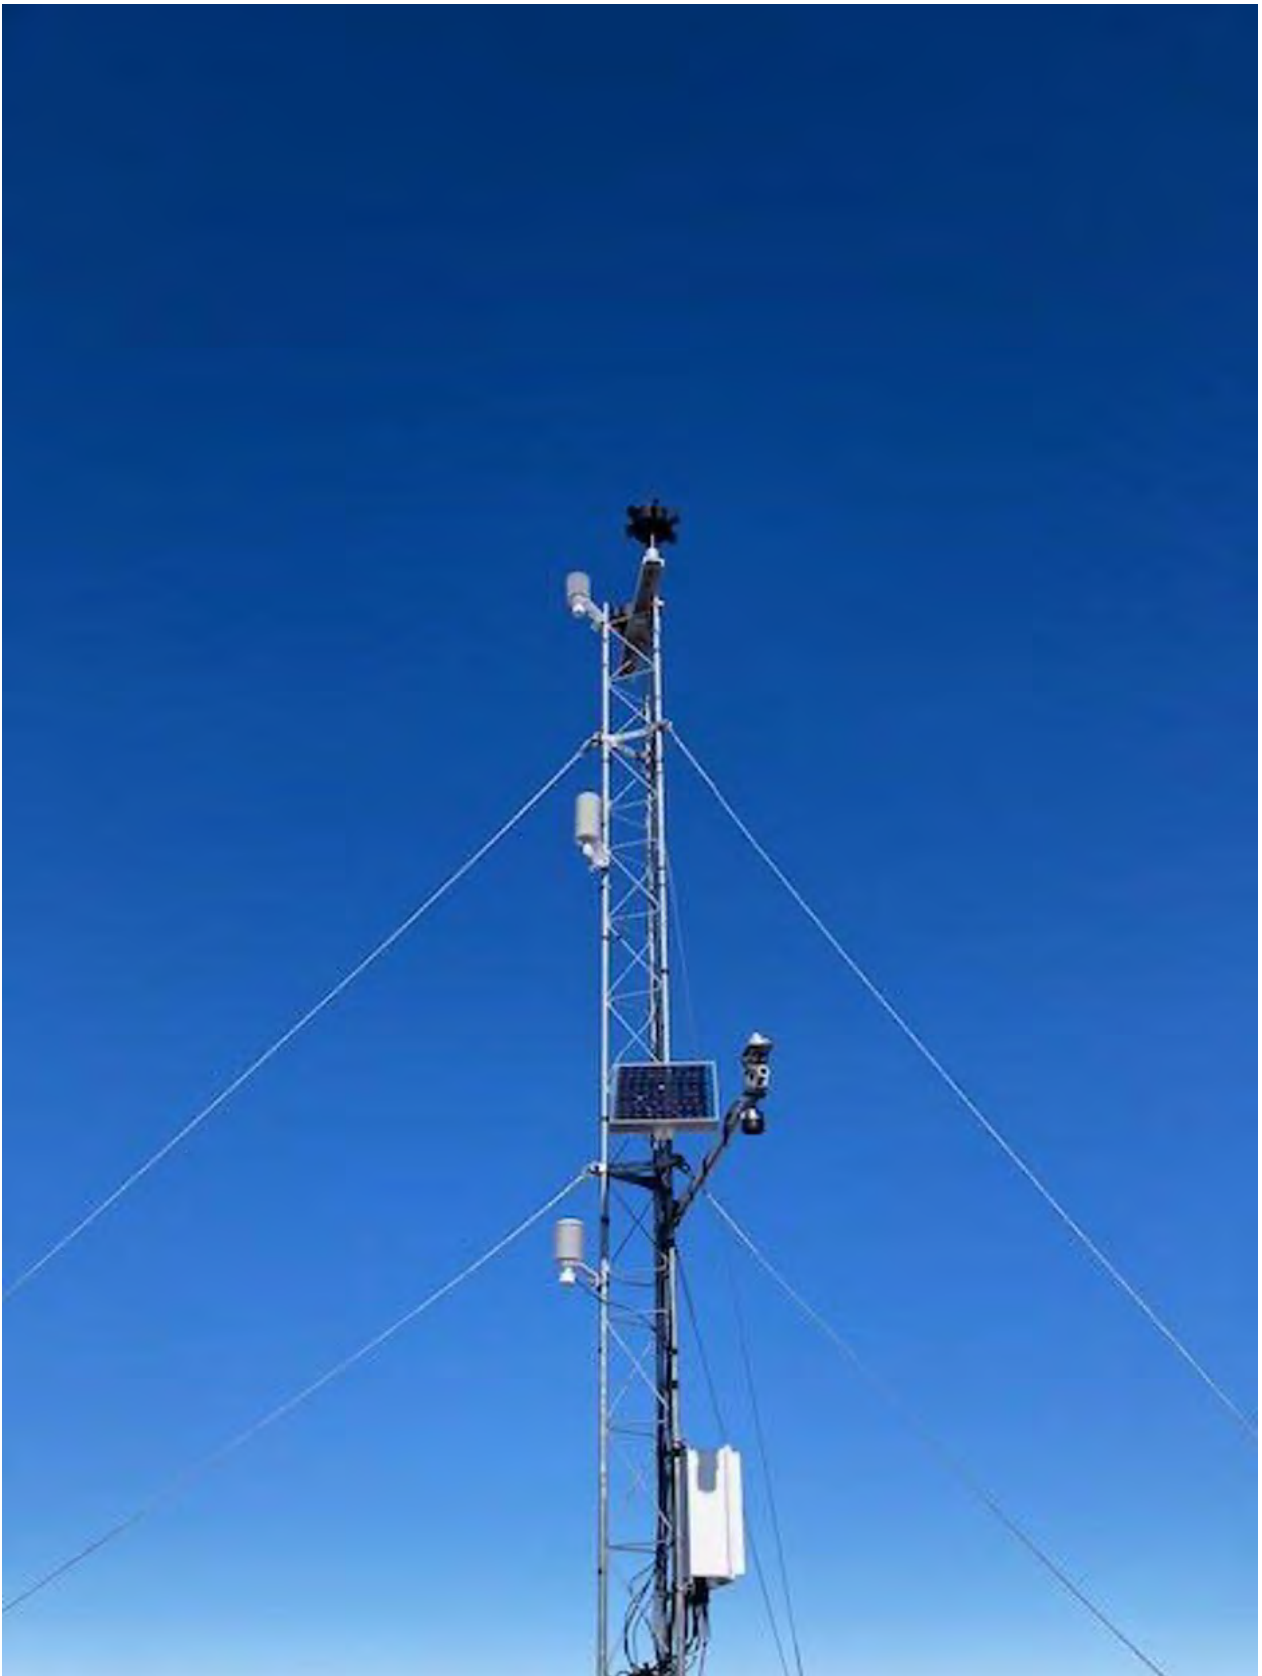
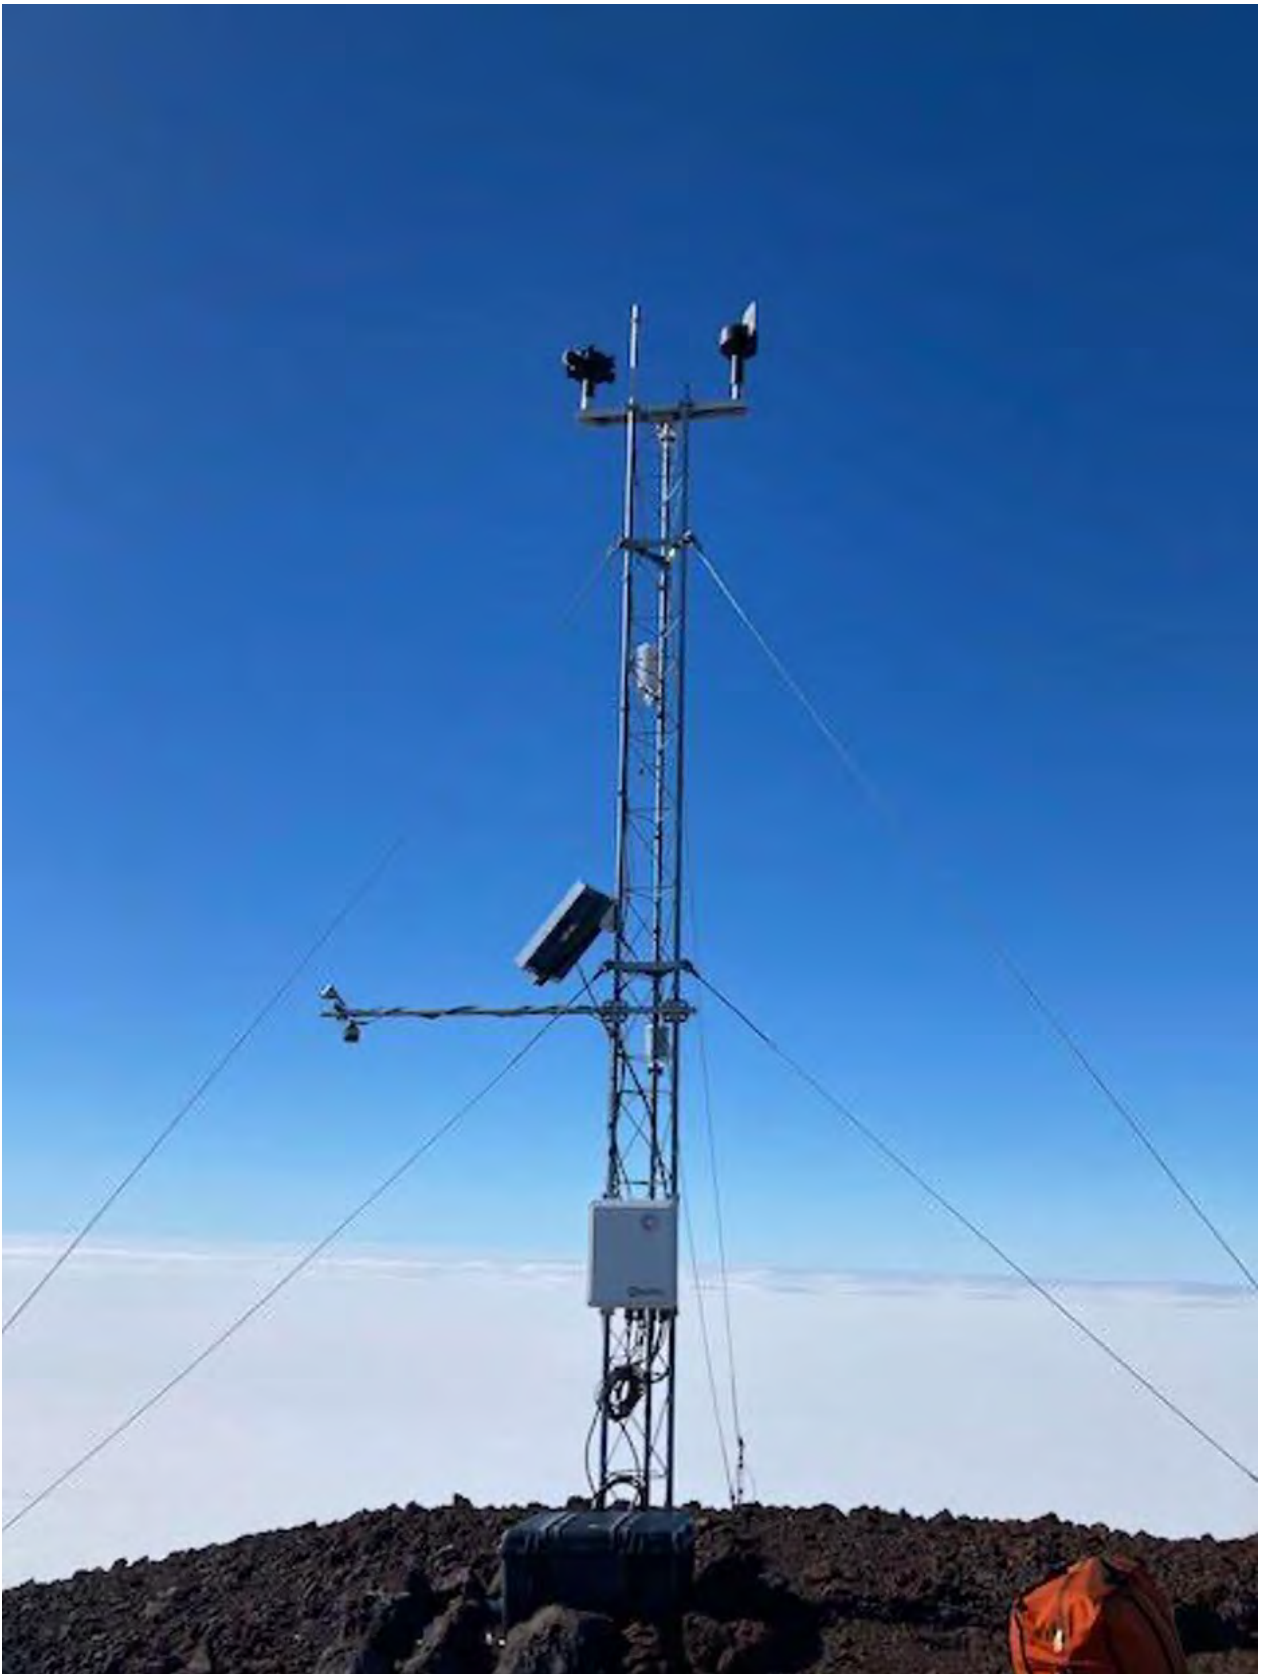
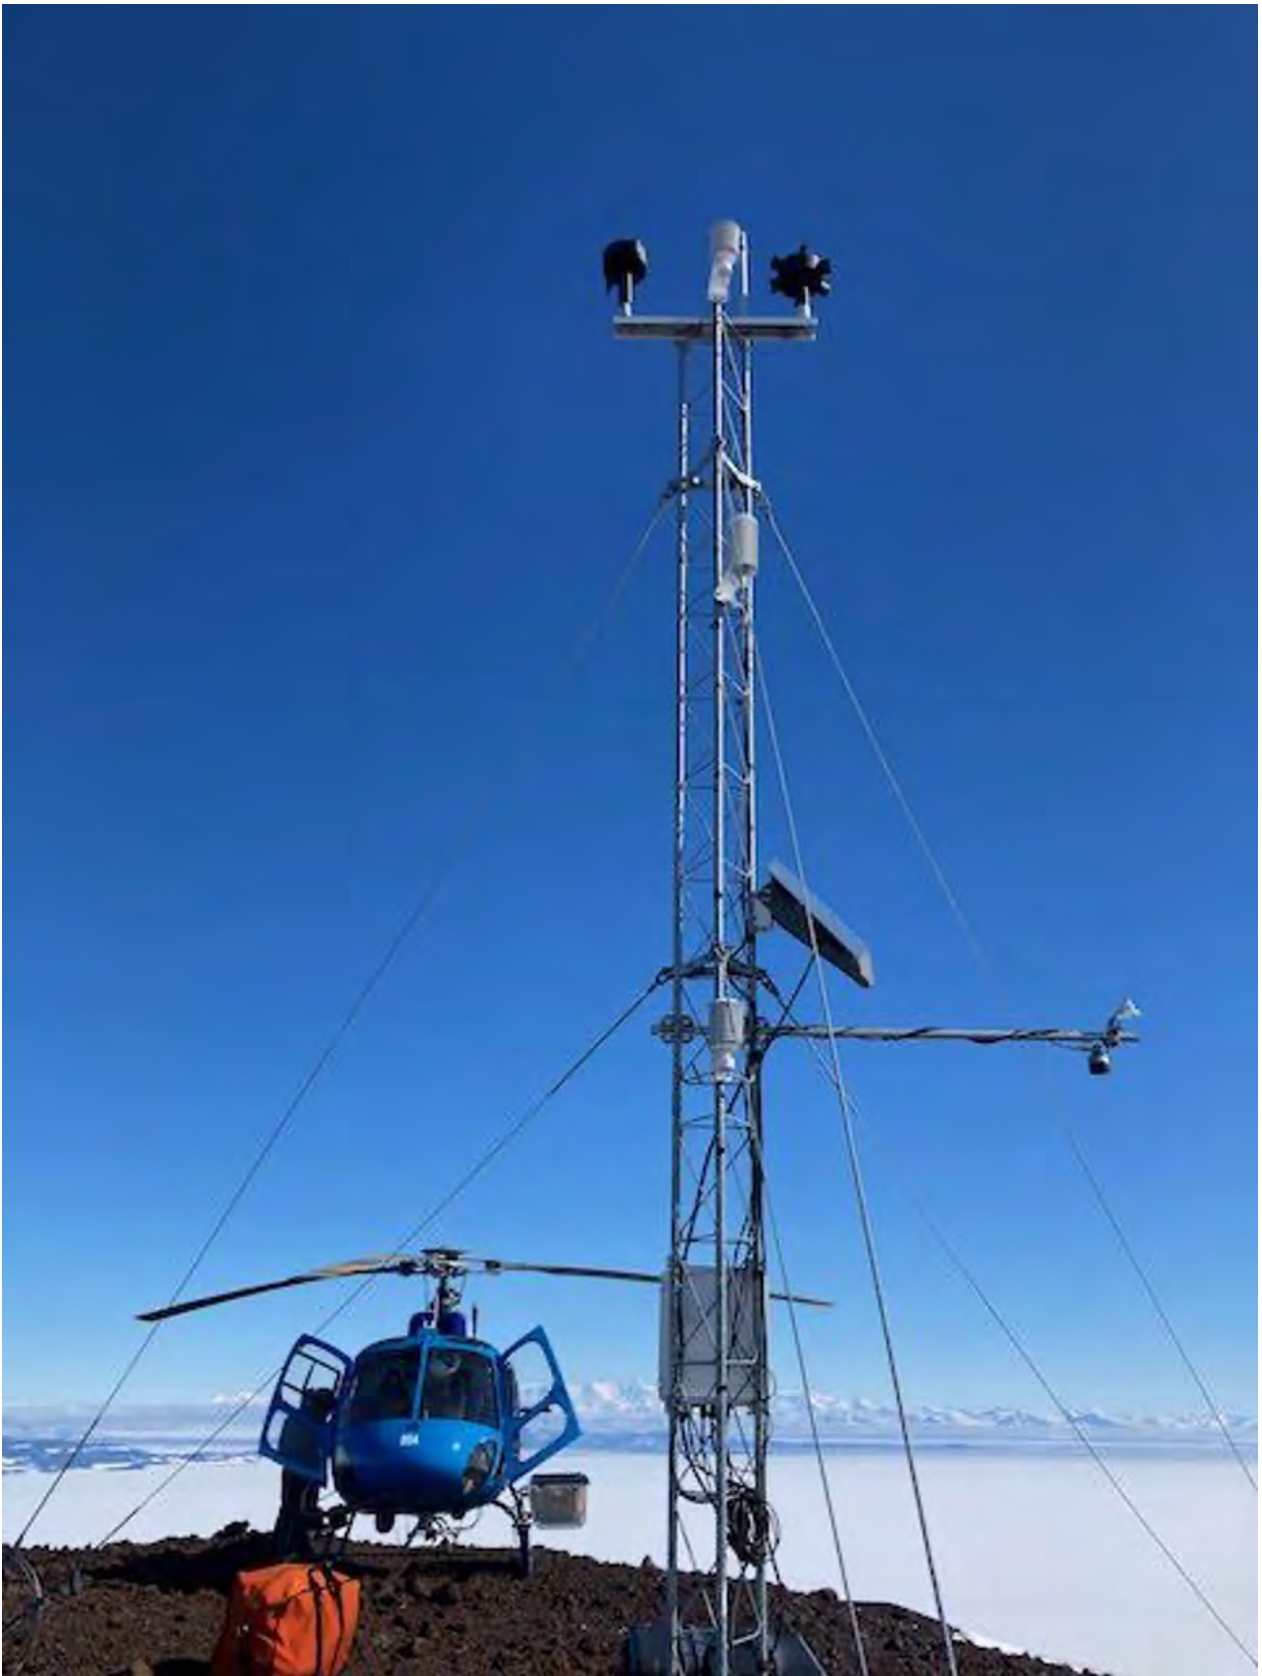
Field Work Notes: We found the RH cable unscrewed! That was the issue there. Added a data card (no card working there, so none removed). MicroSD

Replaced ADG. The incoming solar sensor instrument is not working and needs replacement, and the instruments need e-leveled when doing so.

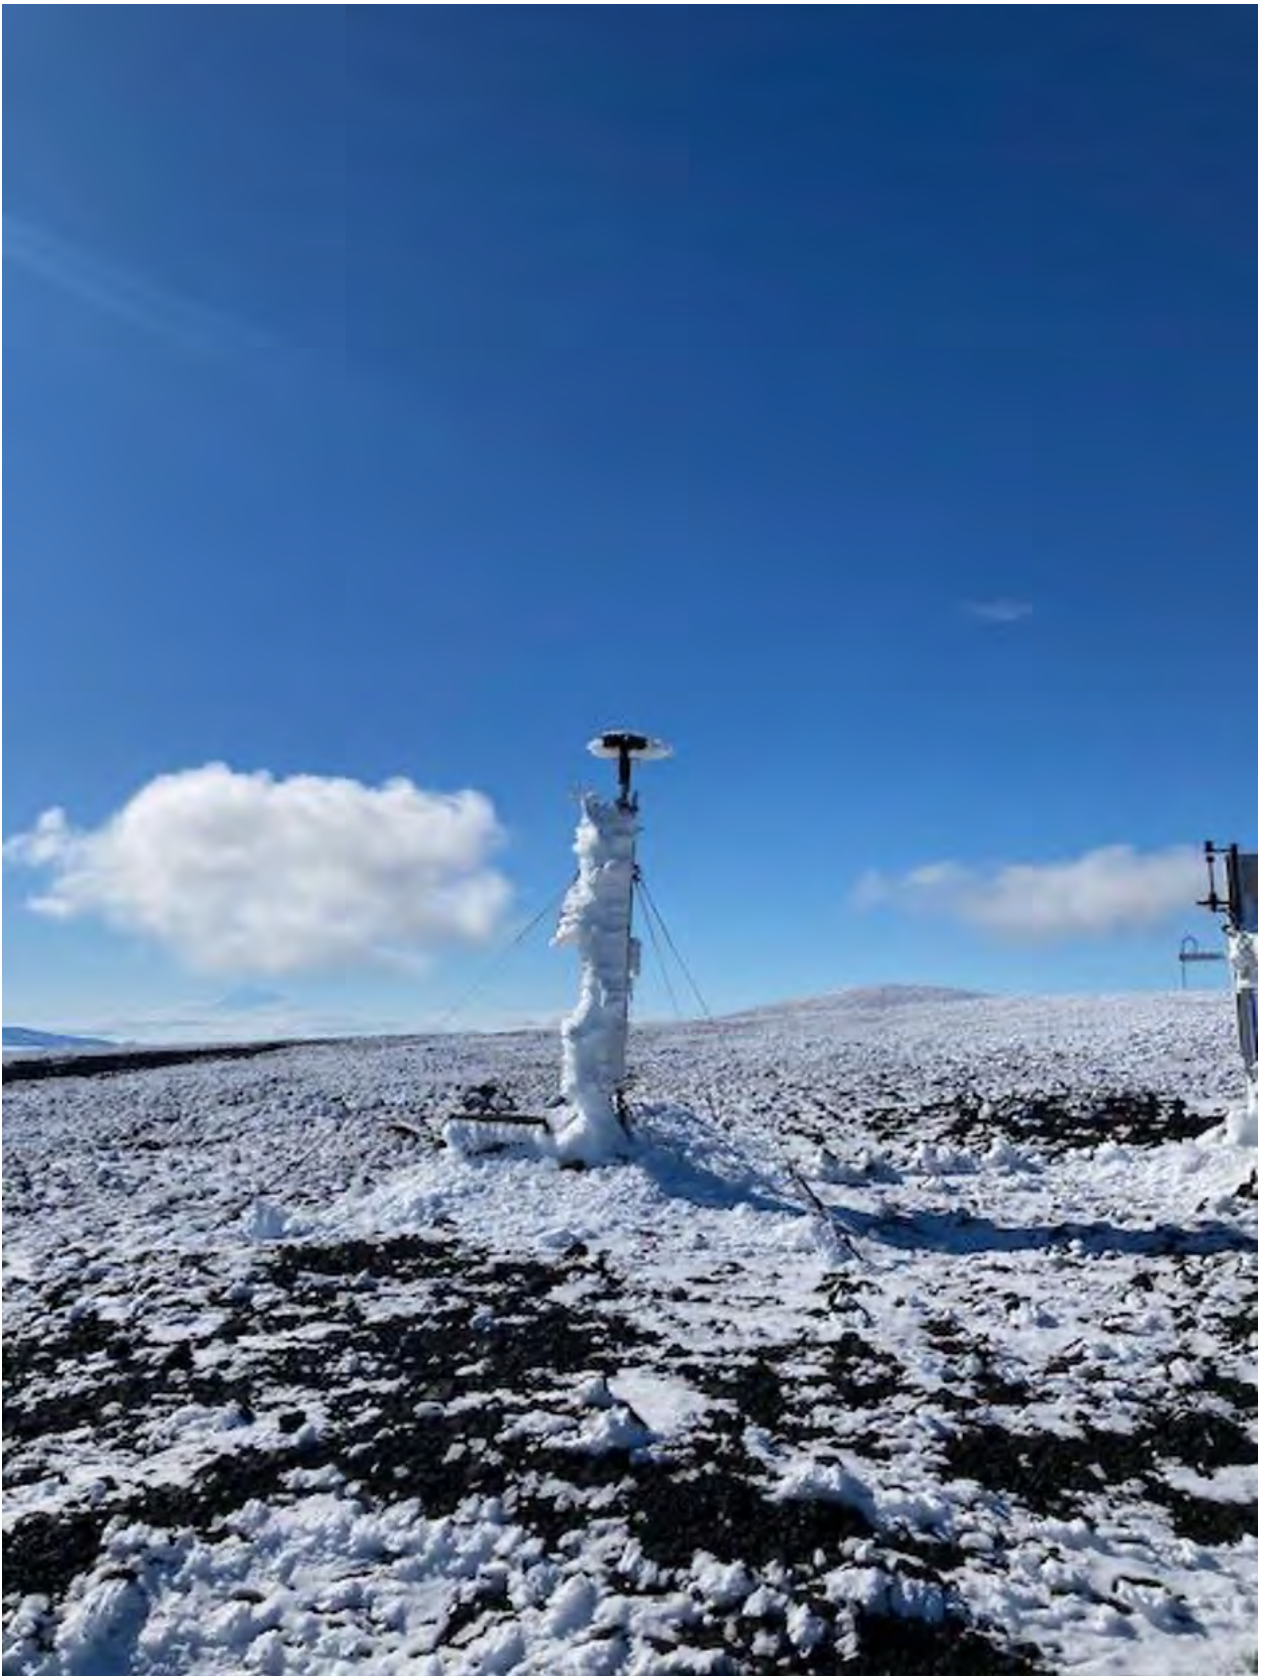
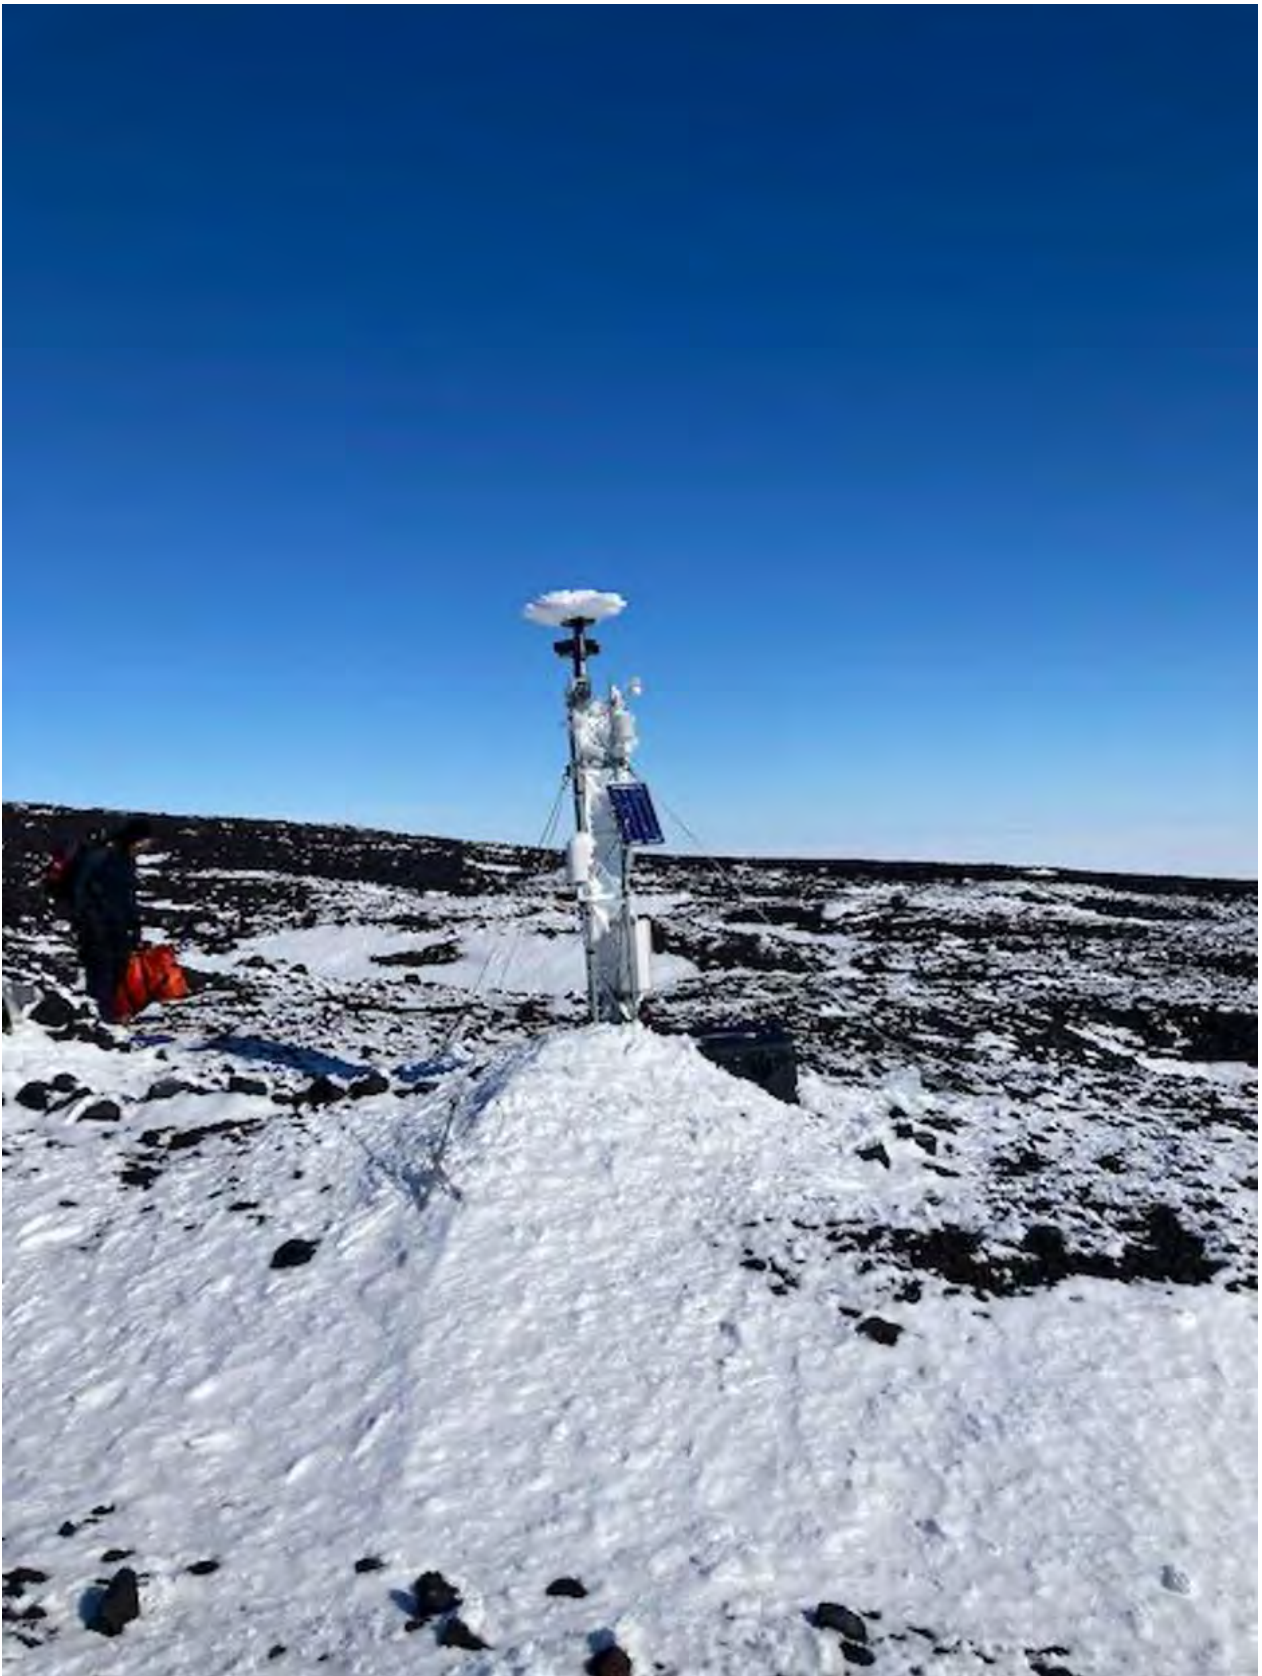
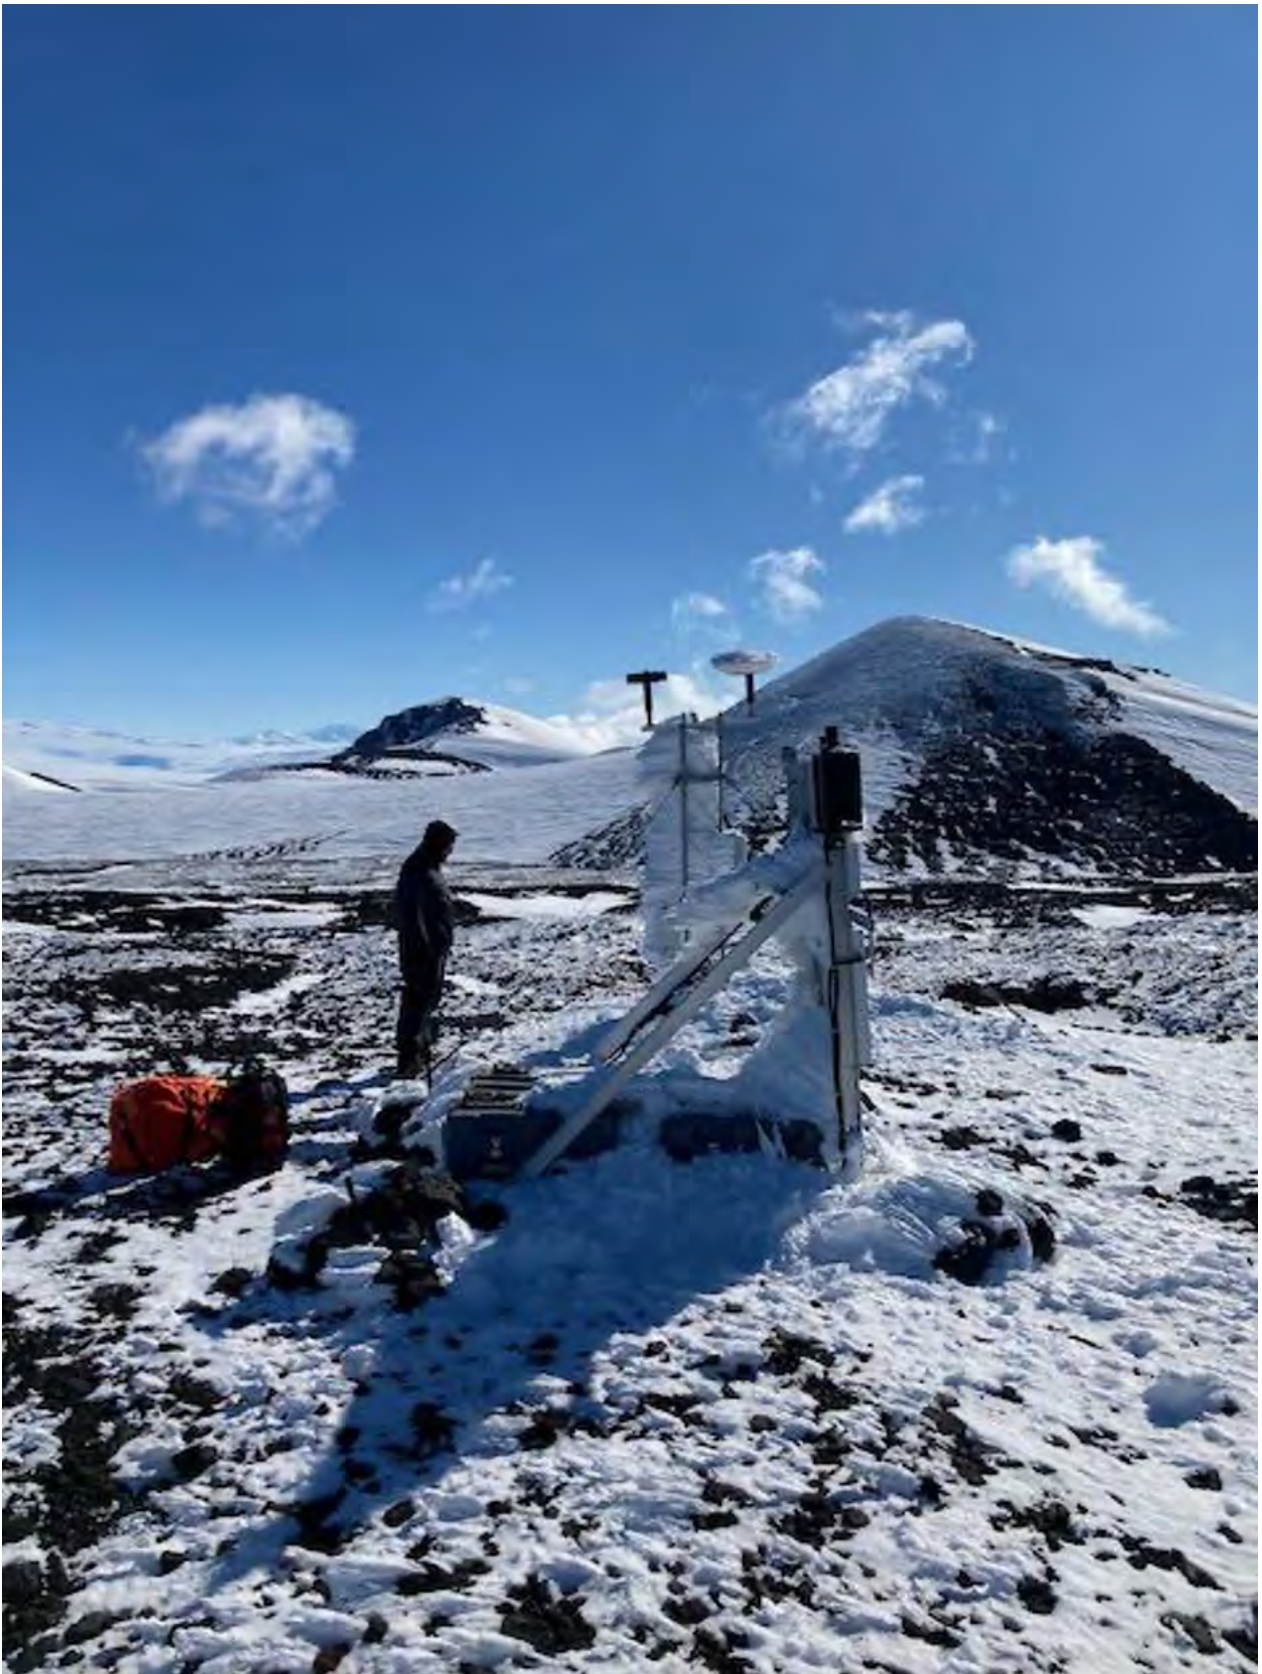
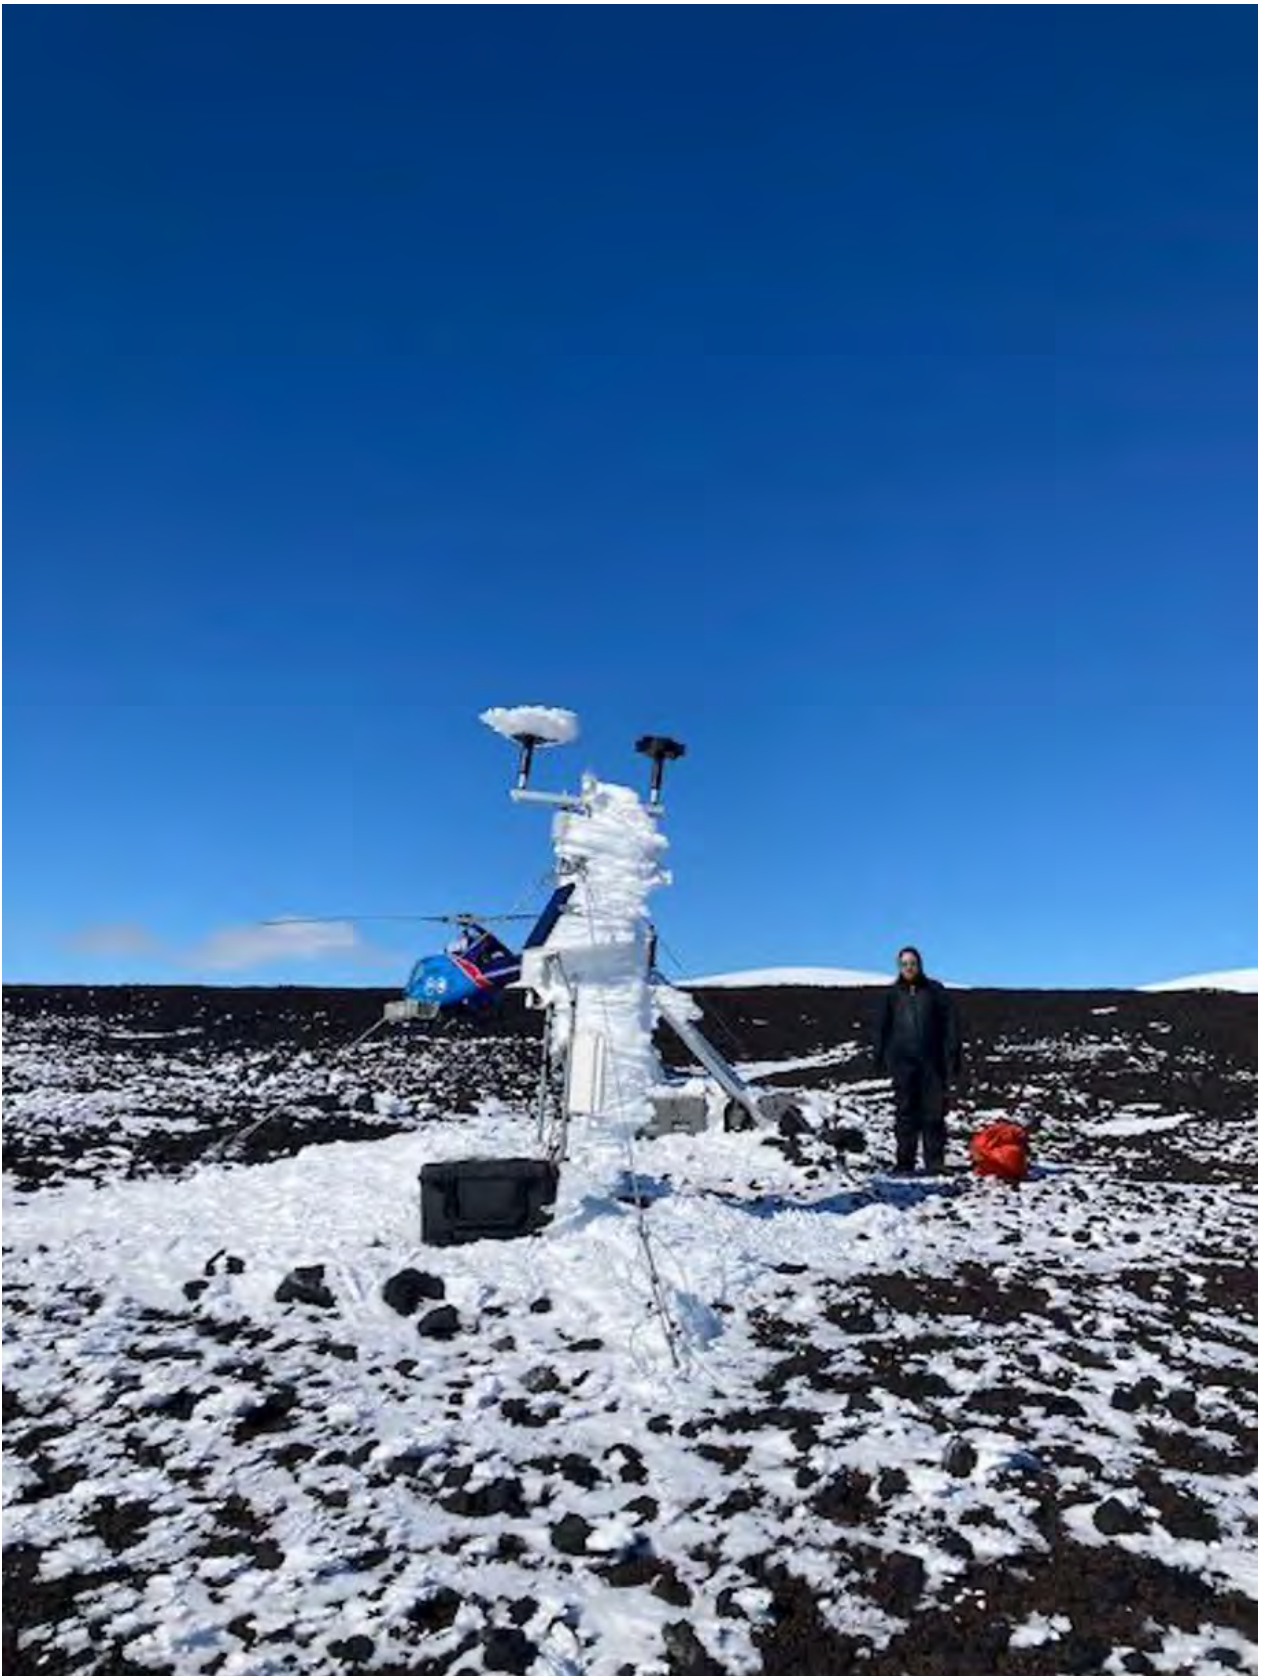
Field Work Notes: Minna was encased in rime ice. Upper temperature sensor was significantly damaged

The wind direction sensor has been completely replaced. The one there no longer has working (not the physical part, but the pin readouts didn't give good values or all the same value)

The I-beam across the top had lost part of the nuts and metal holding the top on. It was all loose. One more storm and it would be blown off. We didn't have a replacement, but used a U-bolt to clamp it in place. We may need a new system here.

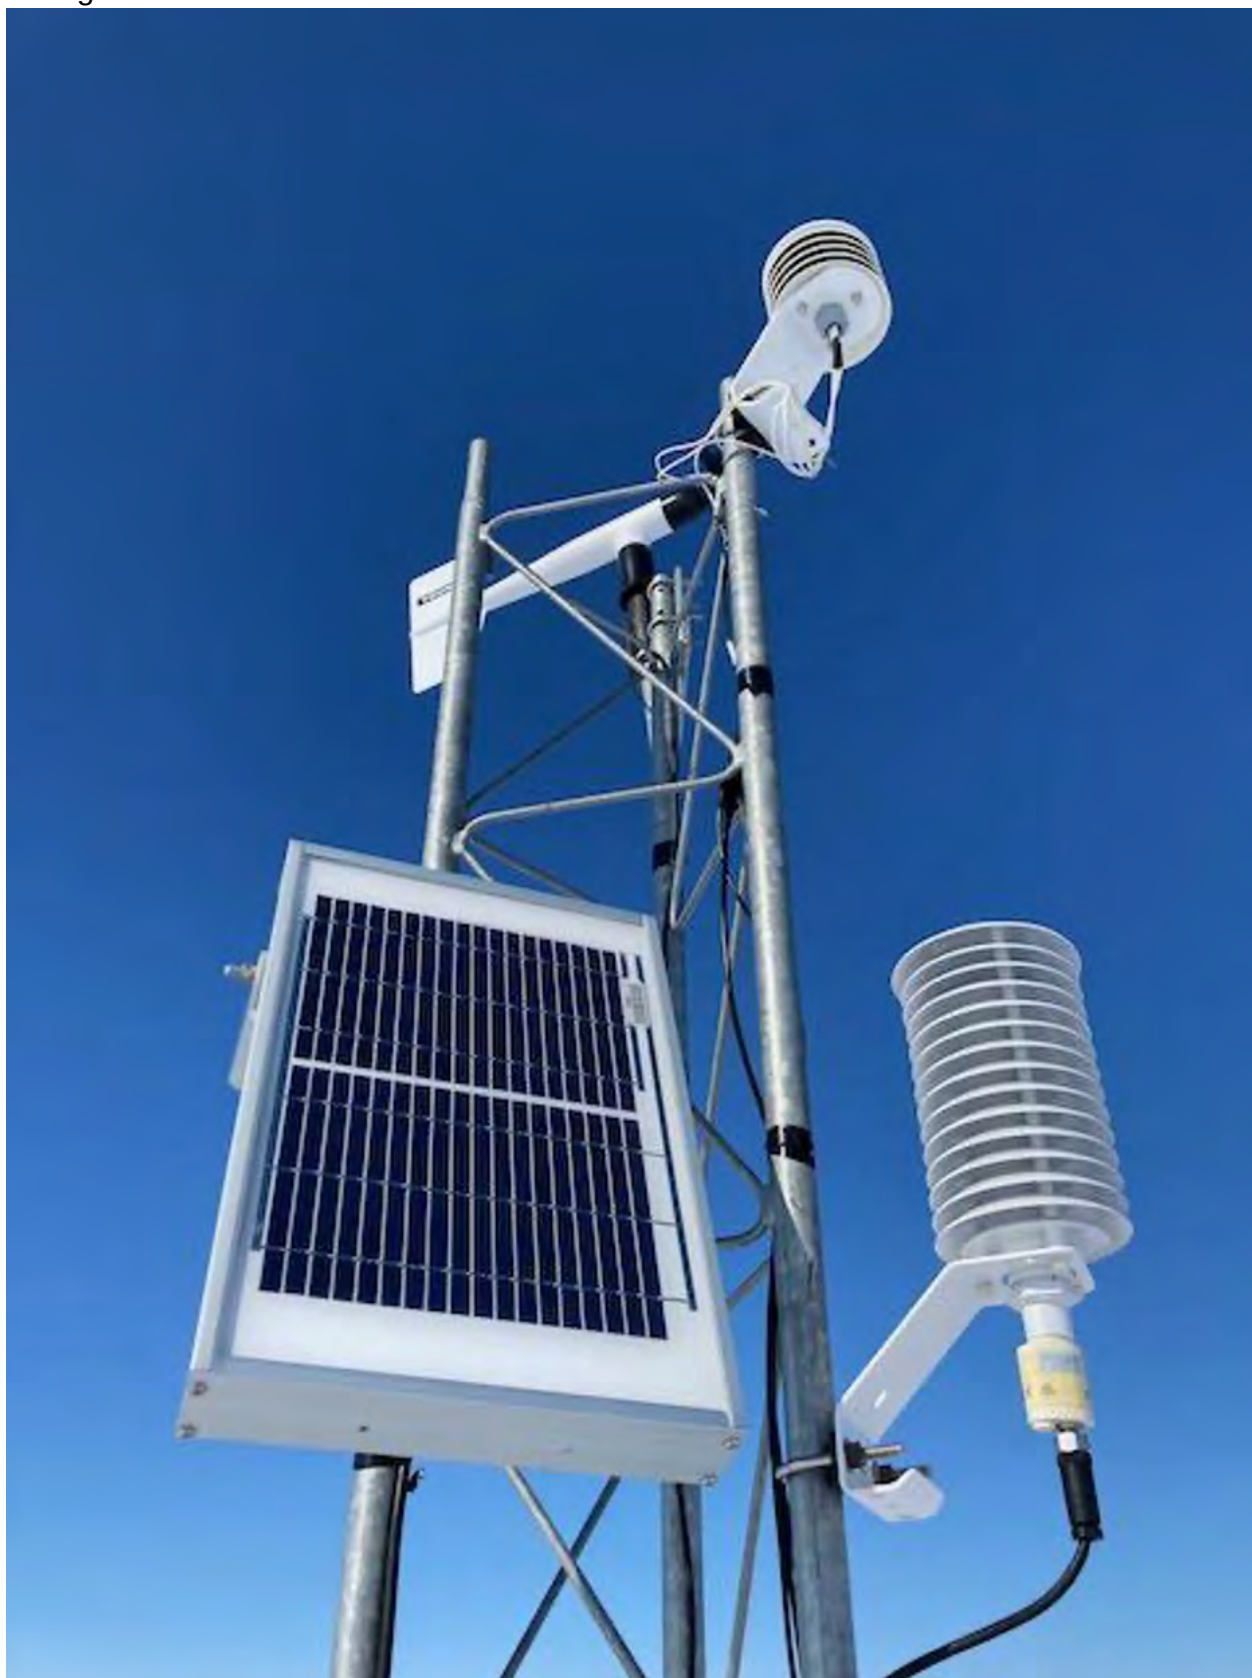
Wind tilting issue.

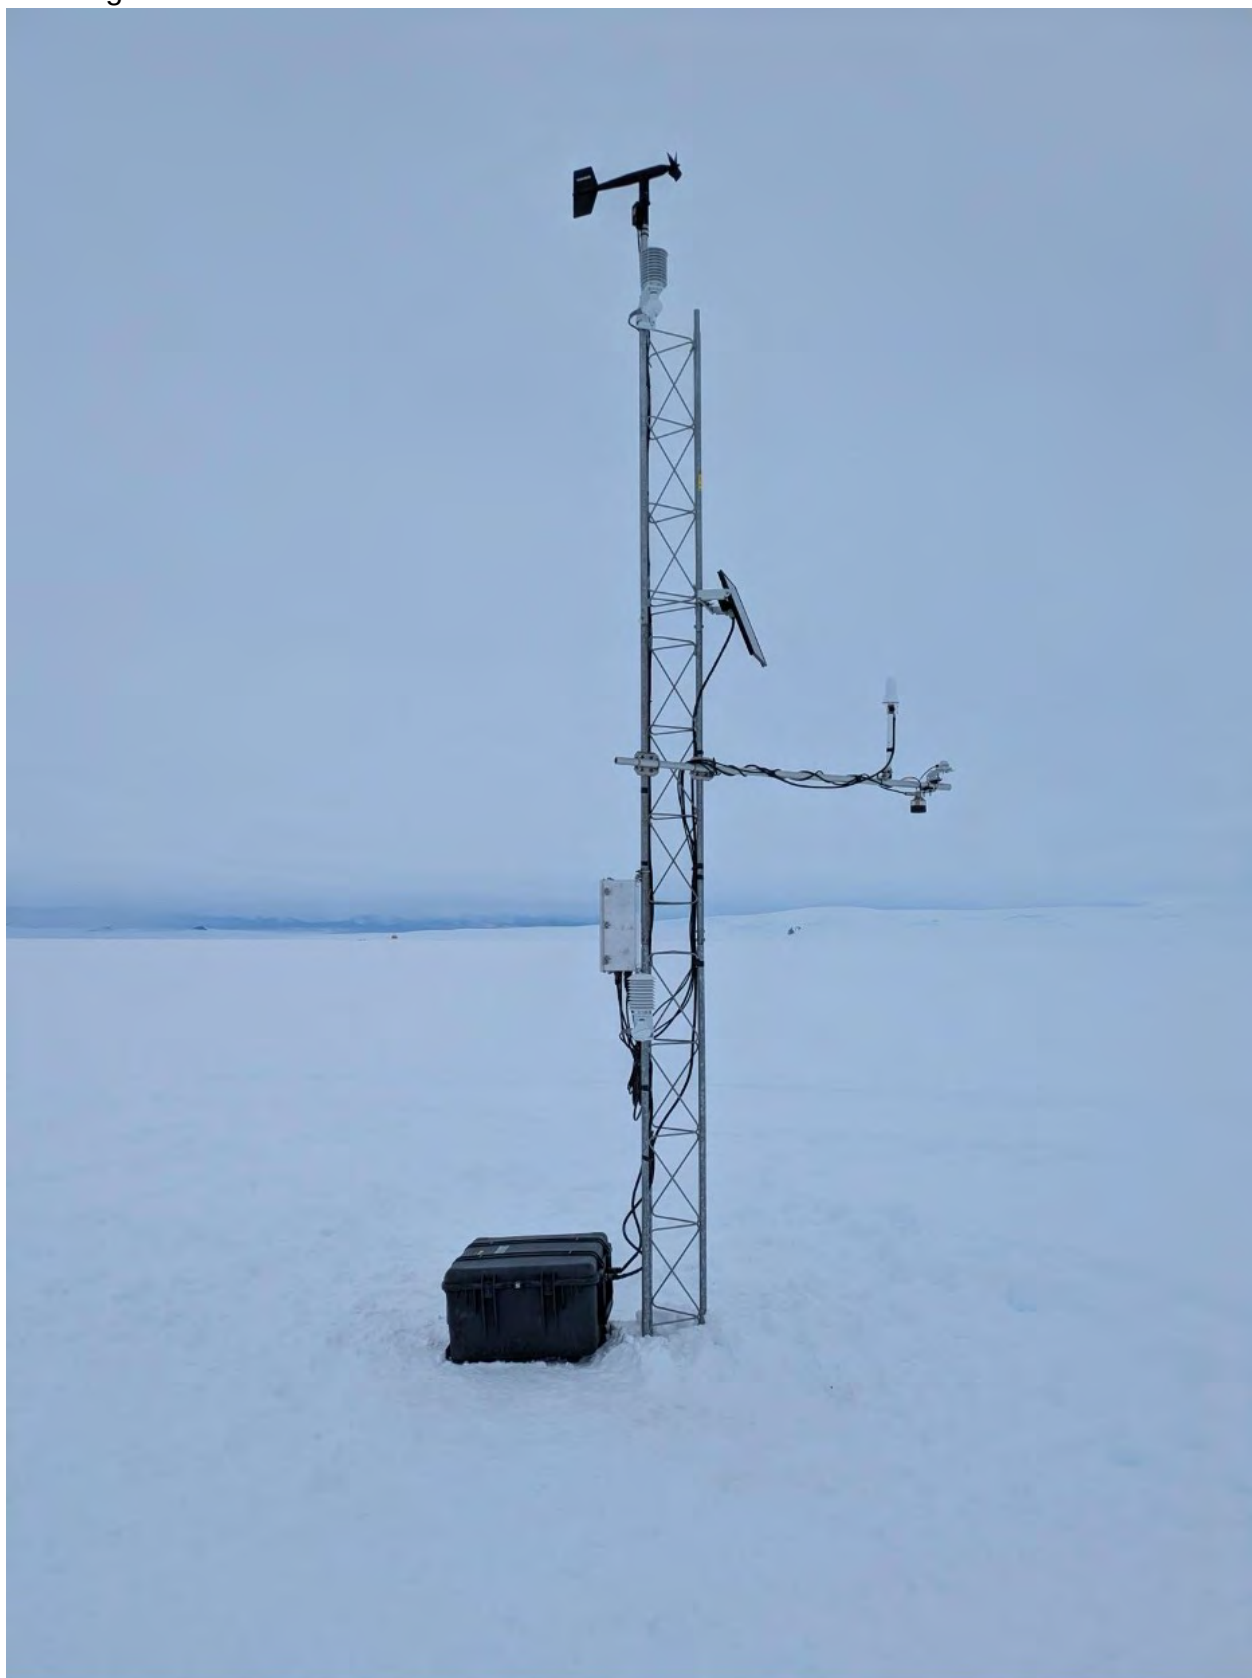
Windless Bight AWS after RH sensor was removed.
