## **AWS Field Report 2025-26**

**Field Team: Matthew Lazzara, Lee Welhouse, Forbes Filip**

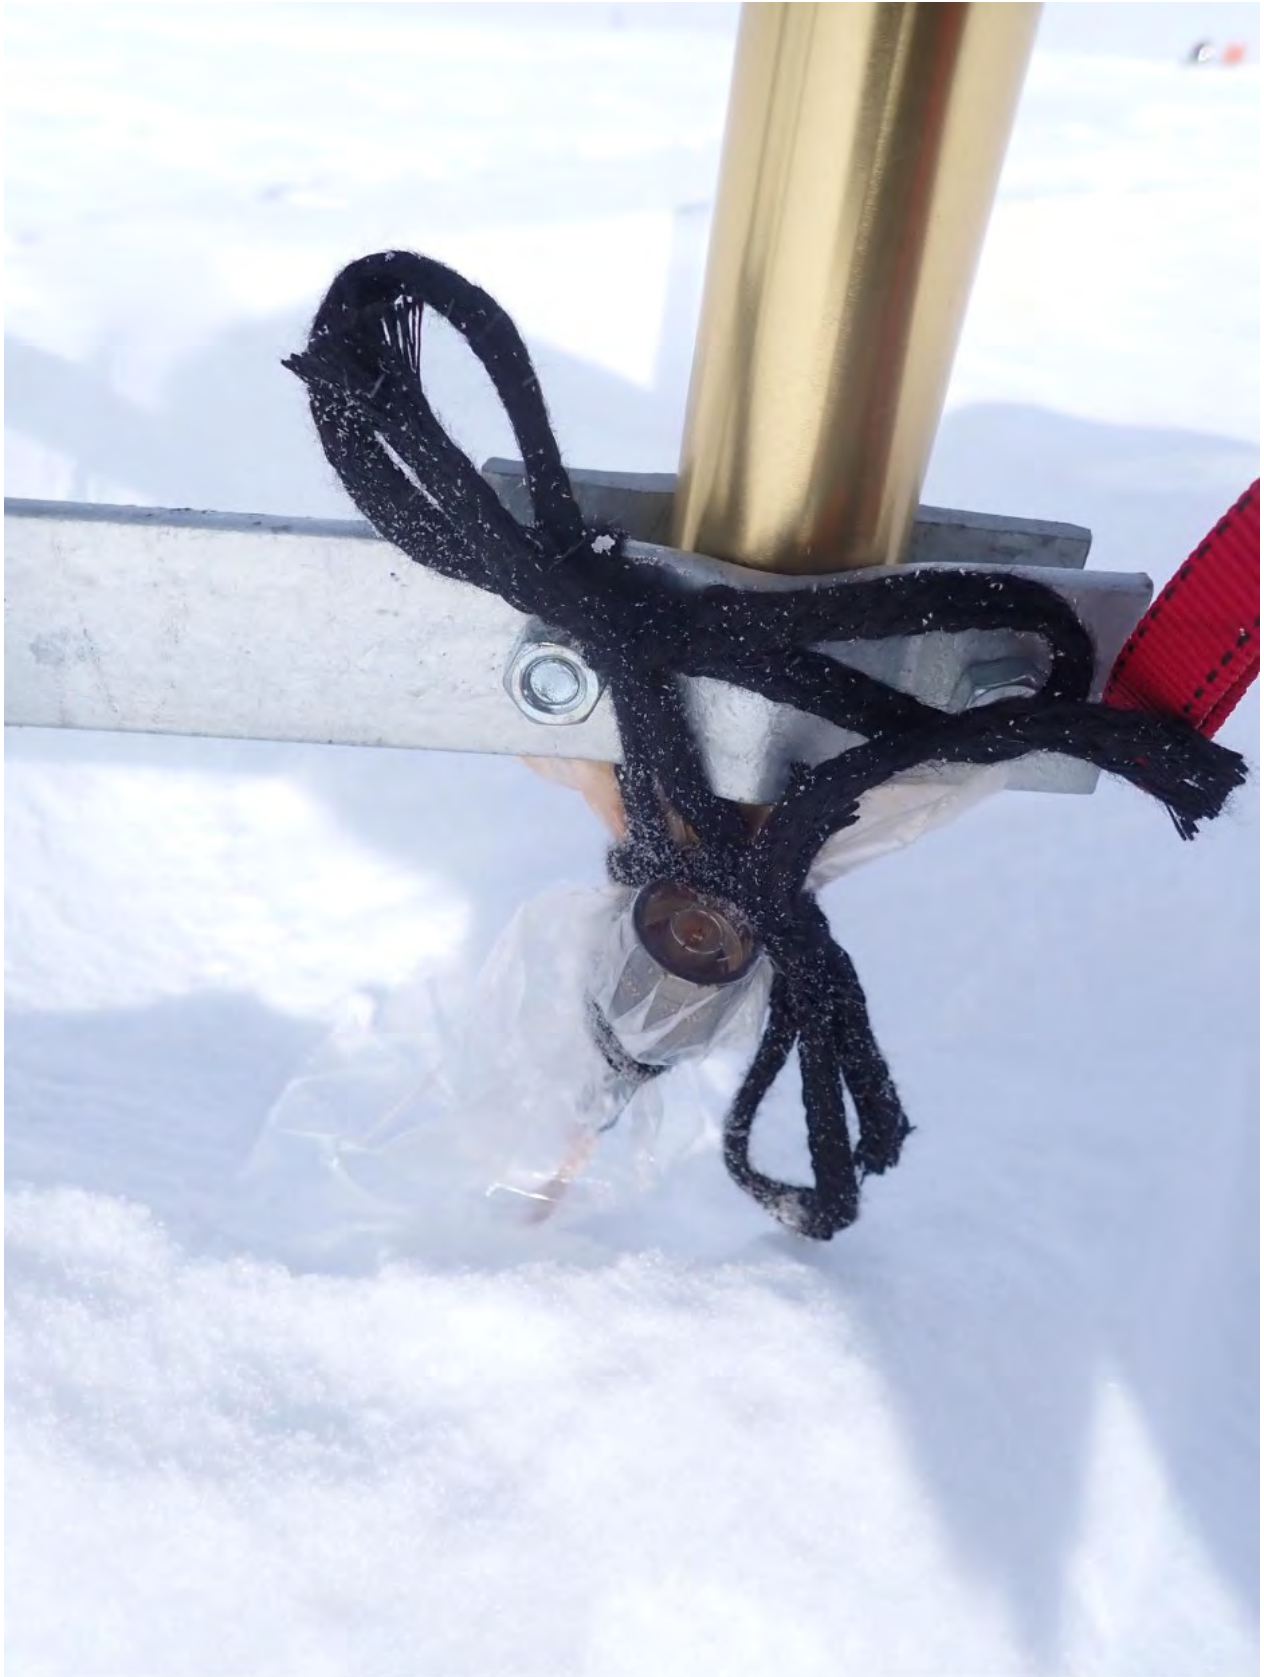
Argos antenna cable unplugged from antenna and secured. Photo courtesy of Prof. Dr. Fumio Nakazawa at NIPR.

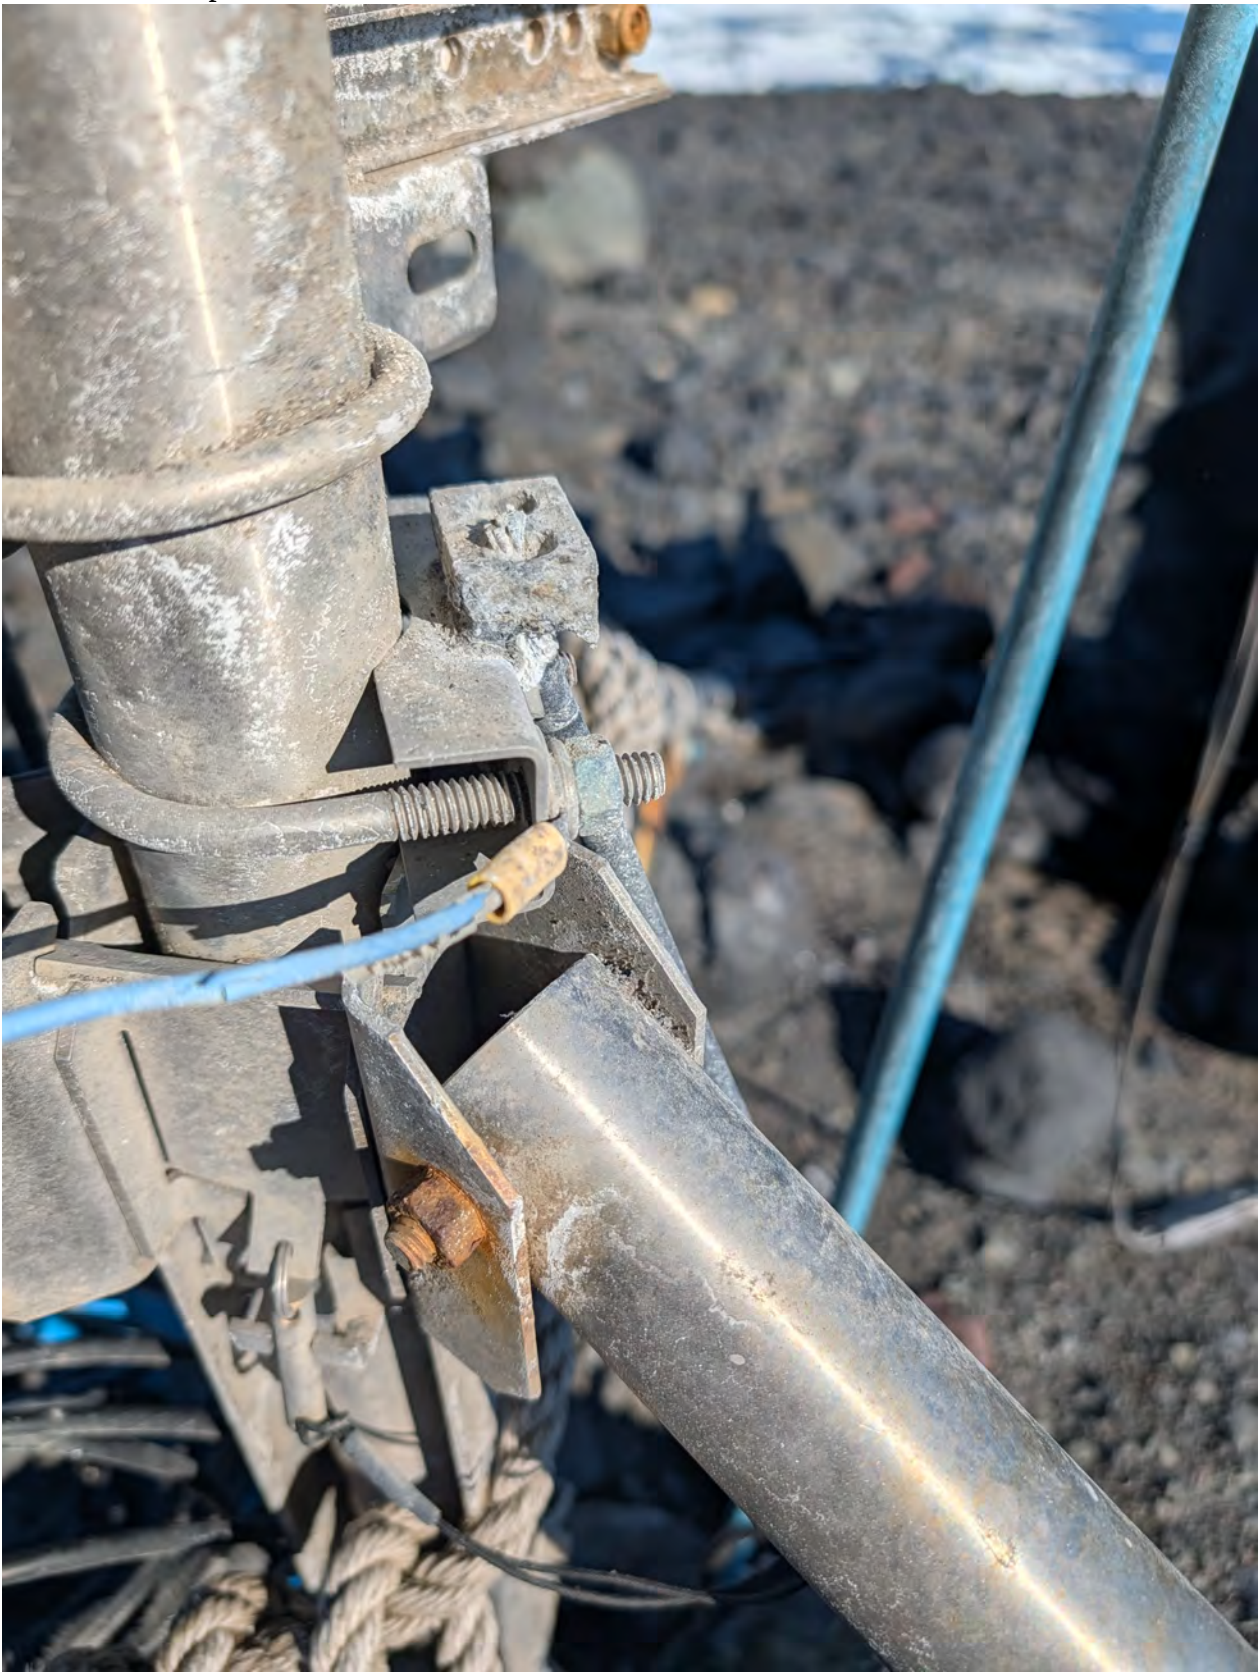
Light corrosion on tripod hardware

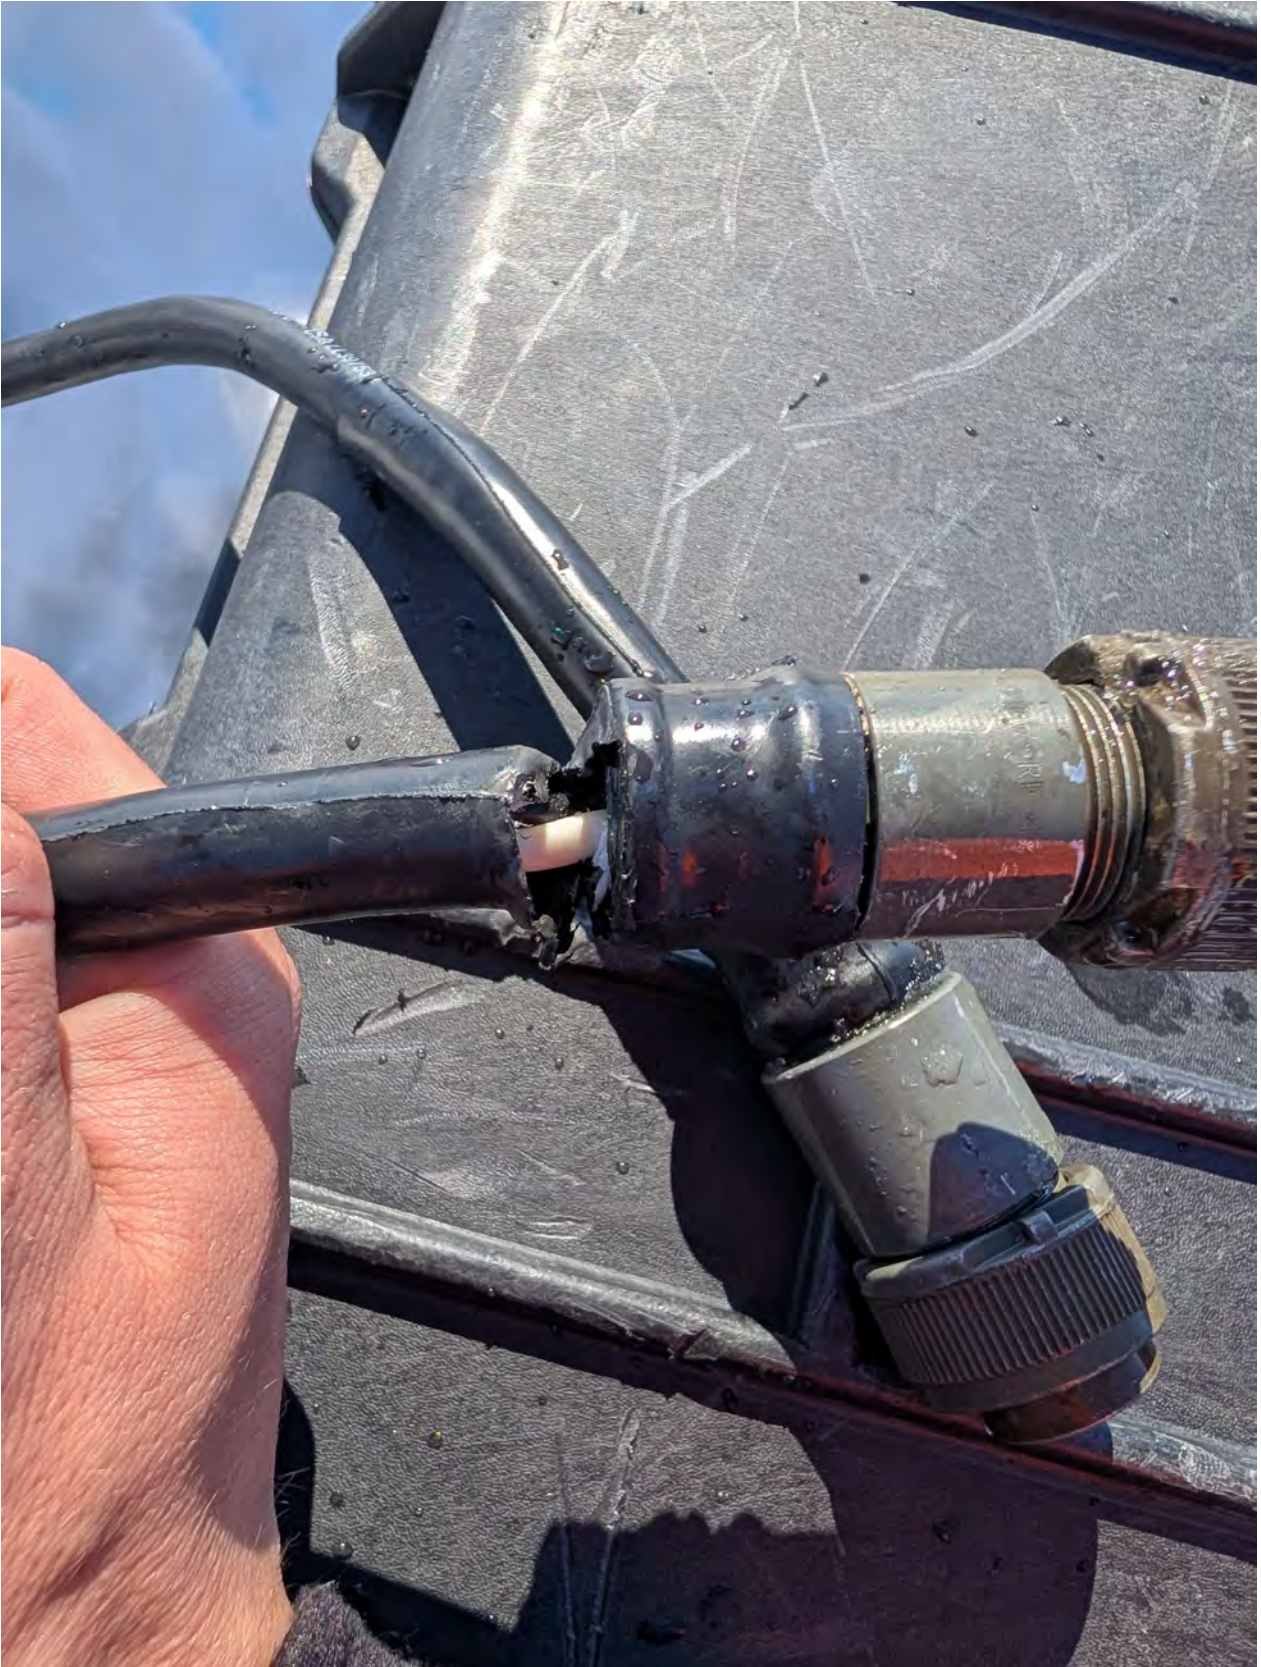
Field Work Notes: All instruments in working shape. Dug out the battery box from around 30" below surface. Replaced two batteries in the battery box. Strain relief on mil-spec plugs that enter the battery box are cracked; verified end-to-end continuity for solar panel and battery power and then repaired separated strain reliefs with electrical tape. Verified Argos transmissions with Telonix before leaving.

Power system cable strain reliefs - cracked

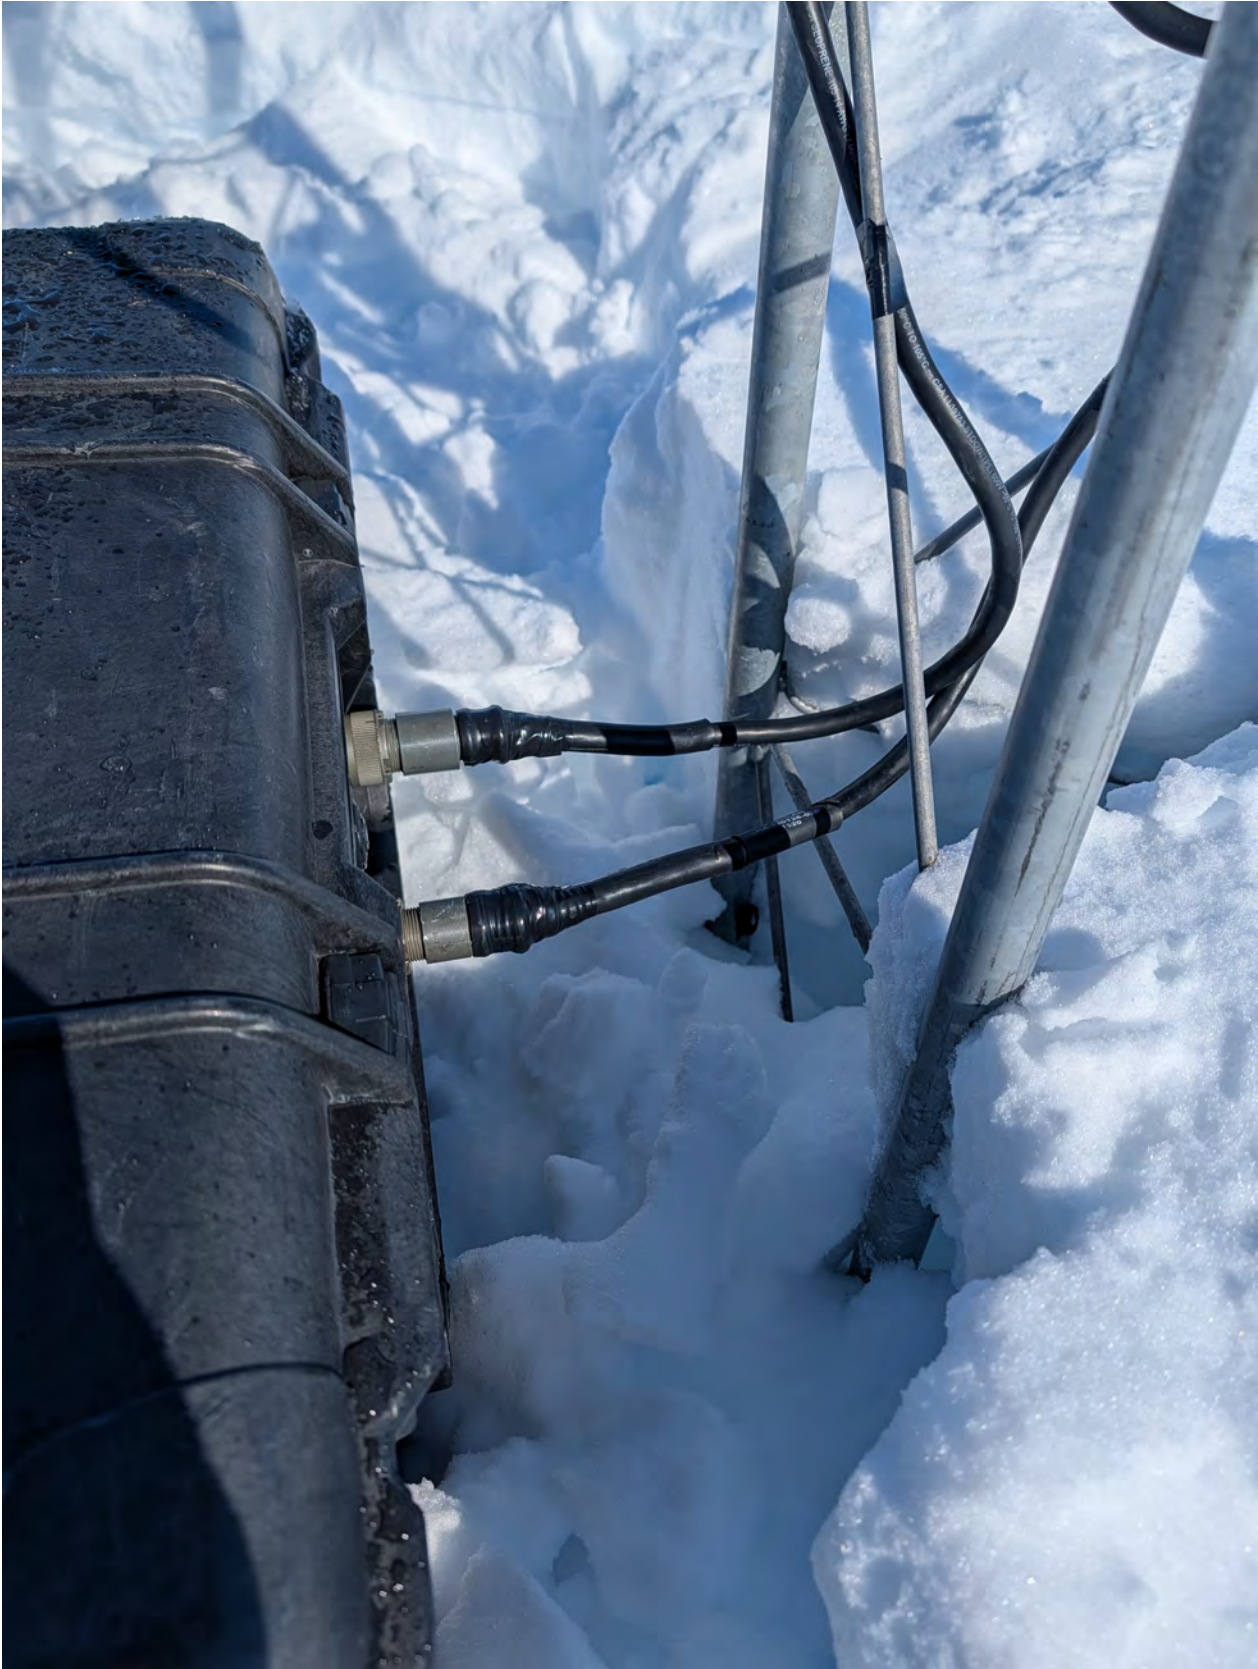
Power system cable strain reliefs - repaired

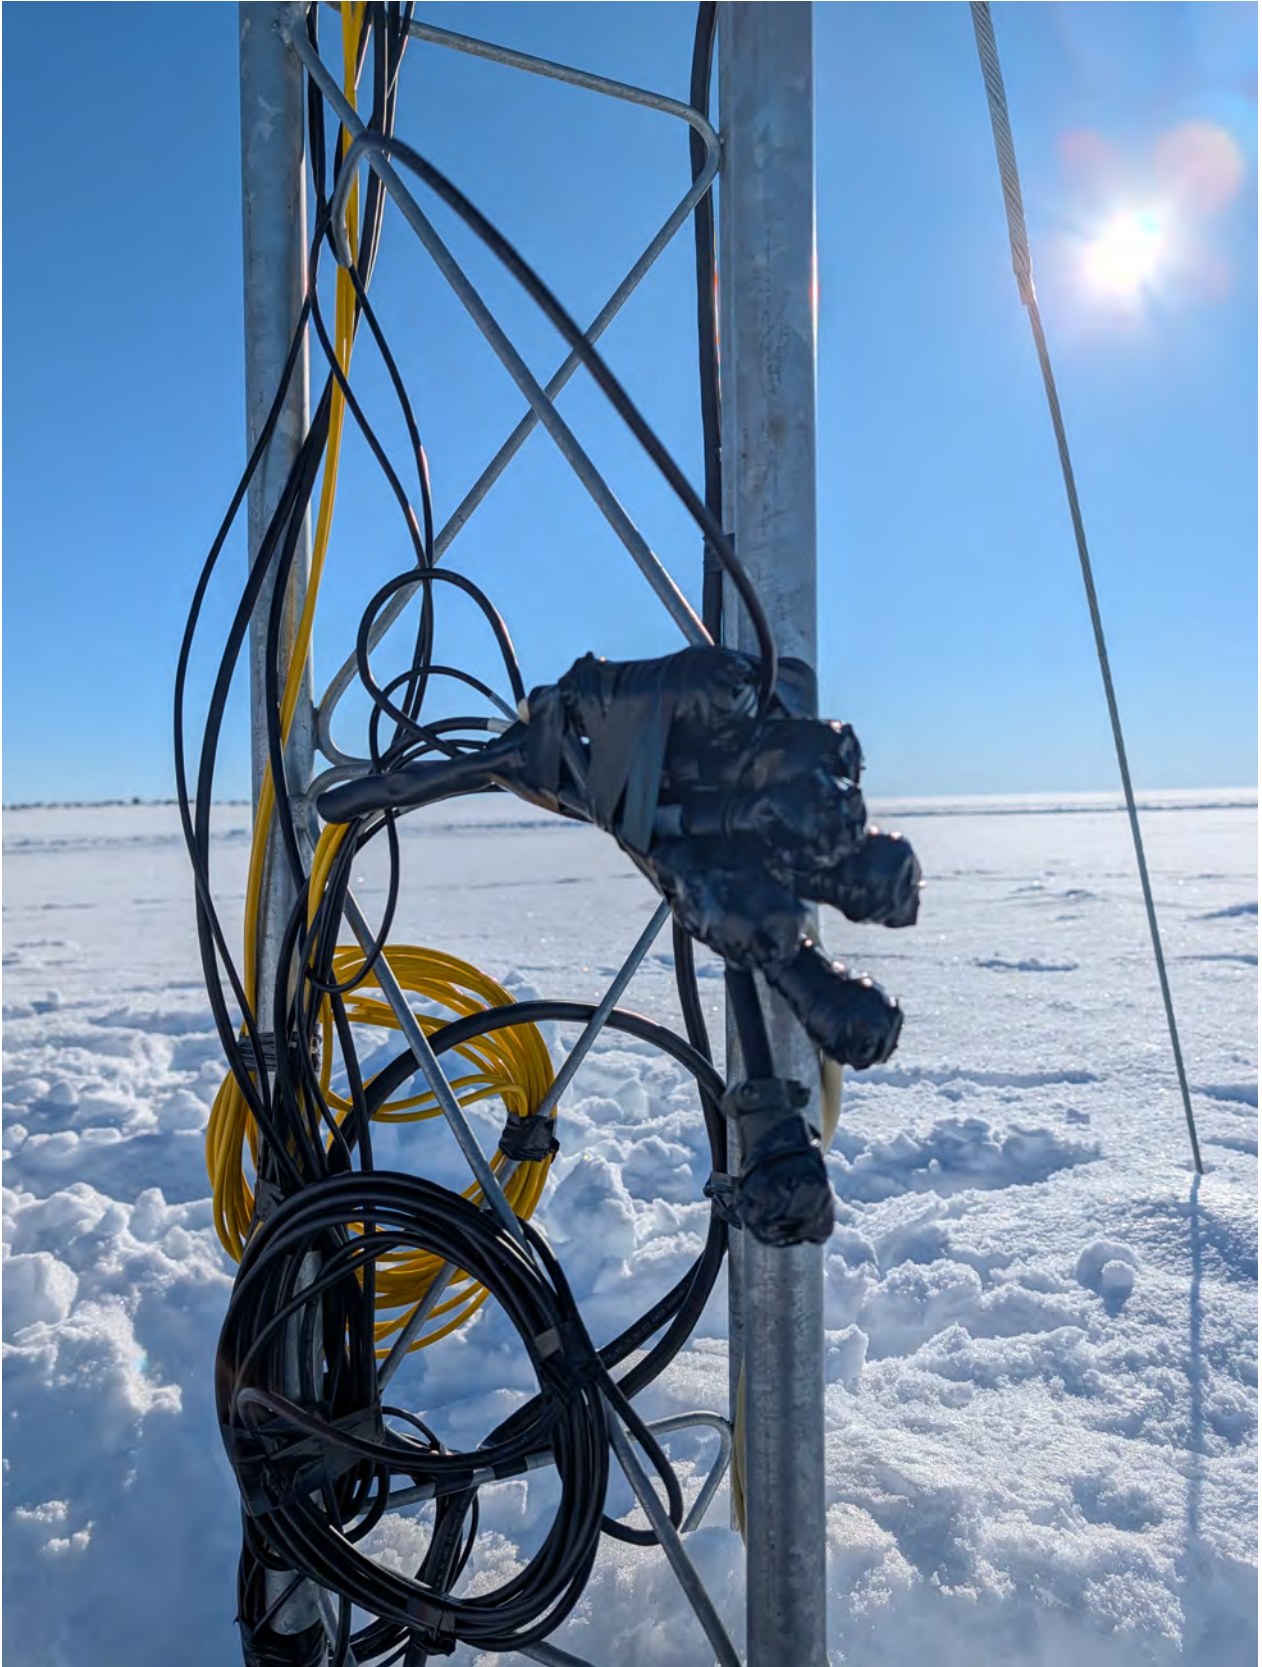
All enclosure plugs covered with electrical tape - courtesy of MKB crew members Luke and Brody

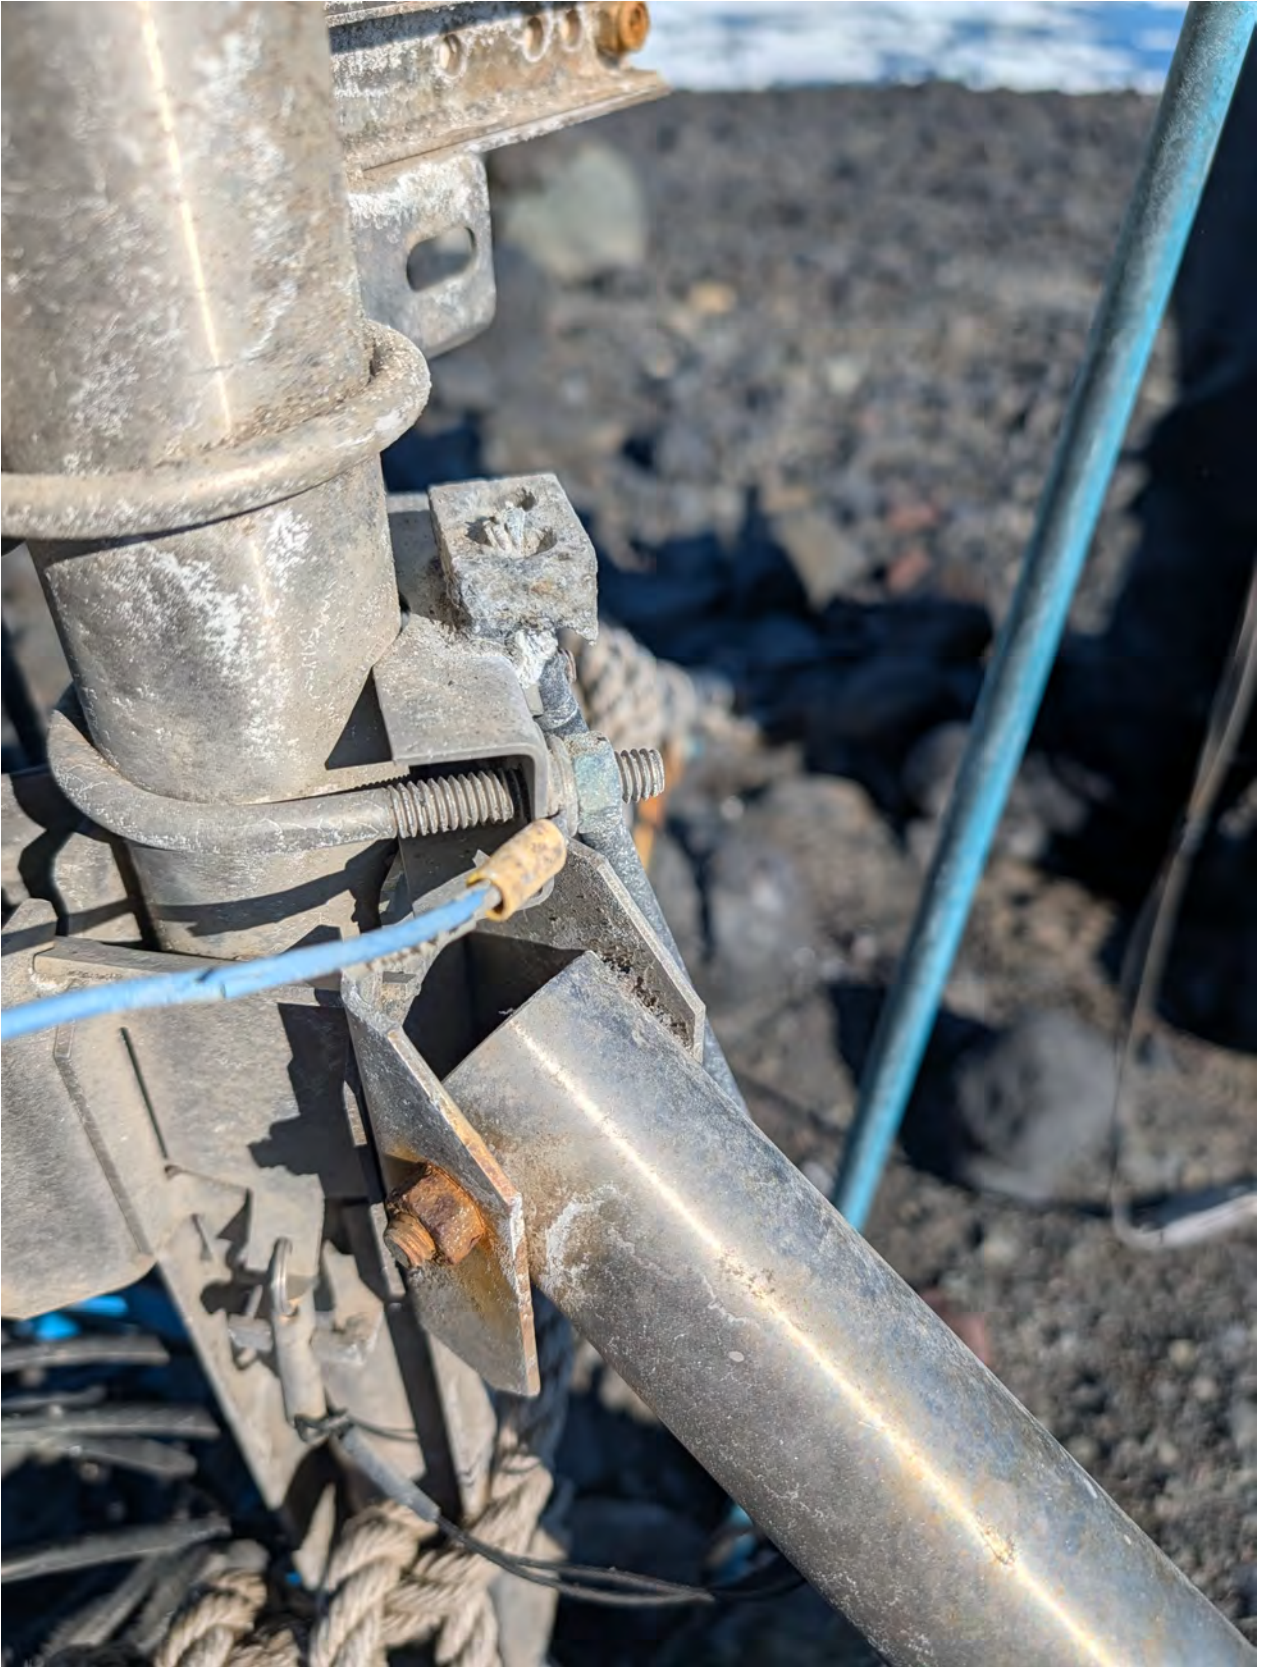
Earth ground strap properly fastened to tripod tower base

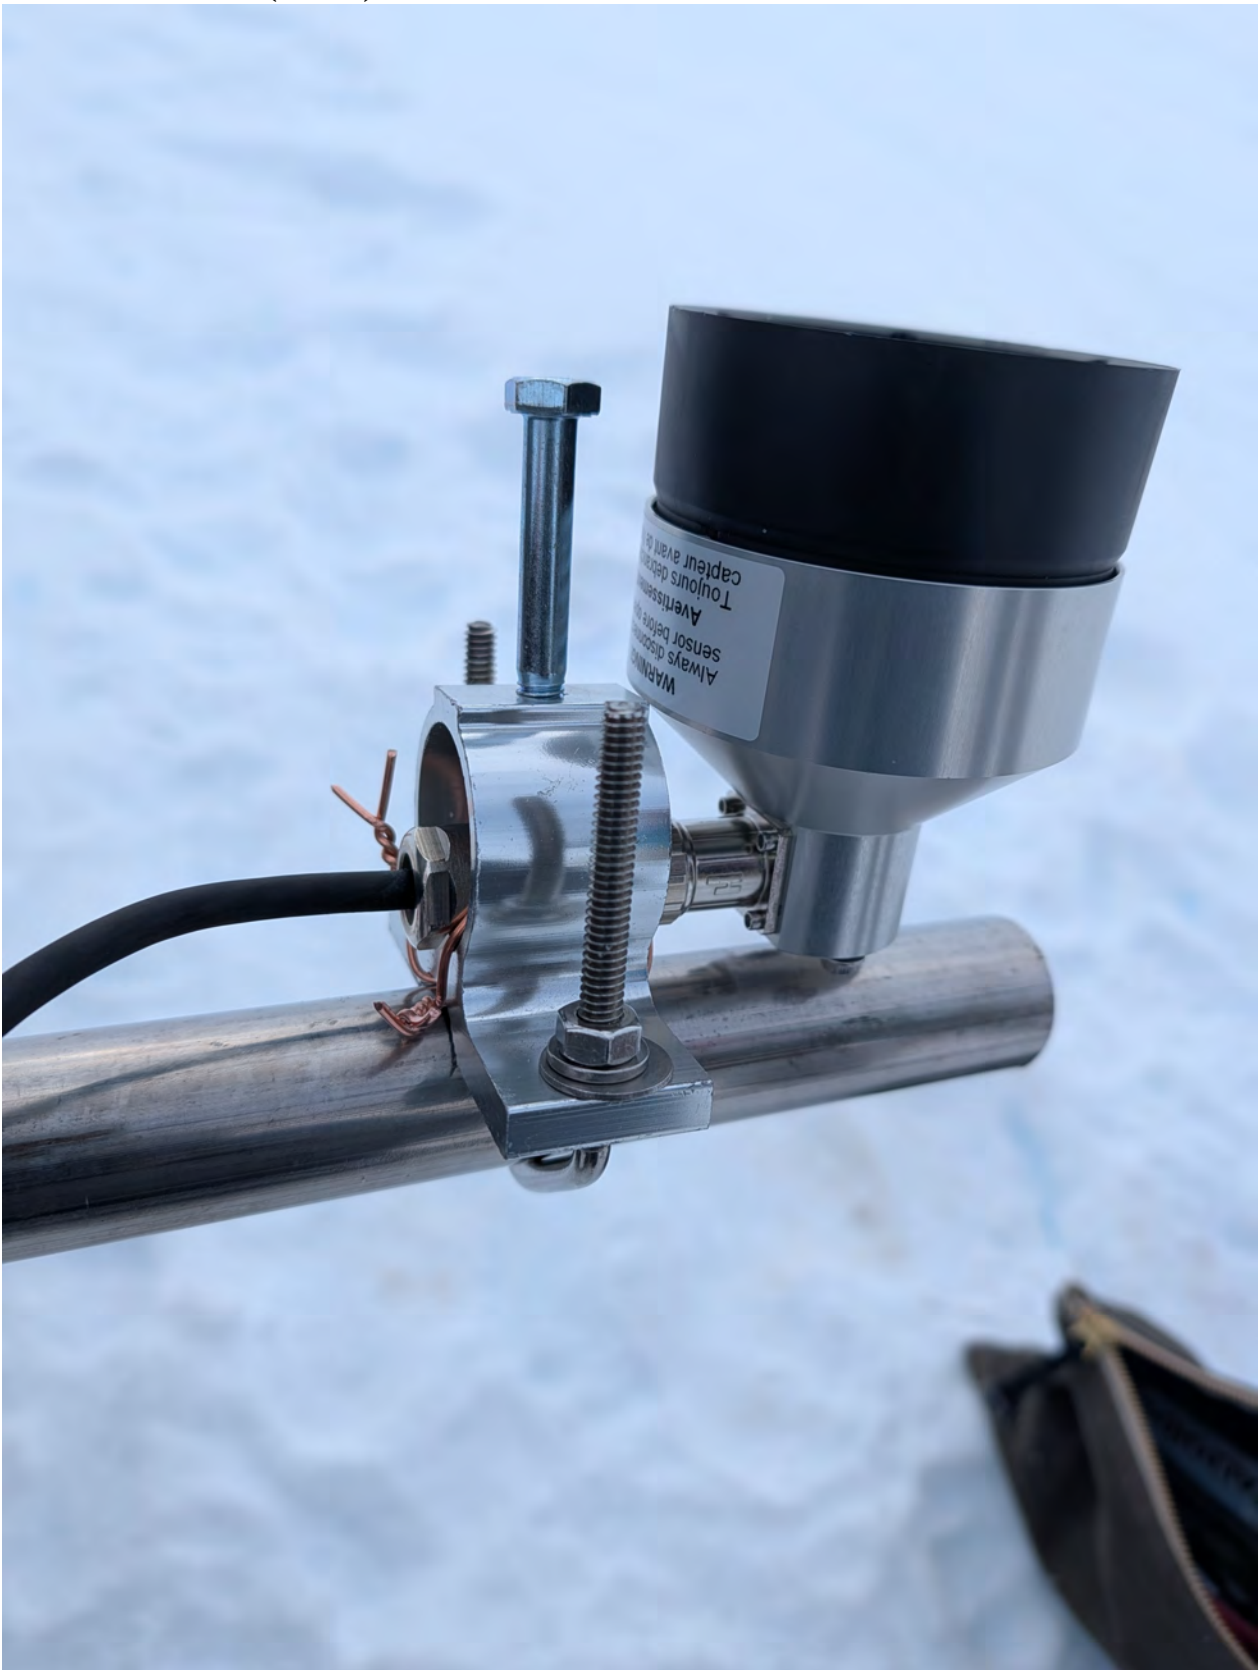
Field Work Notes: The AWS site had a naked tower in place from a previous visit on 12/29/2025. All instruments and electronics were installed on the tower. There was a missing bracket for the ADG instrument; a makeshift bracket was fabricated using a spare antenna mount and copper tie wire. The station was not transmitting before departure; will have to revisit to repair/update.

ADG - makeshift bracket (view 2)
