AWS Field Report 2016-17

Field Team: Lee Welhouse, Carol Costanza, and Dave Mikolajczyk

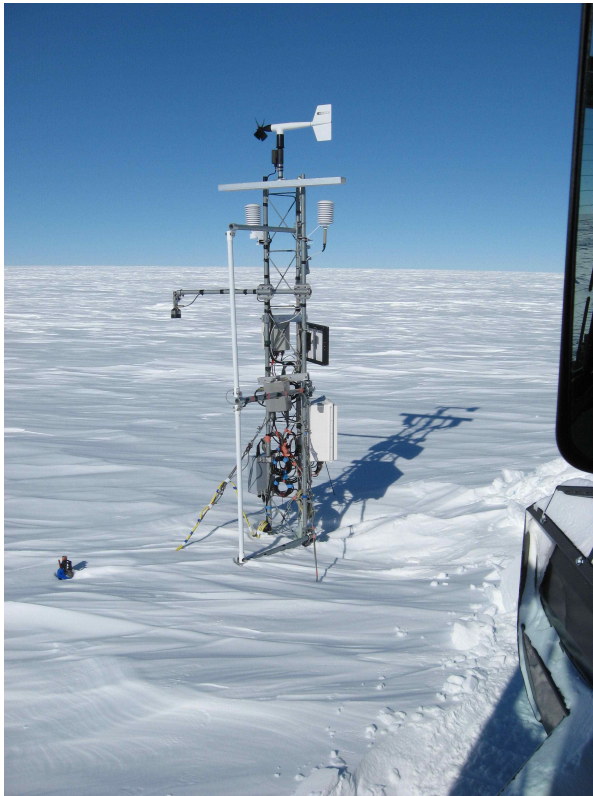
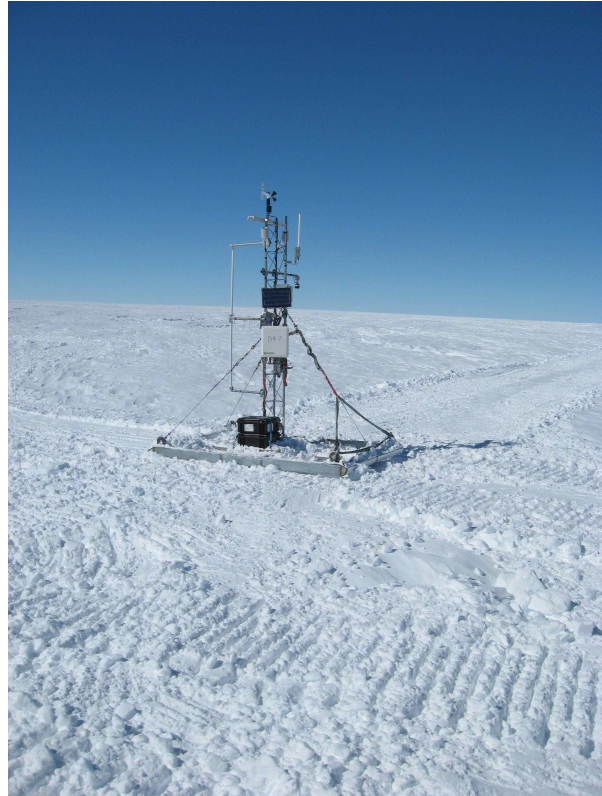
D-47 AWS photos courtesy of Philippe Dordhain

Notes on arrival: The aerovane was missing its propeller. This was found in two pieces on the ground near the mast. Apart from the metal outer tube there was nothing left of the SR50. There were signs of corrosion and salt deposit on the logger box cable glands. All mast instrument attachments were very rusty. The battery box looked in good condition. The guys were rusty with some signs of damage but they were deemed safe. There was a redundant battery box left on the ground near the base of the mast. This was a wooden case with two very corroded batteries inside. (This was returned to Rothera where it was disposed of.)

AWS was very damaged and might not have lasted another year.

The old instruments, solar panel, logger box and dump box were removed. All the U-bolts and attachments were severely rusted so they had to be cut (and bashed) to remove them from the mast. New instruments, ARGOS antenna, solar panel and logger box were attached, starting at the top and working down. The pipe supplied for mounting the propvane fitted over the leg of the mast but one of the bolts was too large for the hole so the pipe could only be secured with one bolt. Despite this, the mount felt secure.
