## **AWS Field Report 2025-26**

**Field Team: Matthew Lazzara, Lee Welhouse, Forbes Filip**

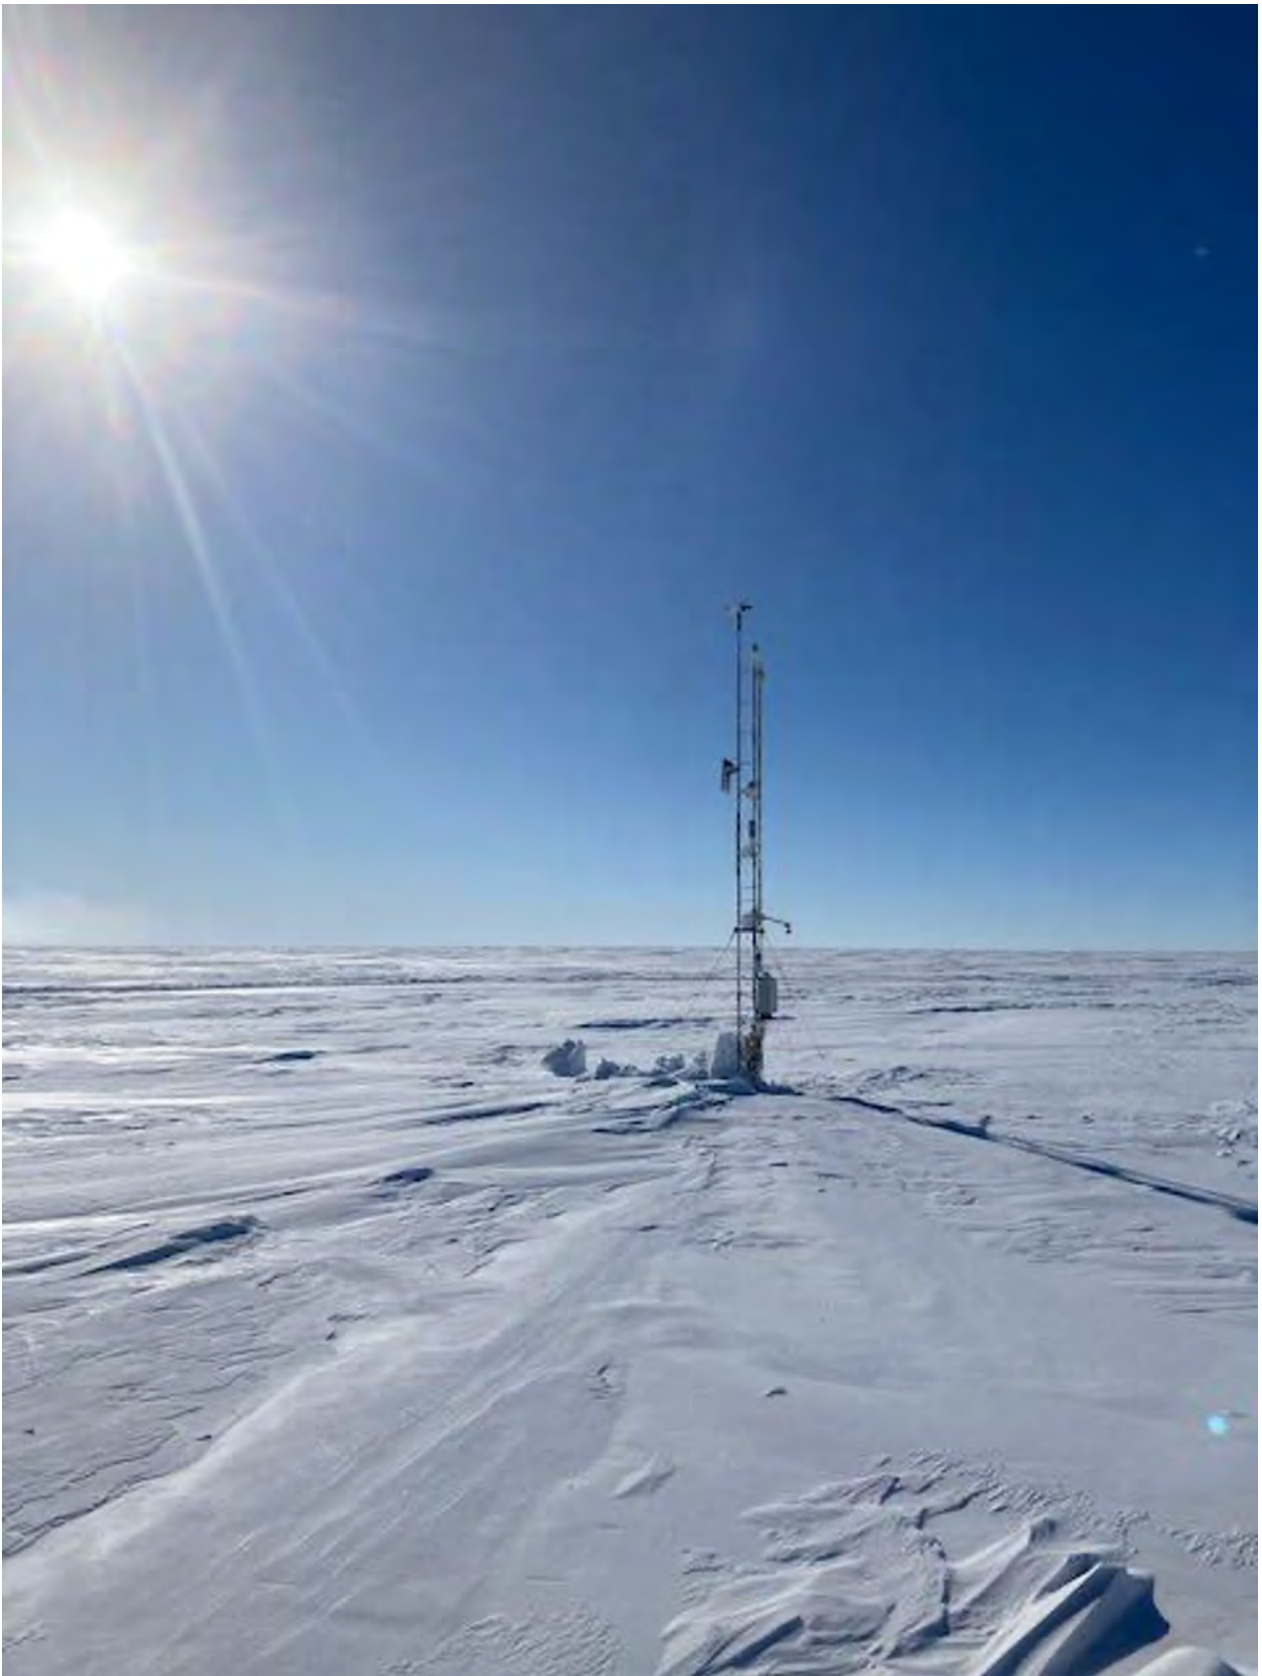
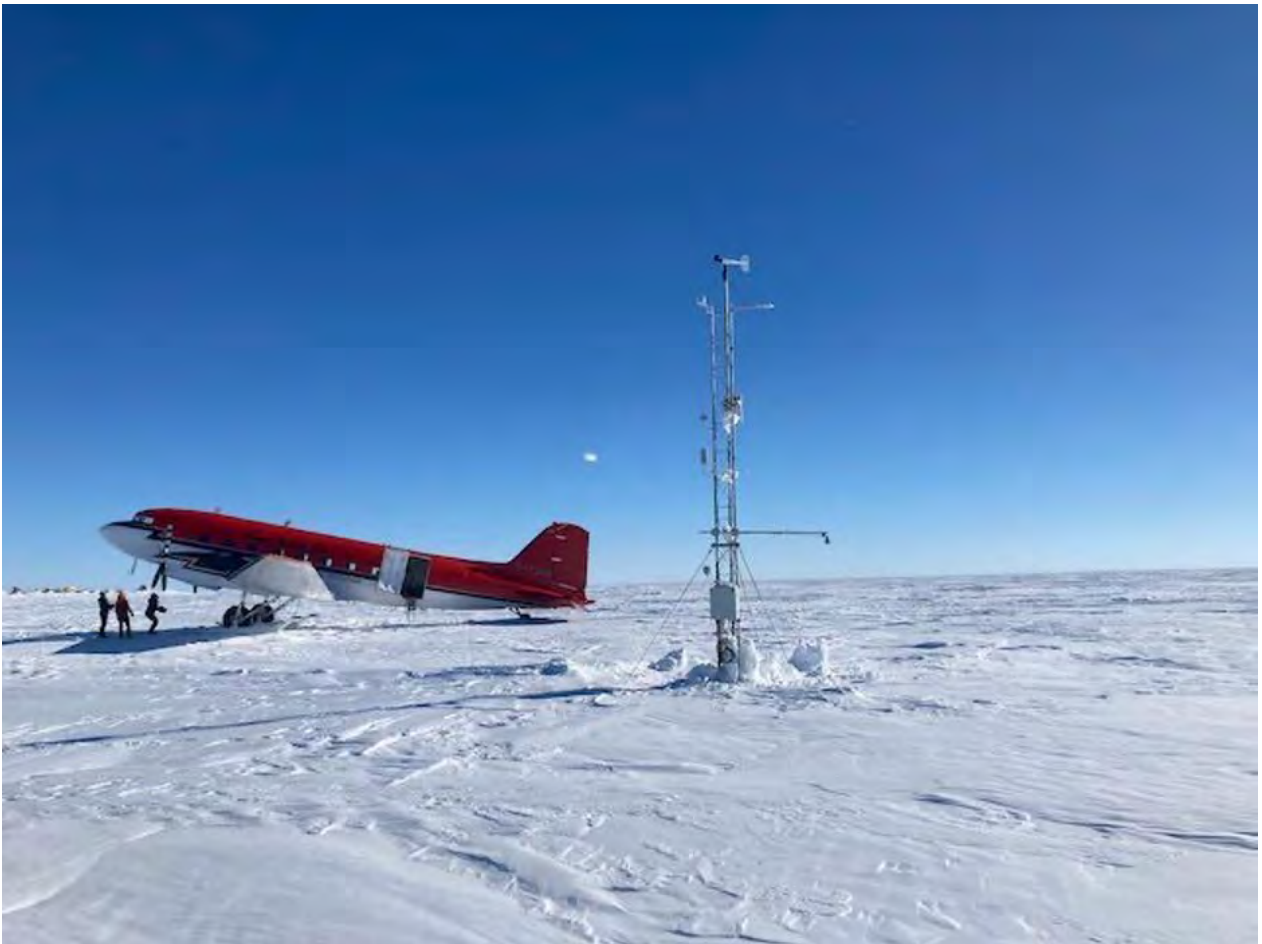
Field Work Notes: The station was covered by ice and rime lately. All of the ice and snow around it is from the tower but we did not do any digging here. I think the fuel test flight from a few weeks ago it was reportedly like that. Only left over remnants could be seen today of the riming. Lee found a few issues with the station: Antenna cable was not in - it explains an instant transmission when we hooked up and he barely touched it. The CR1000 Lithium battery is dying. The main batteries are also not all that they could be. The date on the CR1000 was way off.

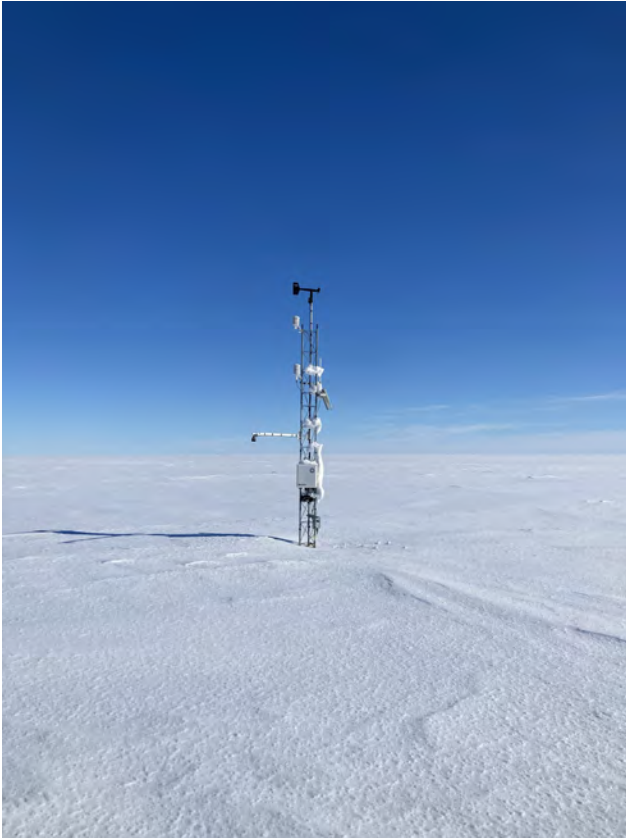
Upper tower nipples are starting to rust...bring a wire brush next time to clean off before mounting new tower

ADG is no working and the sensor should be replaced at next visit

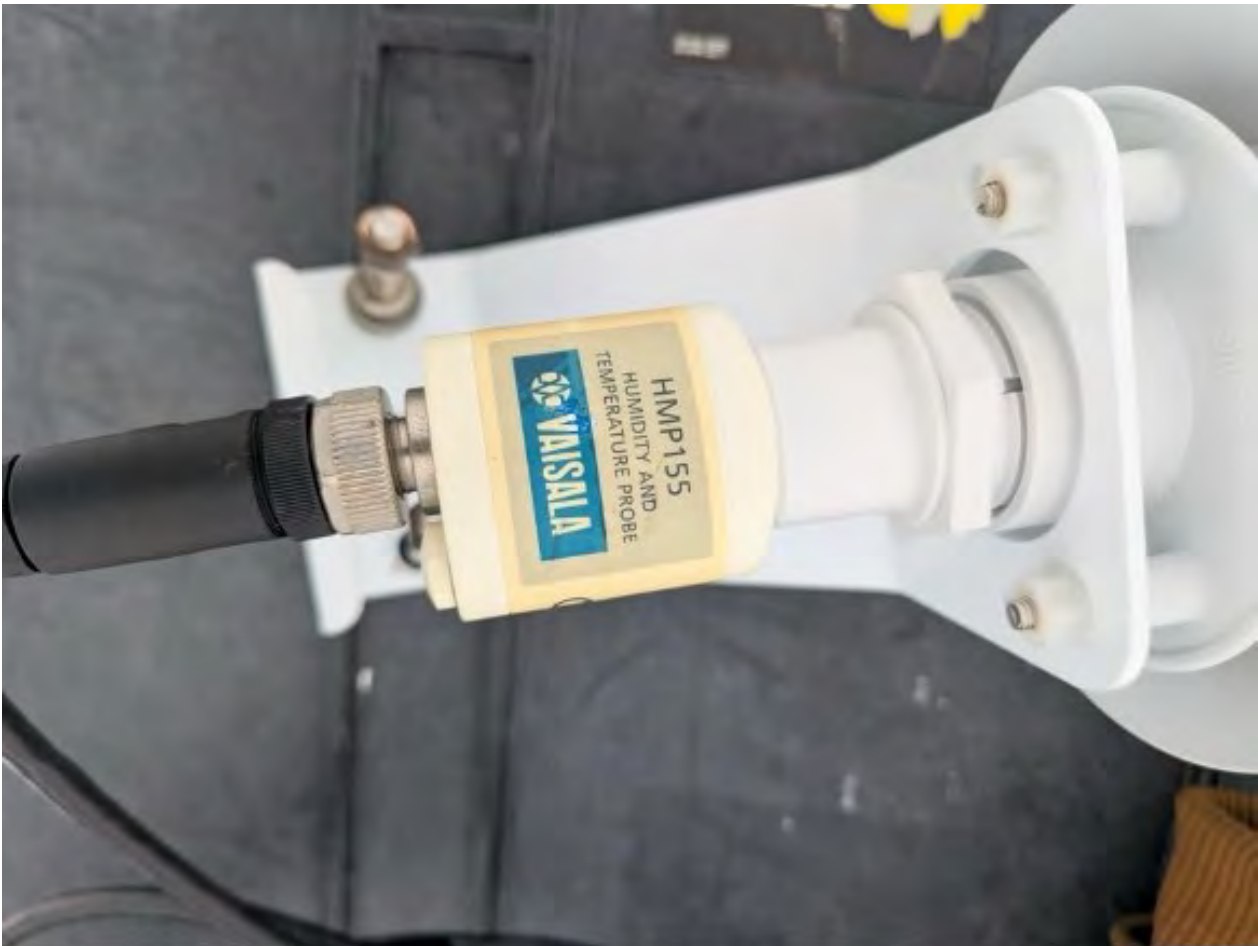
RH sensor that was removed

Purpose for Visit: Replace RH sensor

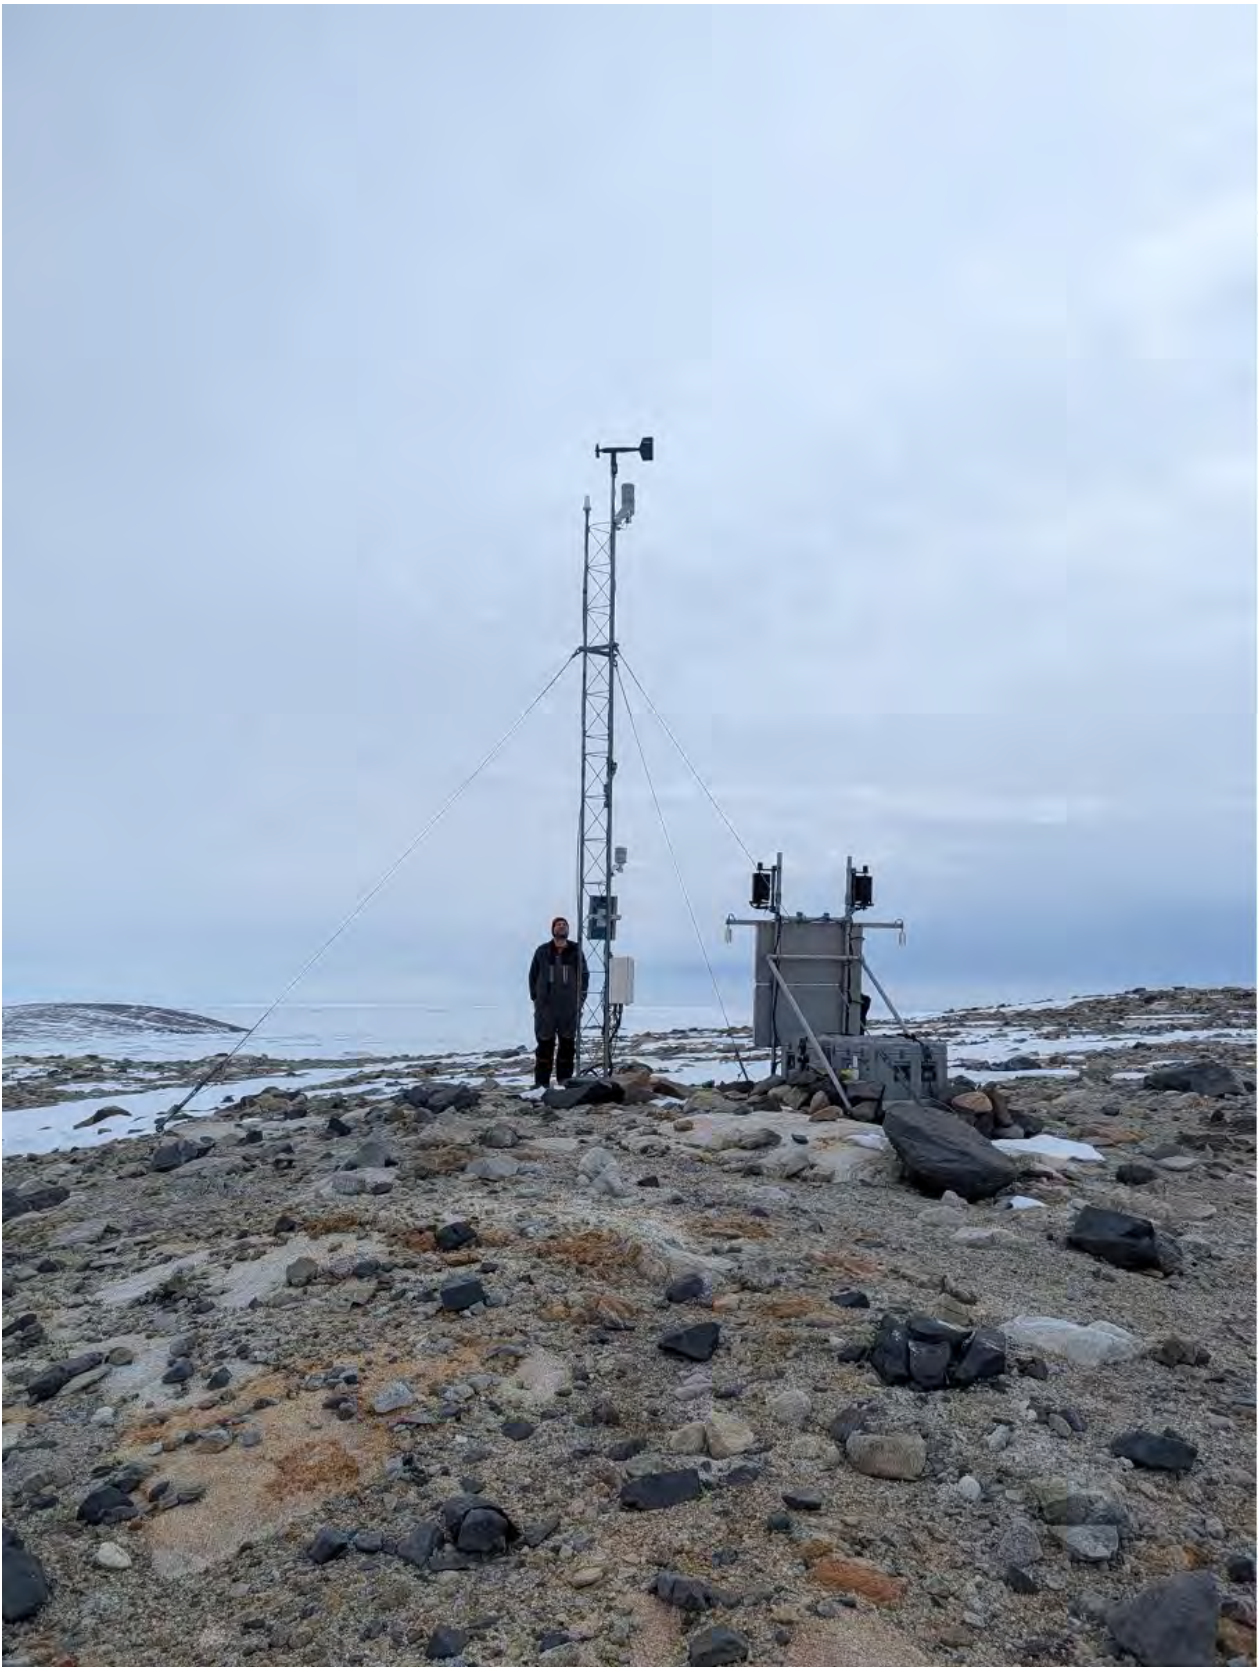
Field Work Notes: Noted that nuts and bolts need to be replaced at next visit. ADG has some corrosion, yet still functional (need to consider viability of ADG at site). No new measurements taken, rock floor site.
