## **AWS Field Report 2025-26**

**Field Team: Matthew Lazzara, Lee Welhouse, Forbes Filip**

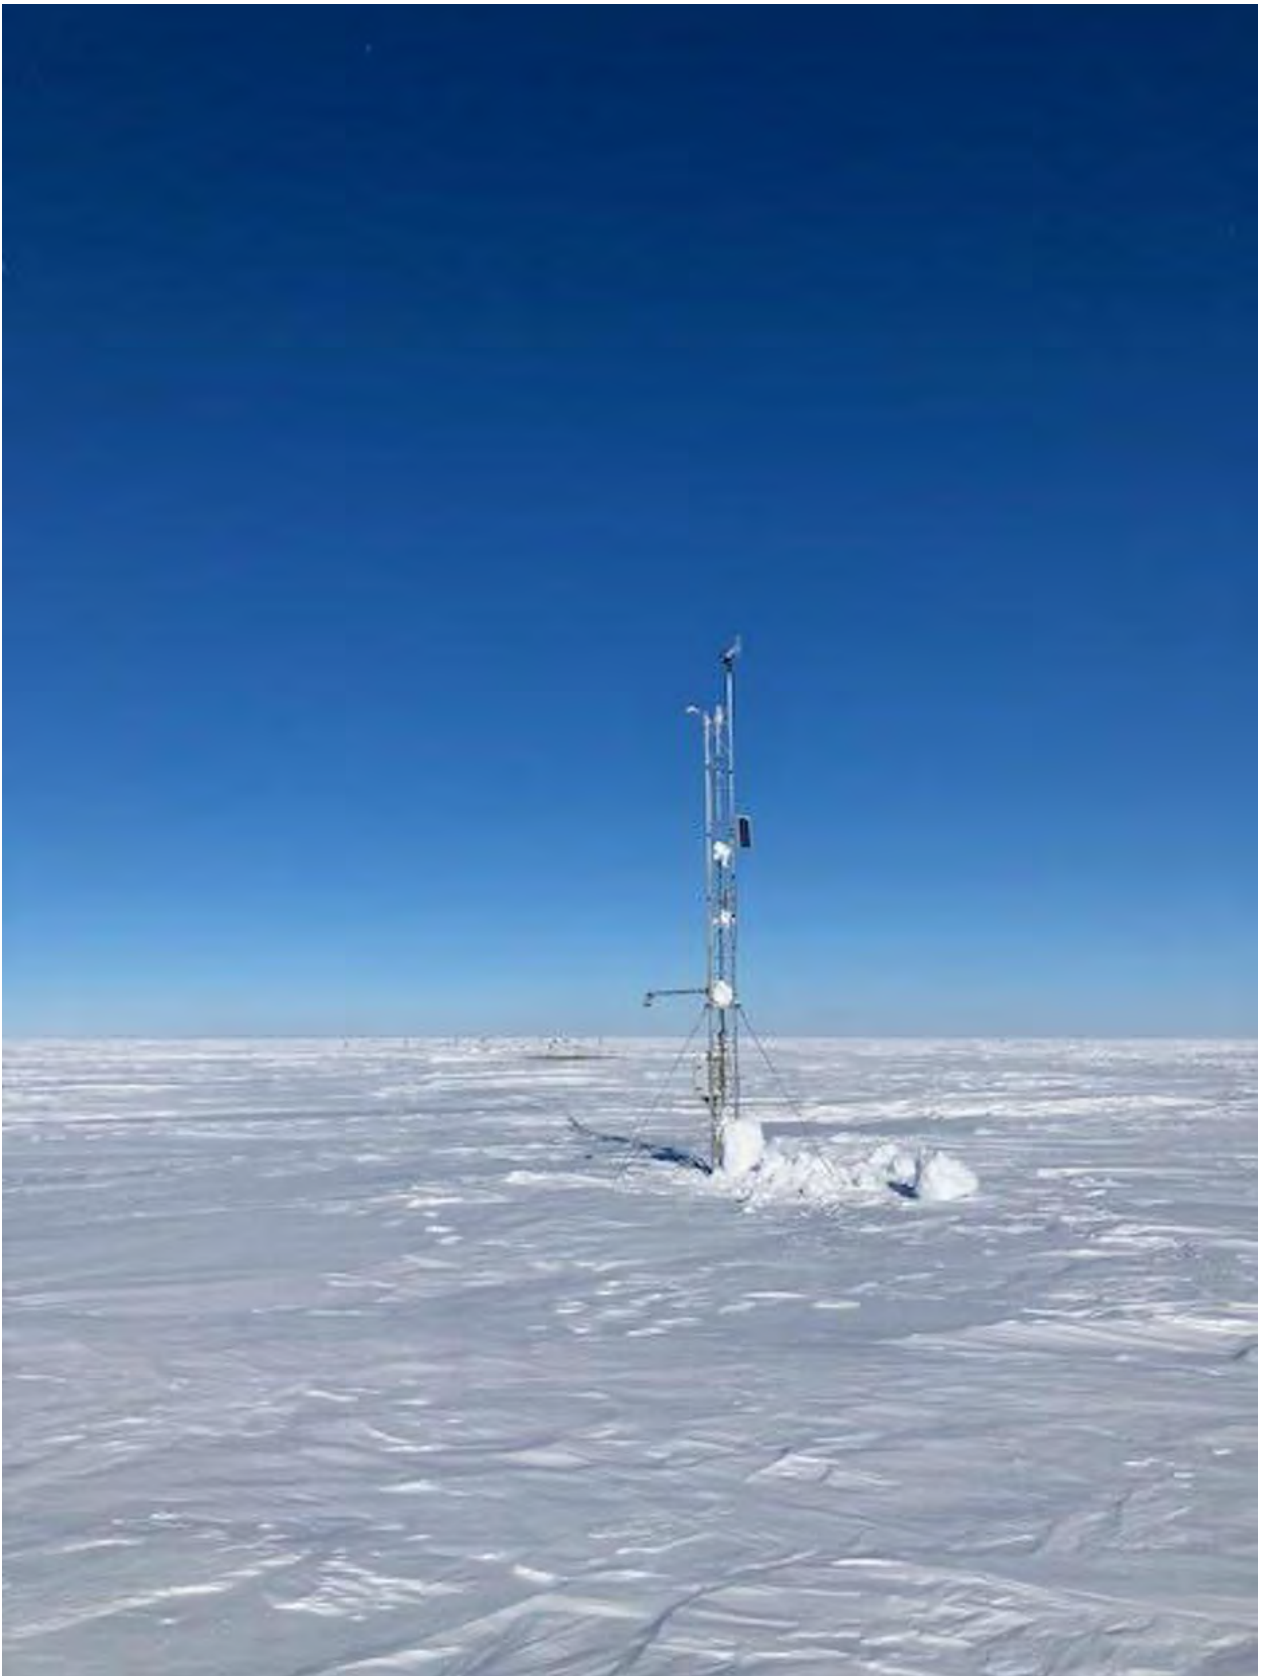
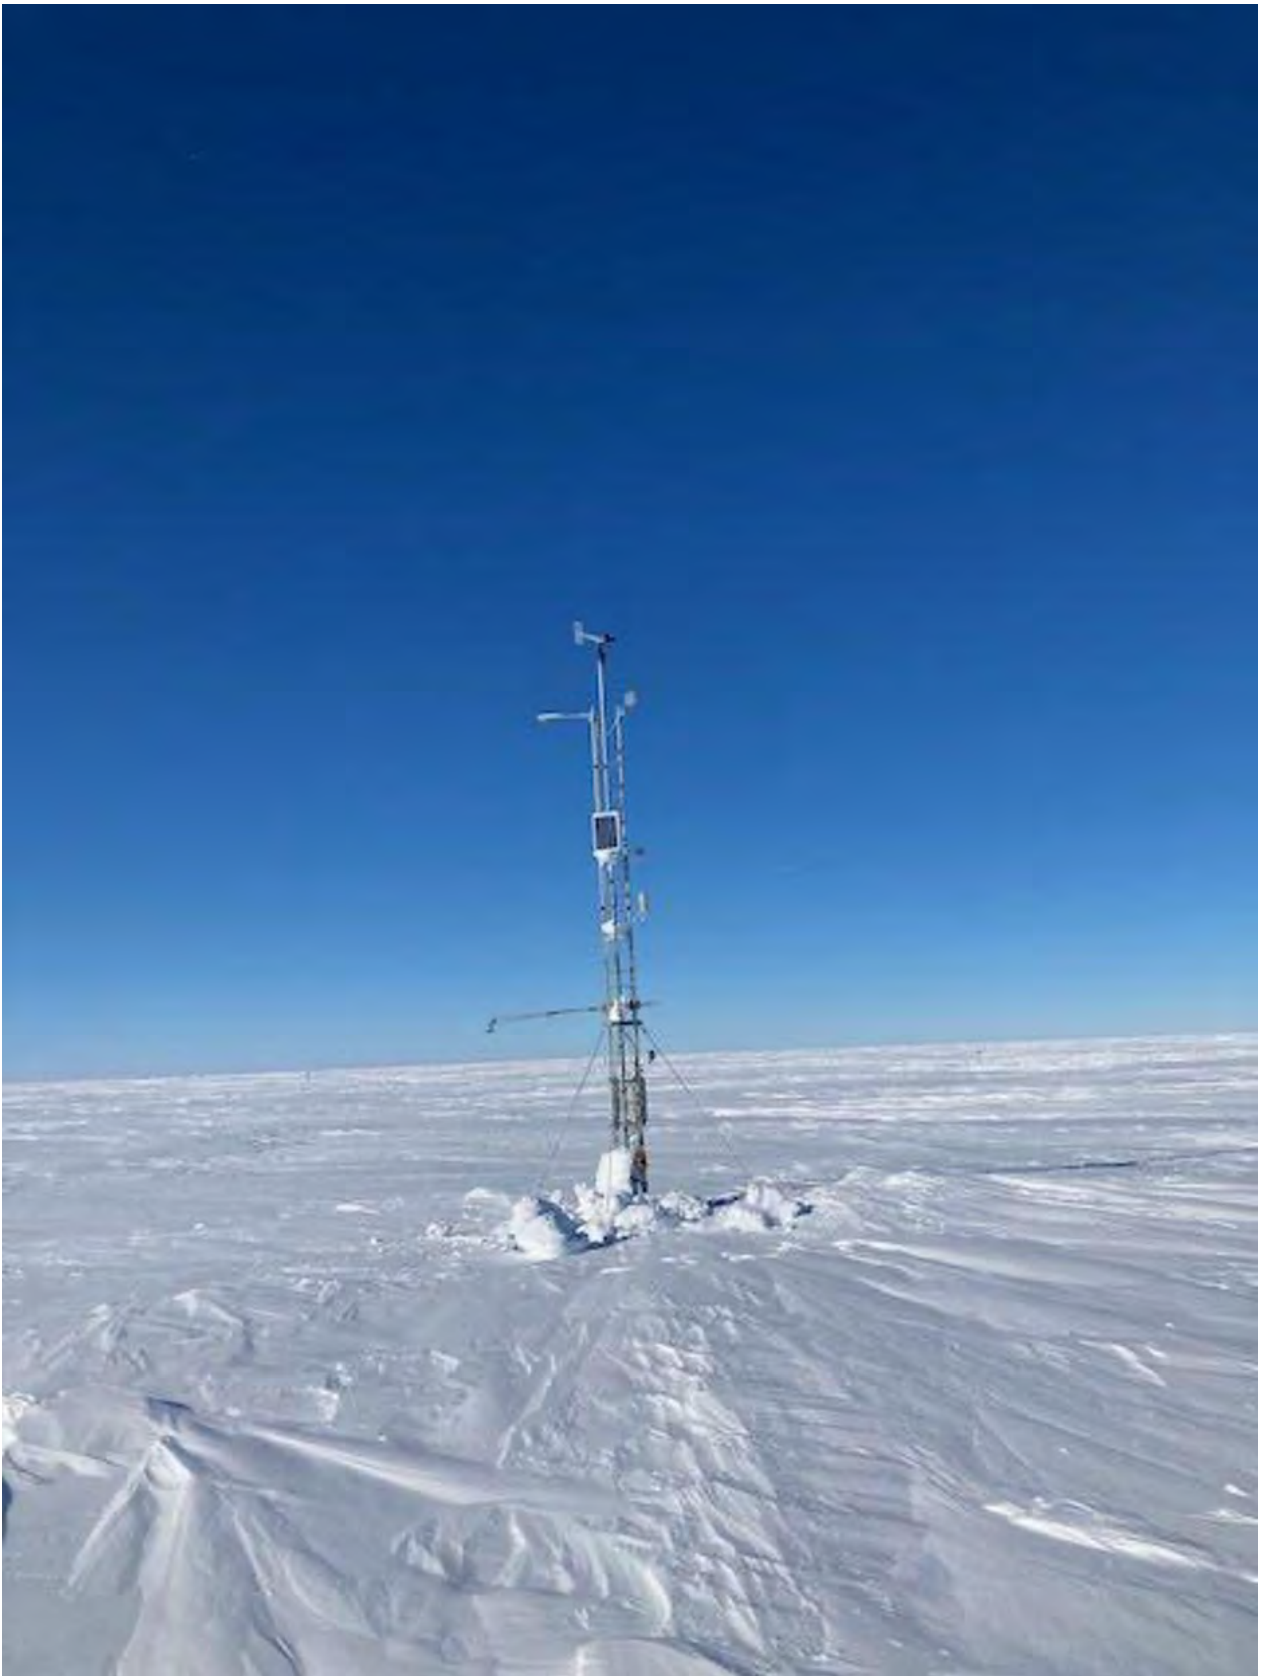
Field Work Notes: The station was covered by ice and rime lately. All of the ice and snow around it is from the tower but we did not do any digging here. I think the fuel test flight from a few weeks ago it was reportedly like that. Only left over remnants could be seen today of the riming. Lee found a few issues with the station: Antenna cable was not in - it explains an instant transmission when we hooked up and he barely touched it. The CR1000 Lithium battery is dying. The main batteries are also not all that they could be. The date on the CR1000 was way off.

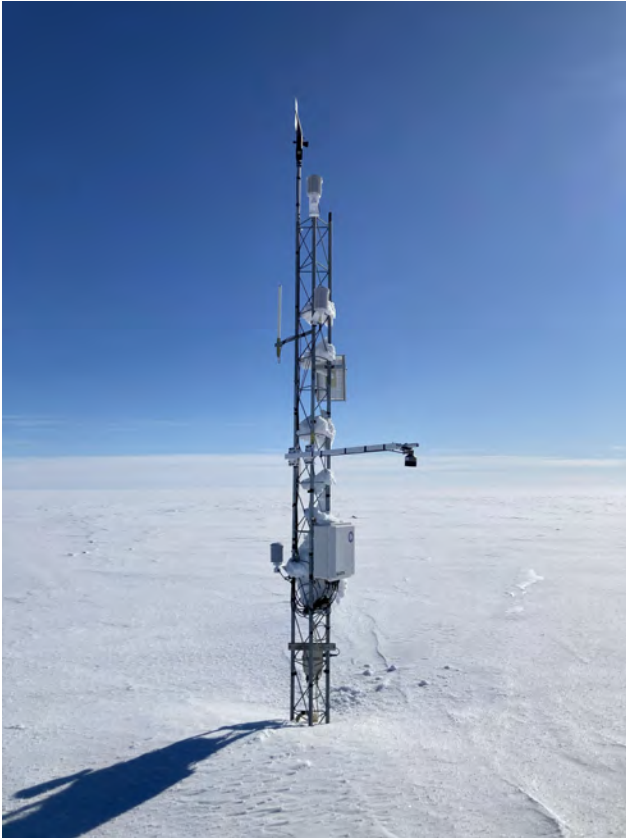
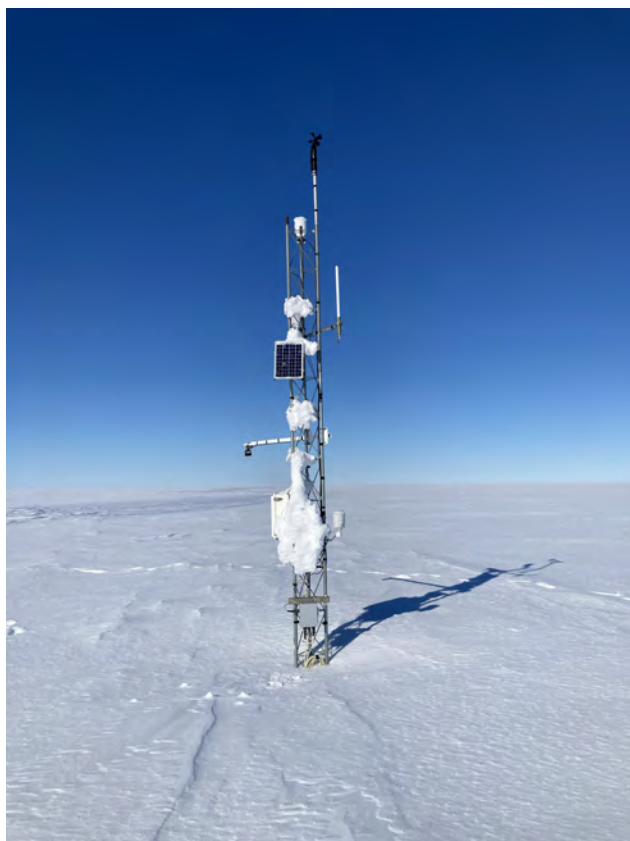
Upper tower nipples are starting to rust...bring a wire brush next time to clean off before mounting new tower

ADG is no working and the sensor should be replaced at next visit

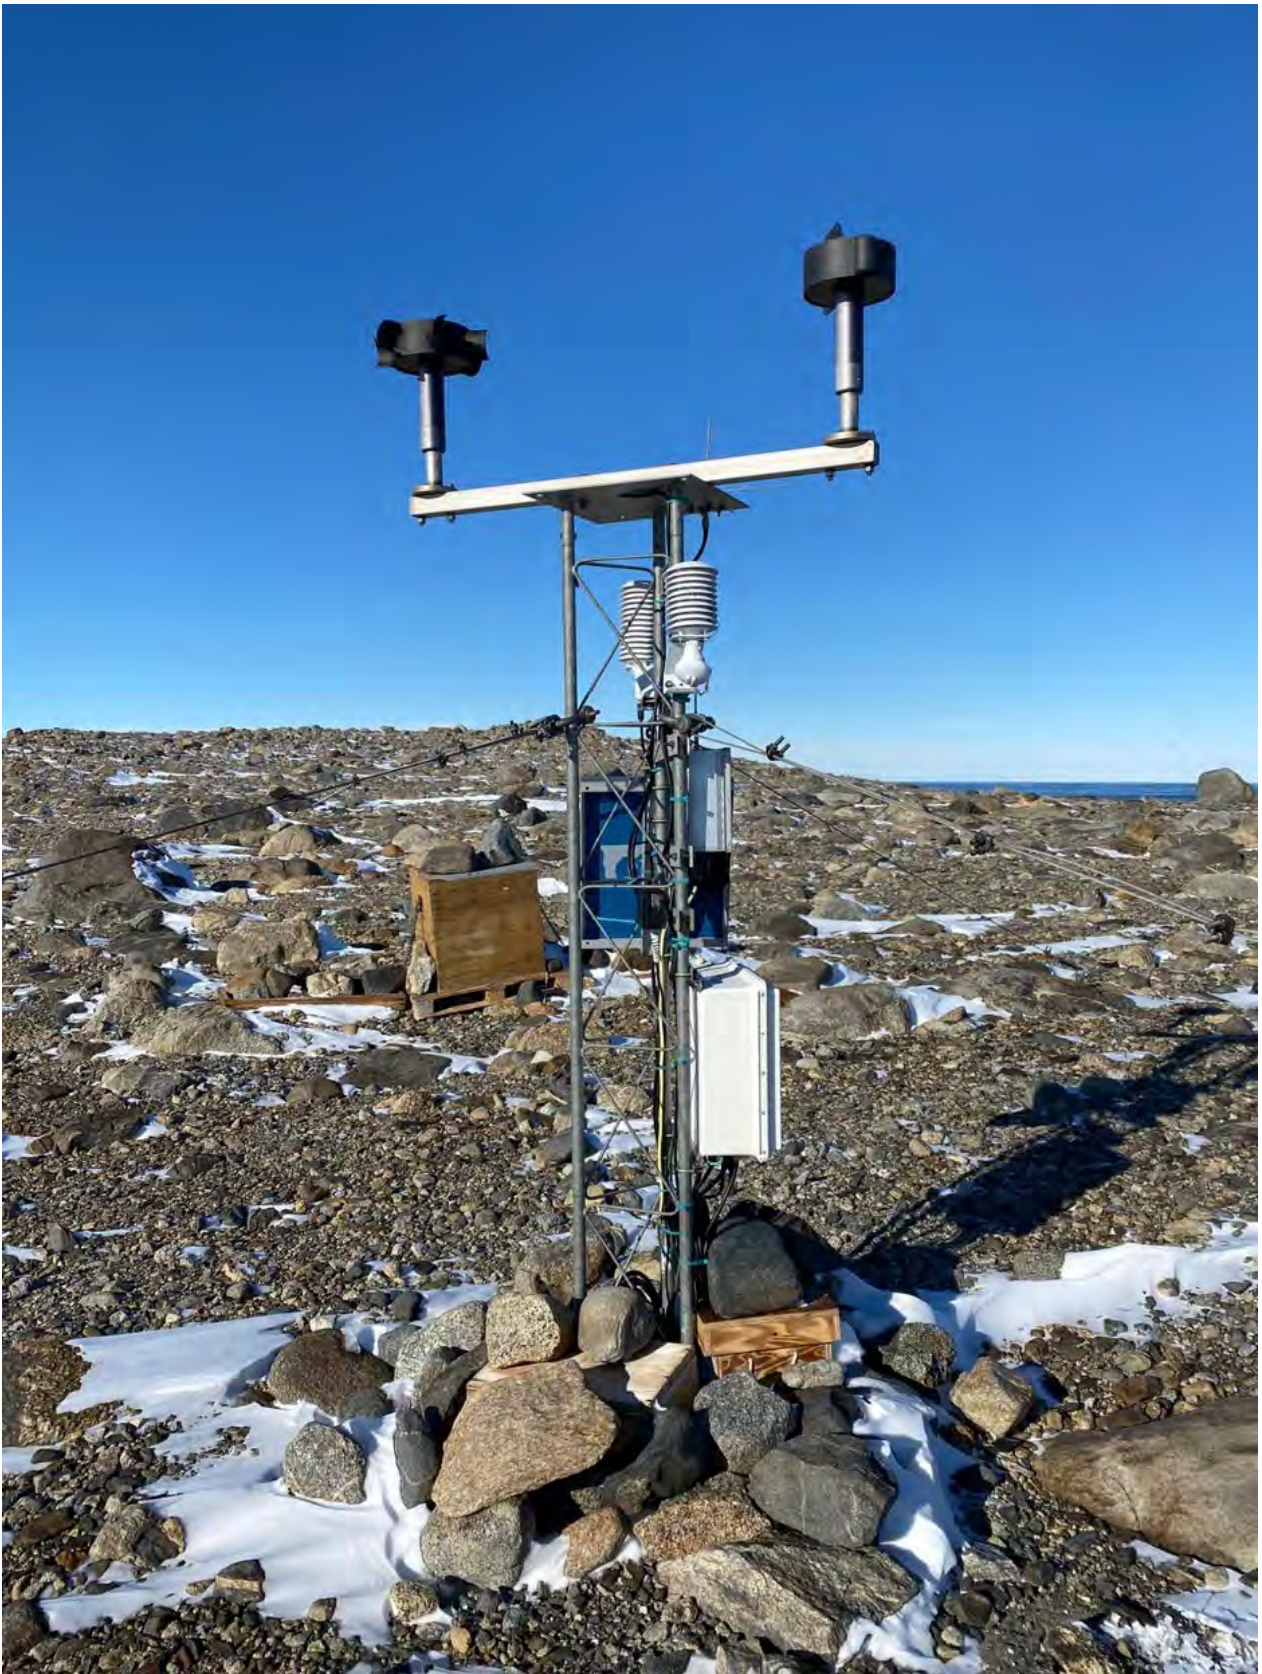
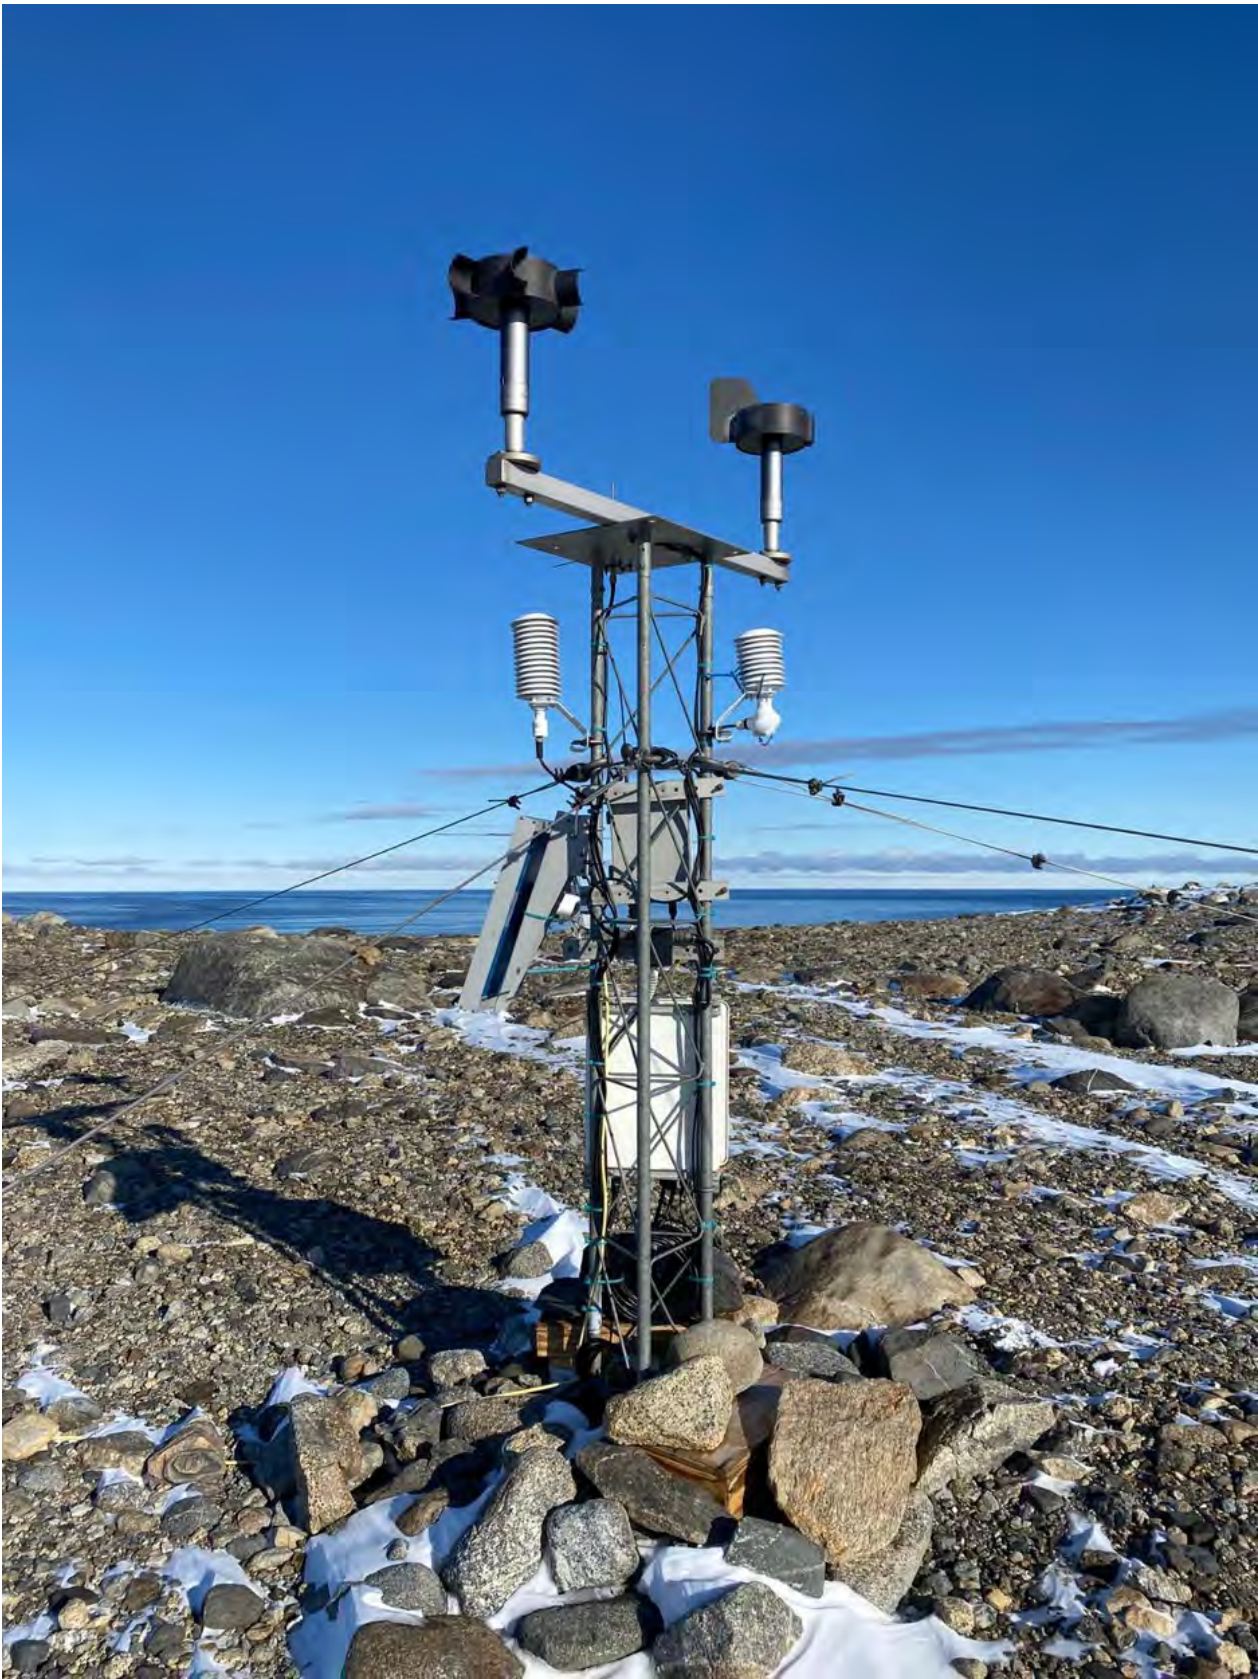
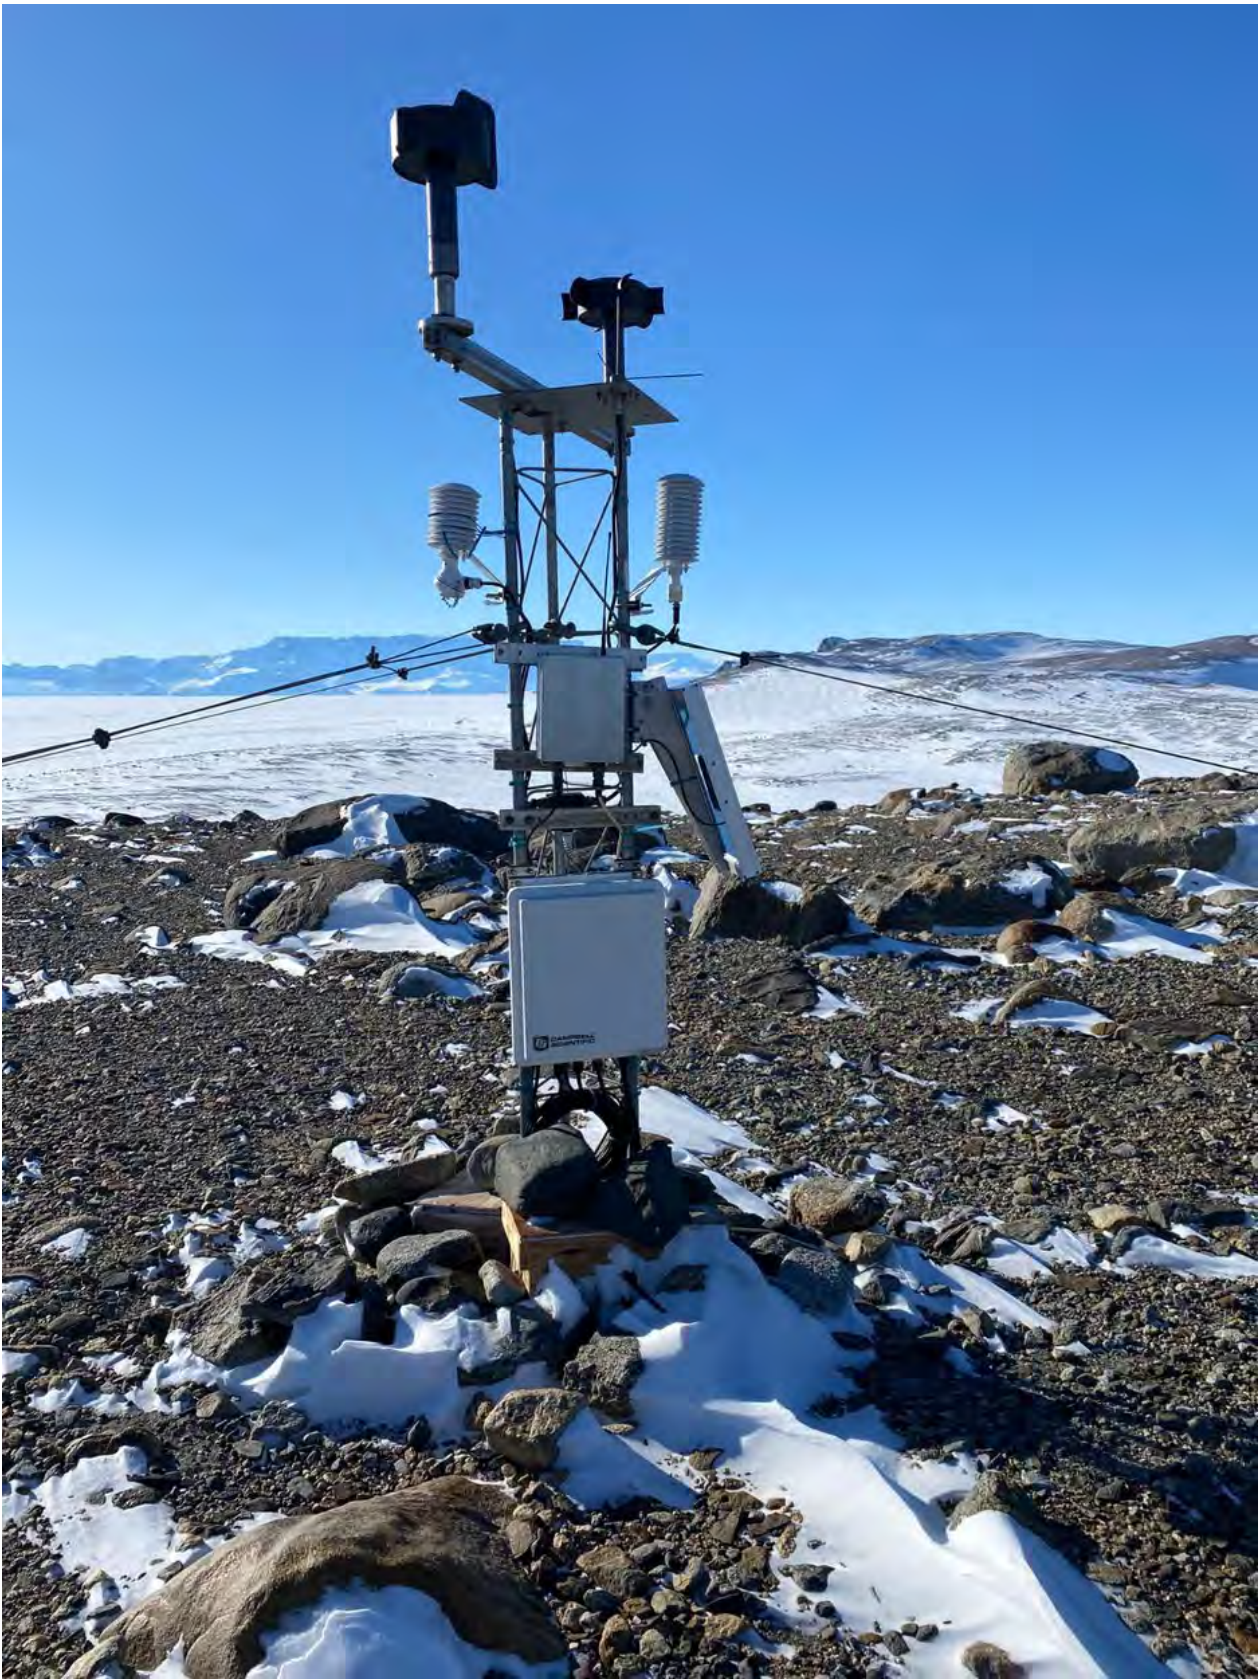
Field Work Notes: Not sure why stopped transmitting. Visit did not show any obvious damage. Lorenzo di Silvestri says that apparently (and from outside) the AWS appears in good health. Photos are courtesy of Lorenzo di Silvestri (ENEA)

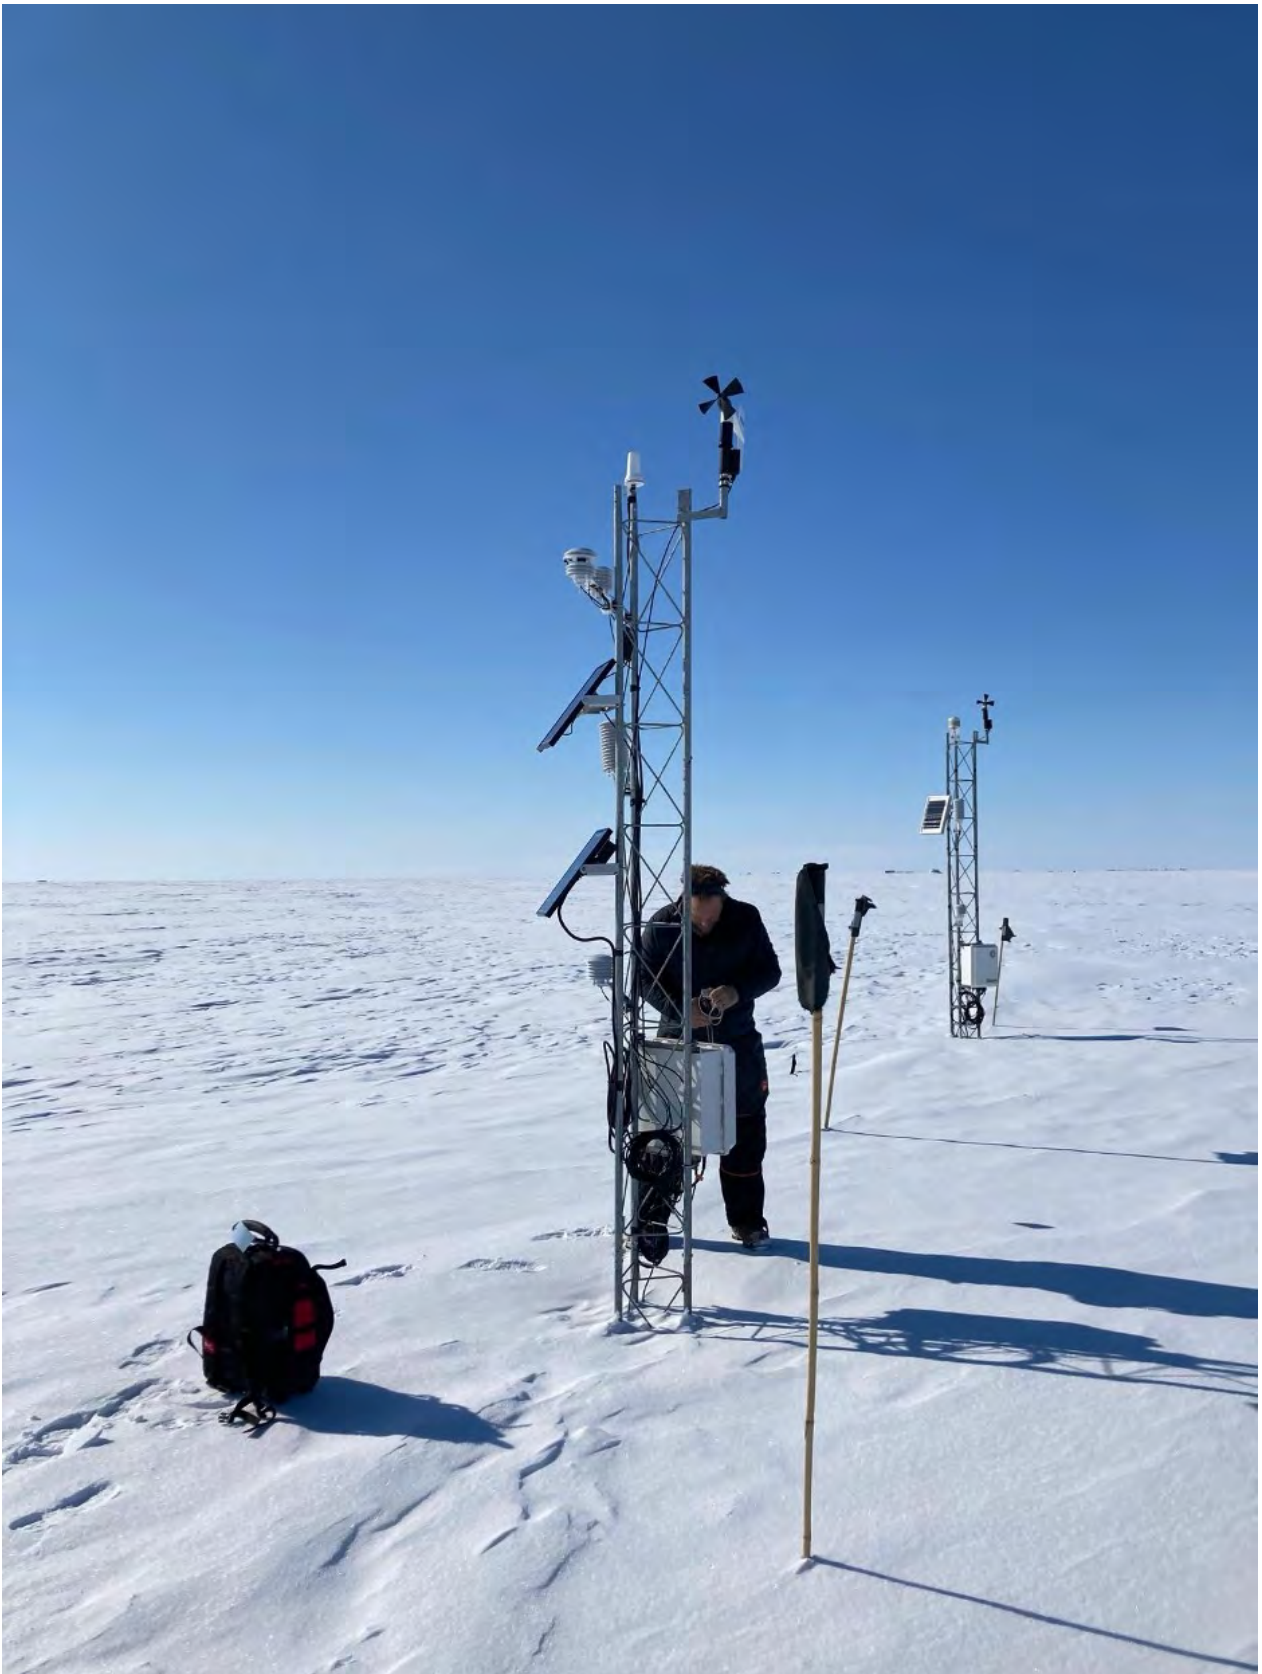
Field Work Notes: Upper temperature sensor itself failed (thermistor itself). One of the two that just broke that we have ever had. One upper temperature sensor failed due to cable inside the plug it has been over crimped (and this is a guess only). Doing a solder connection would be better. This is the first failure in the field (Lee caught the rest before deployment and only a couple at best). All temperature sensors and electronics enclosure all removed for repair in Crary Lab at McMurdo. No height measurements.

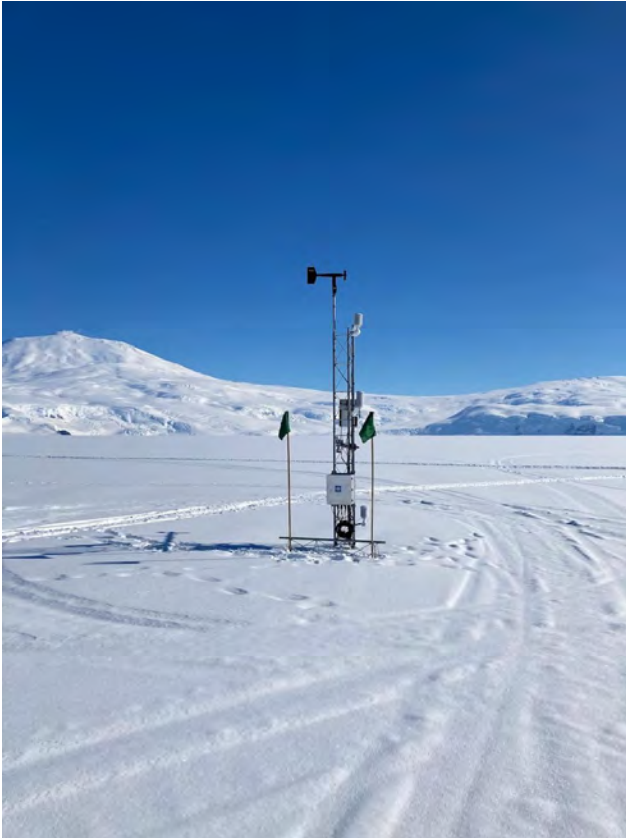
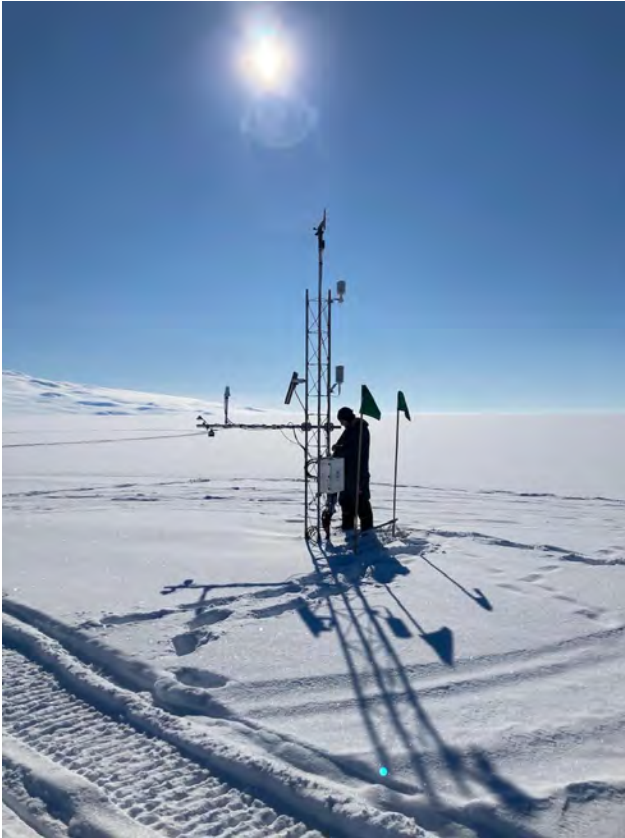
Field Work Notes: Five (5) foot section added. All instruments and batteries raised. Batteries left on the surface. Failure of the system due to low batteries - only at 3 volts. Batteries are old (~10 years or more). ADG is broken, failed. No data card in the system, no data card left in the system

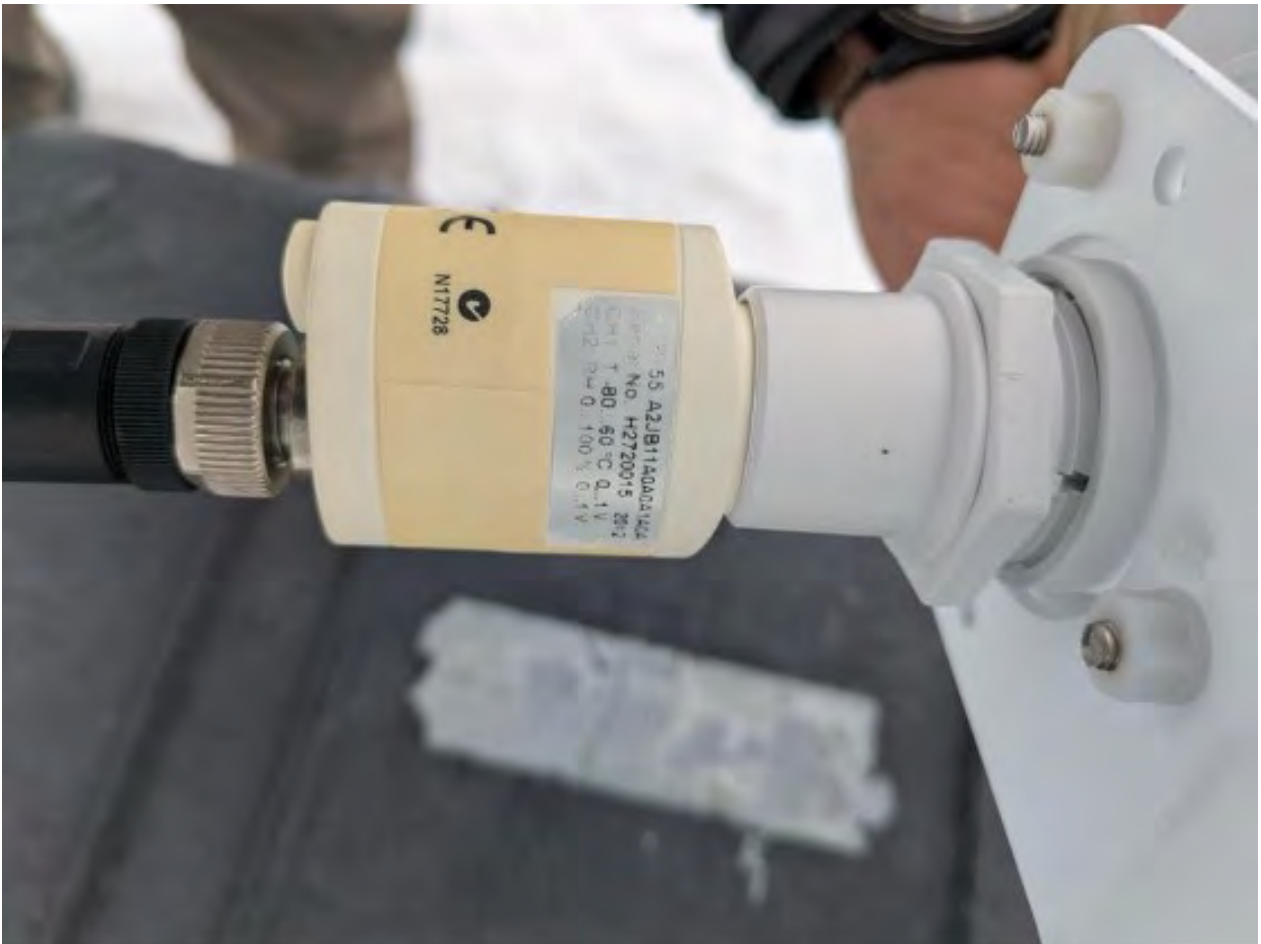
RH sensor that was removed

Purpose for Visit: Replace RH sensor

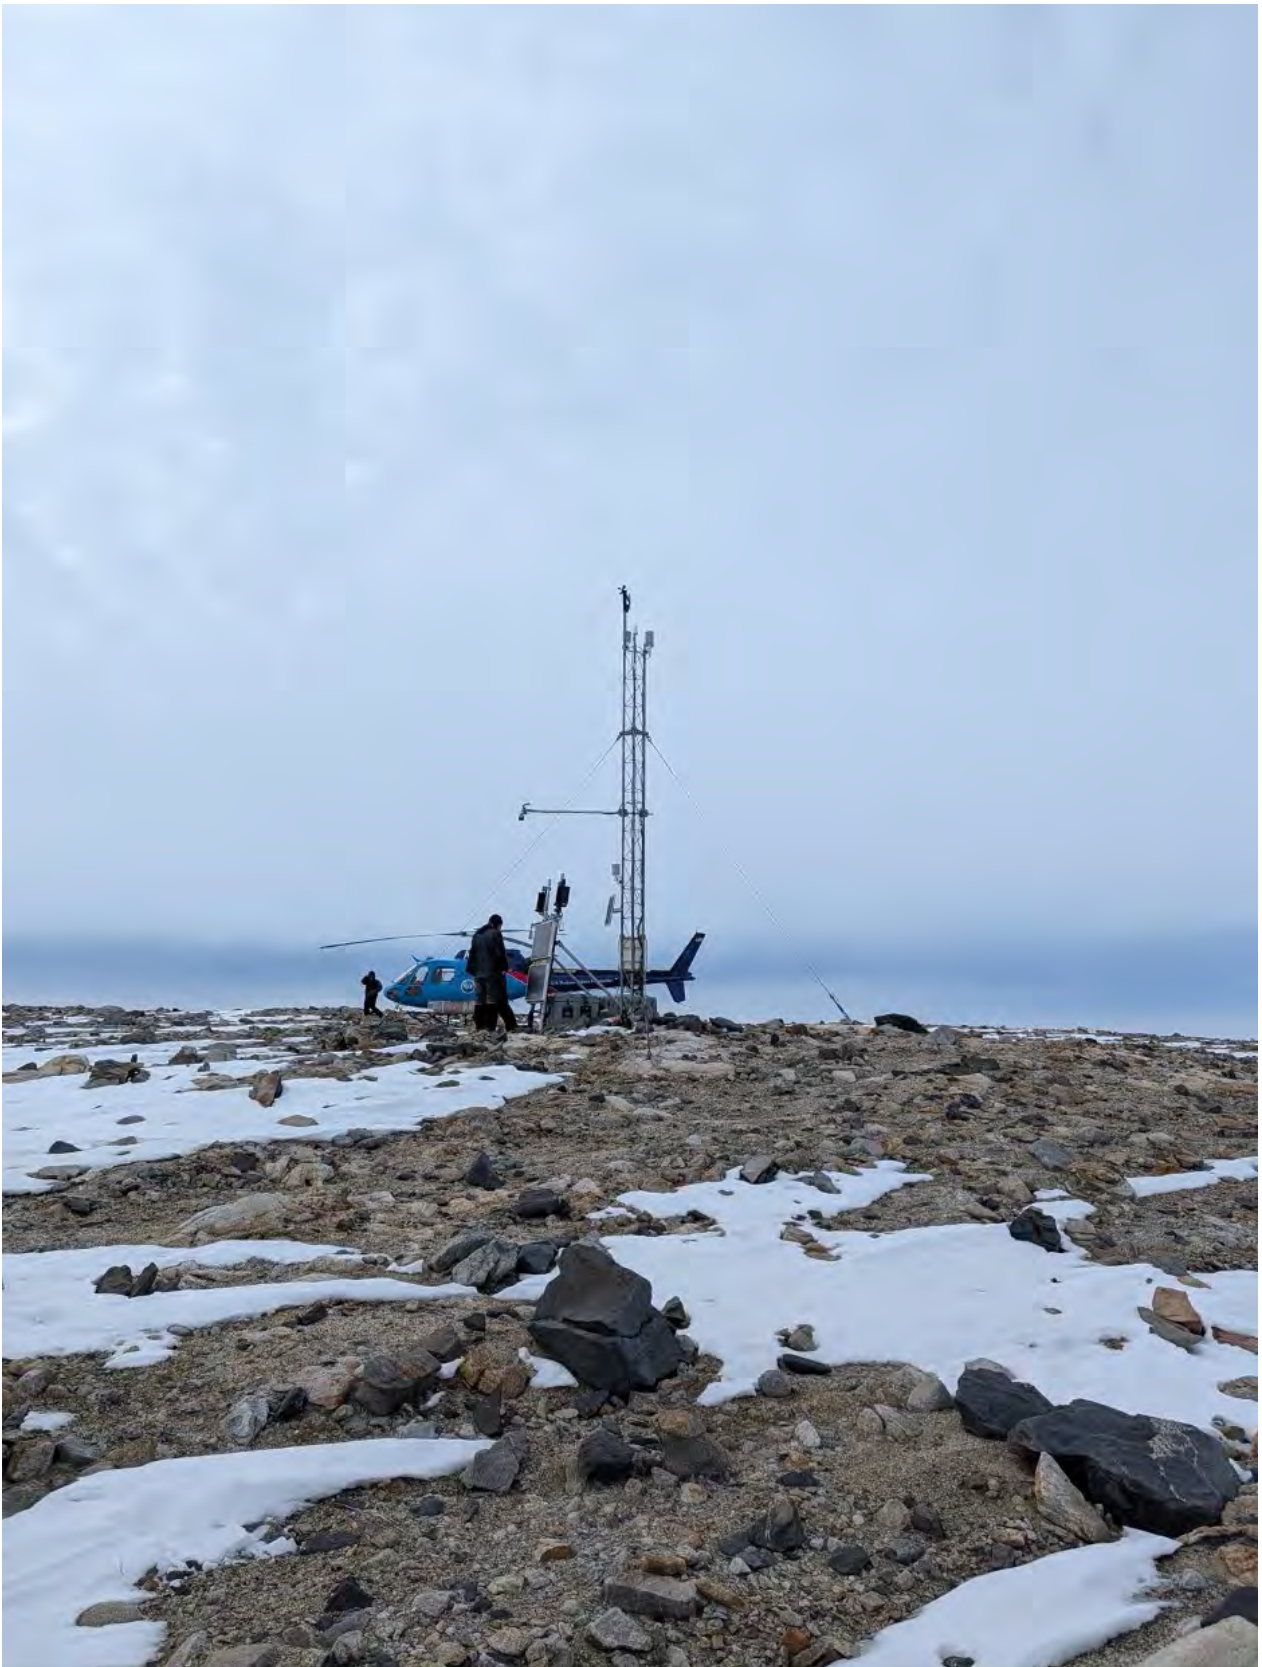
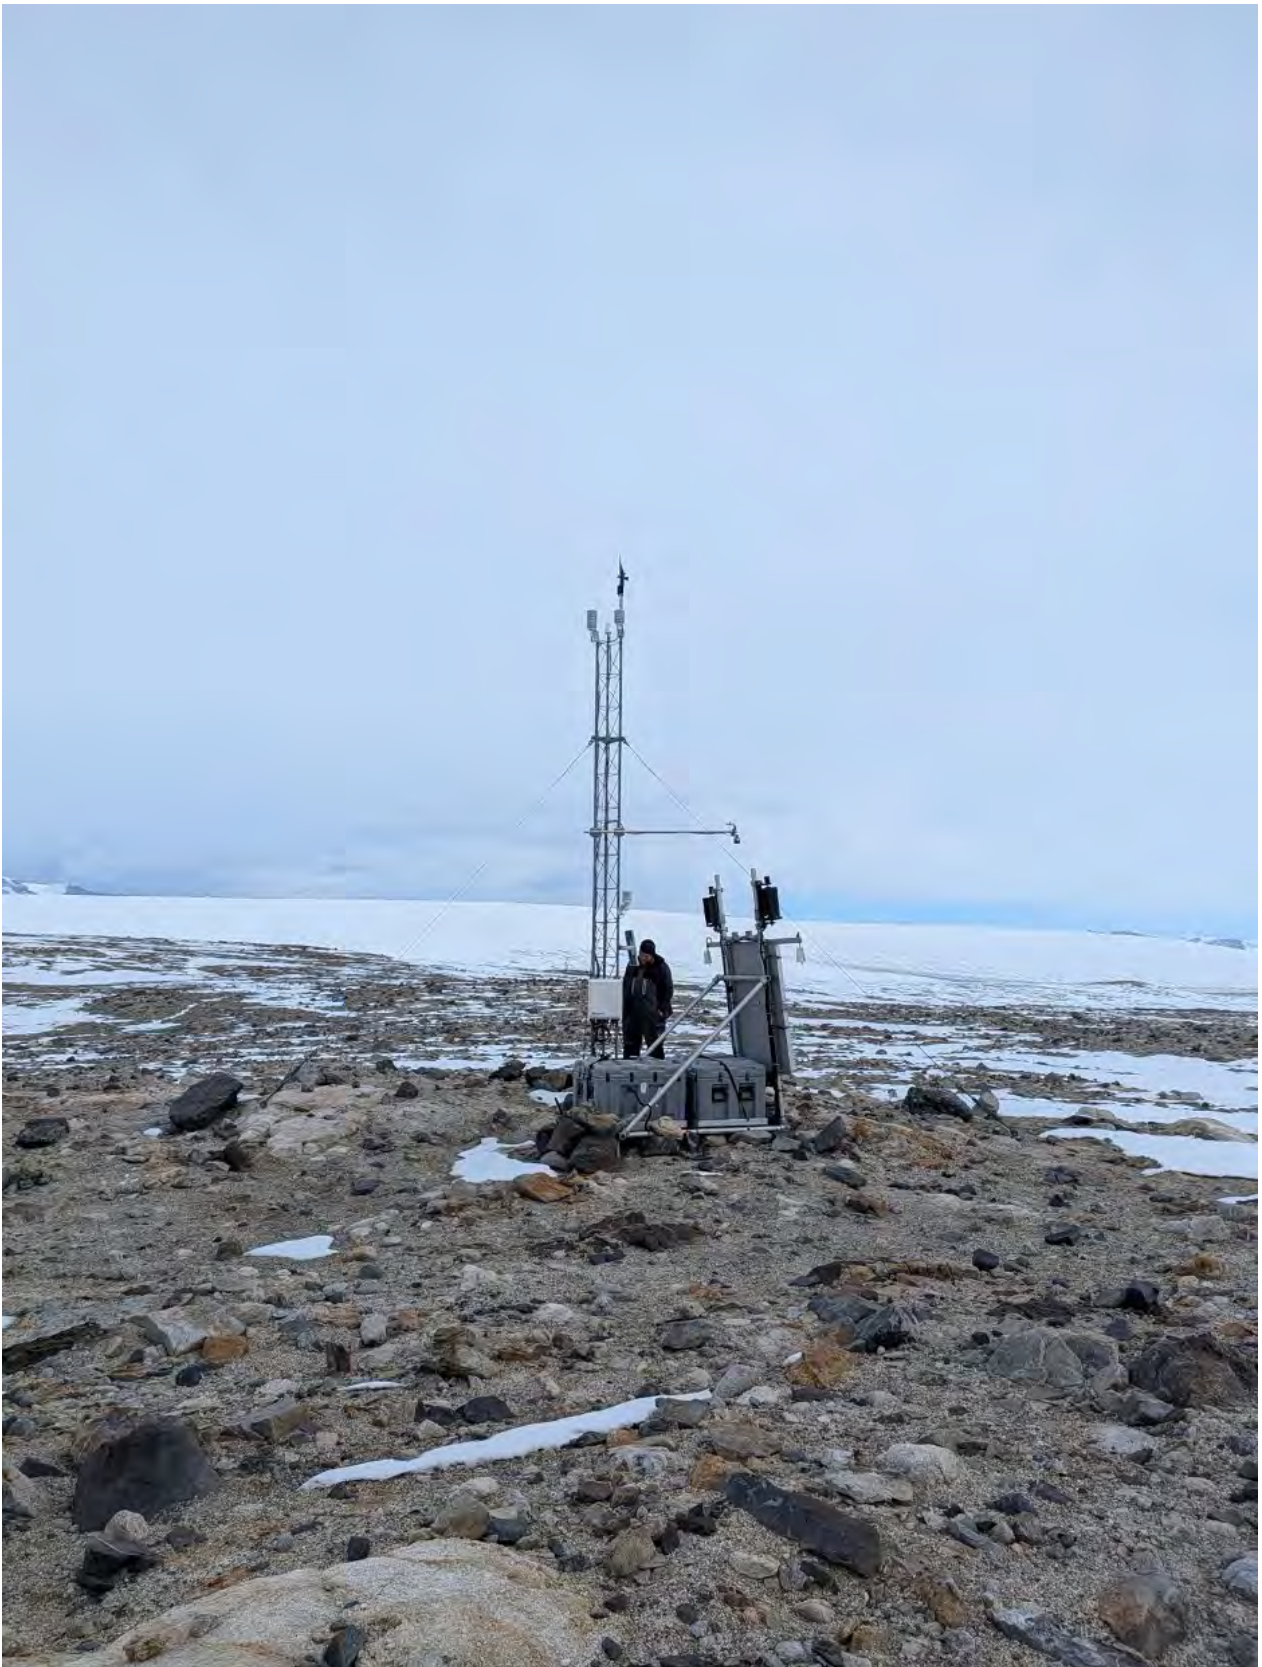
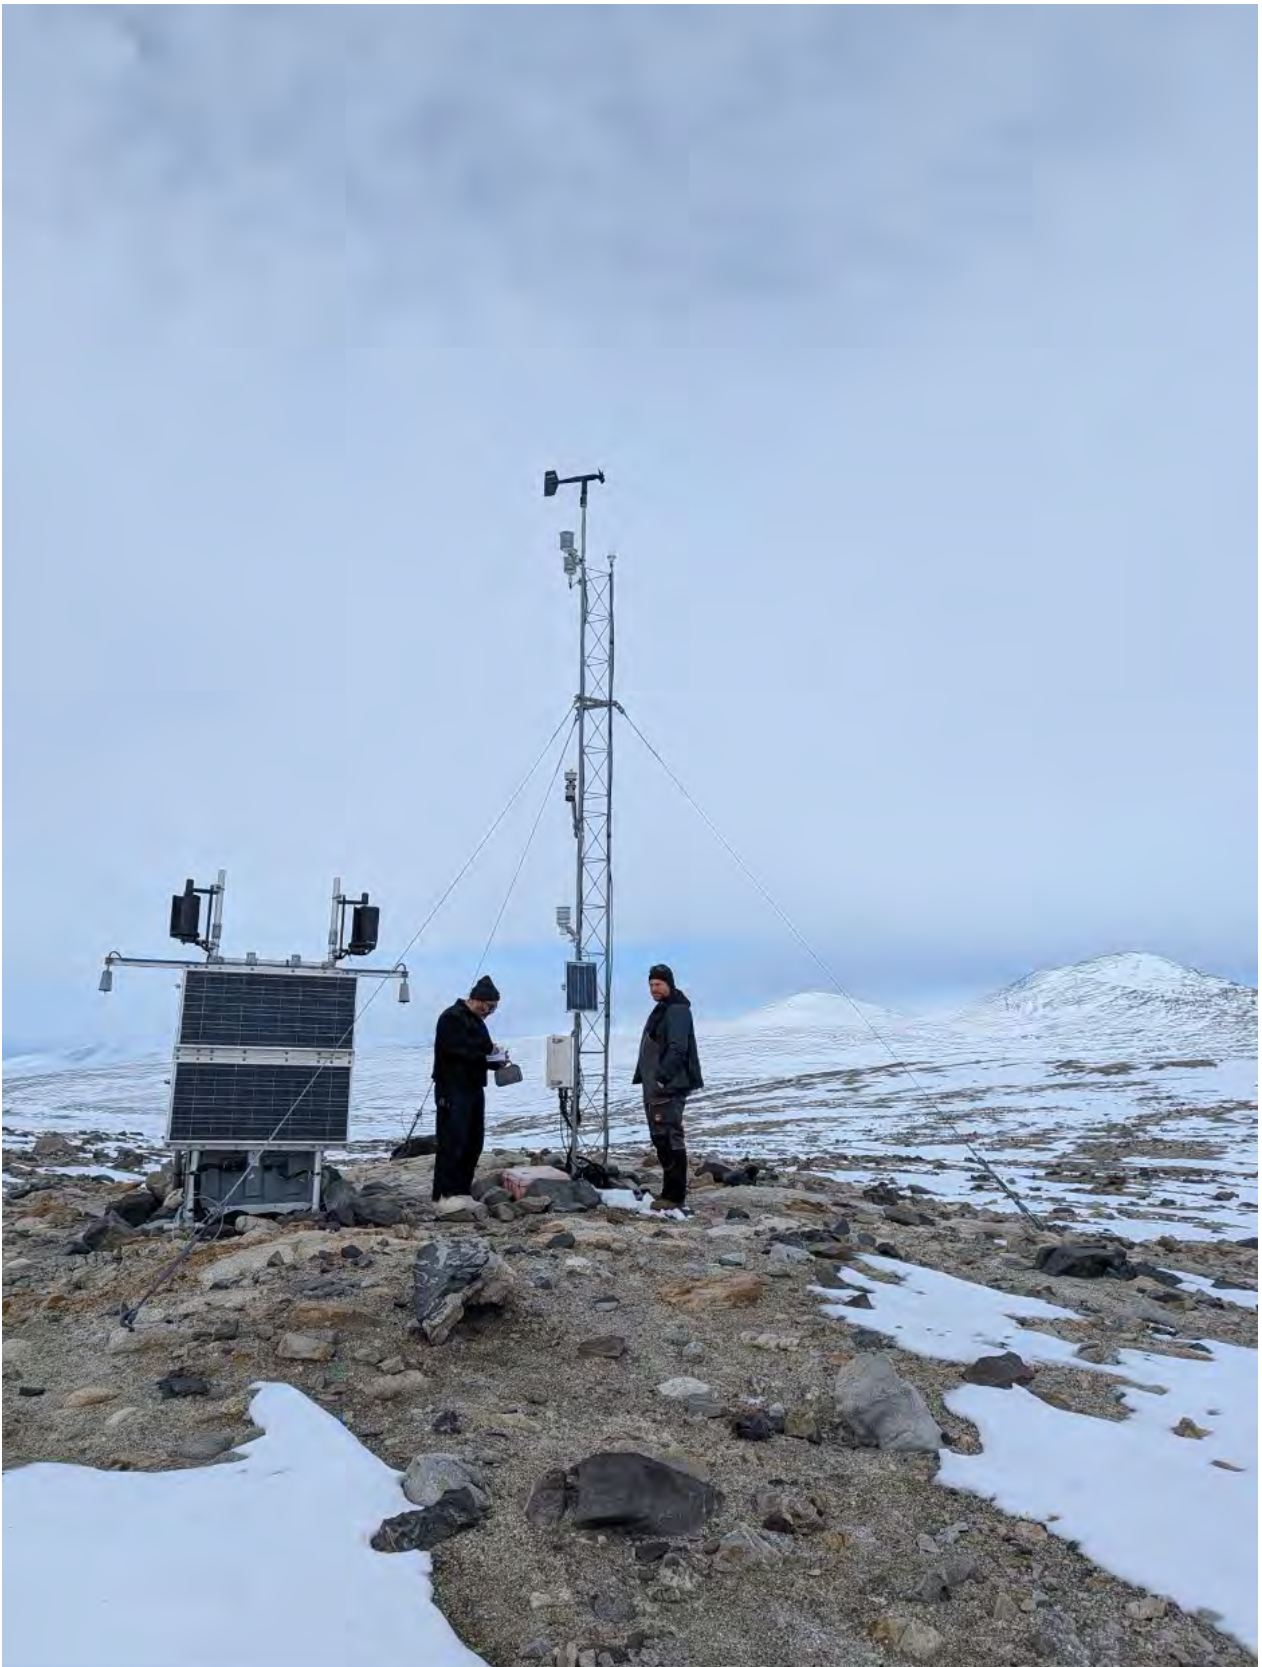
Field Work Notes: Noted that nuts and bolts need to be replaced at next visit. ADG has some corrosion, yet still functional (need to consider viability of ADG at site). No new measurements taken, rock floor site.
