## **AWS Field Report 2025-26**

**Field Team: Matthew Lazzara, Lee Welhouse, Forbes Filip**

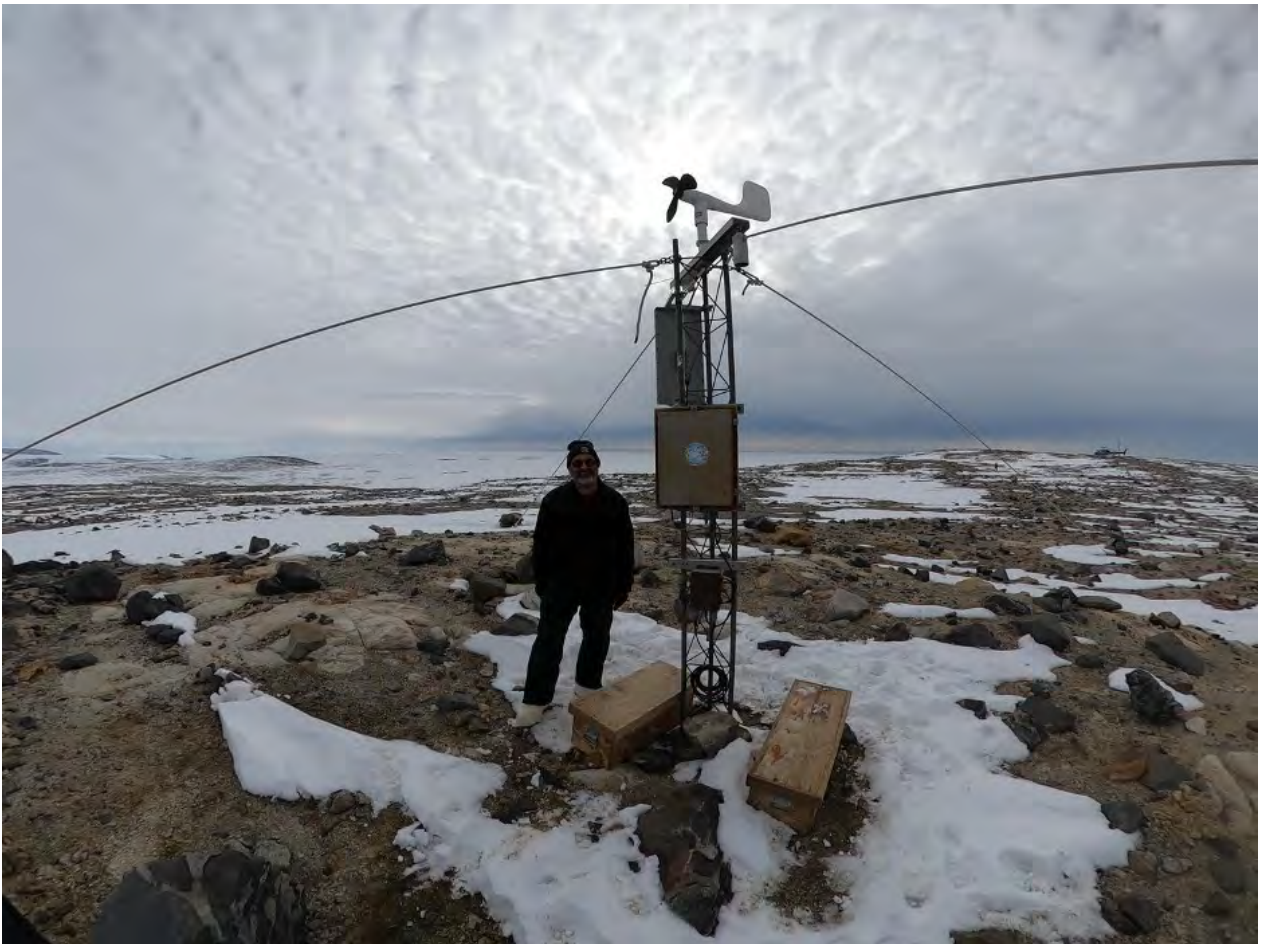
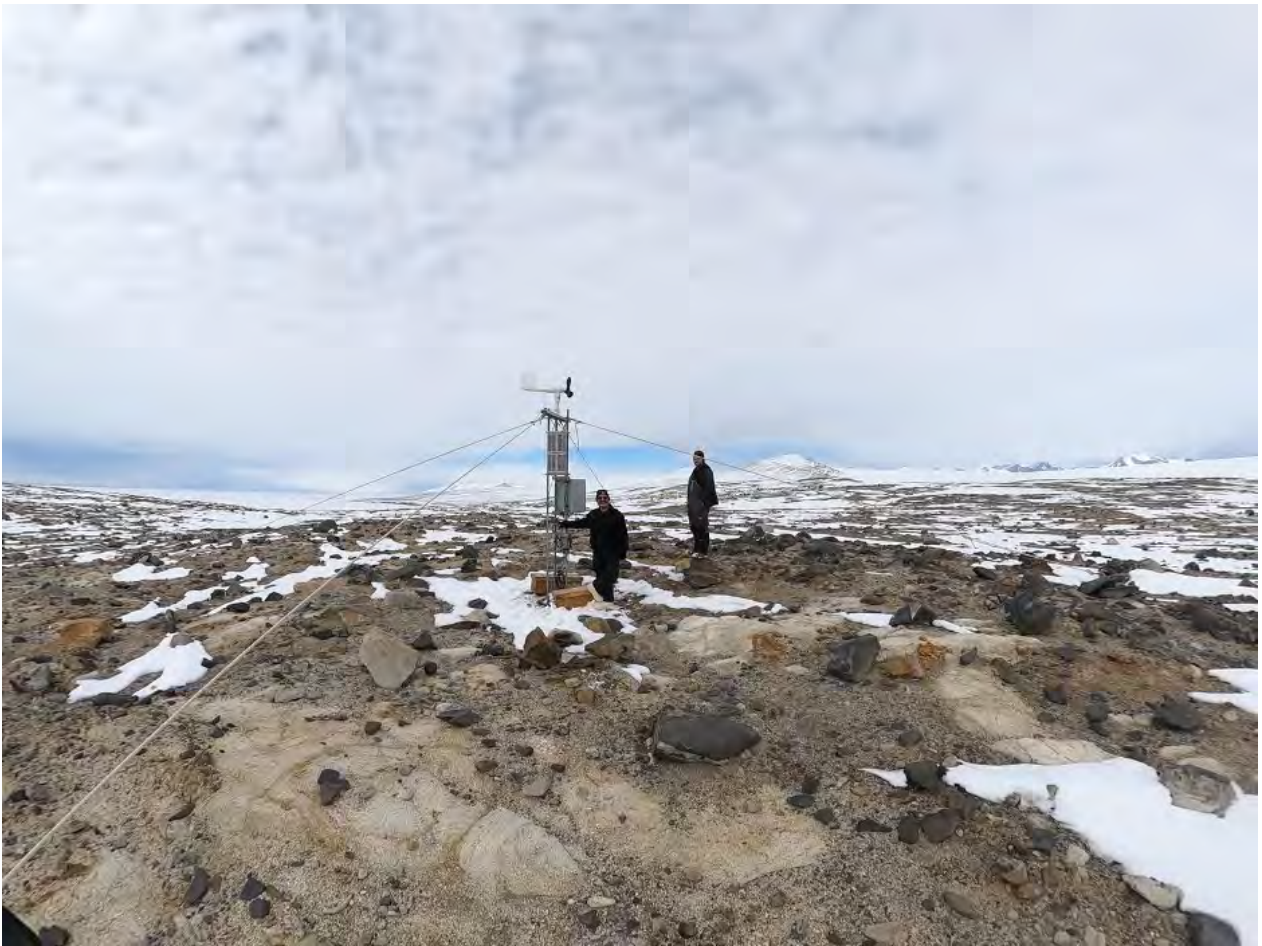
Field Work Notes: Noted rust. Taped loose cables. Inspected guy wires, they are nominal. No new measurements taken, rock floor site.

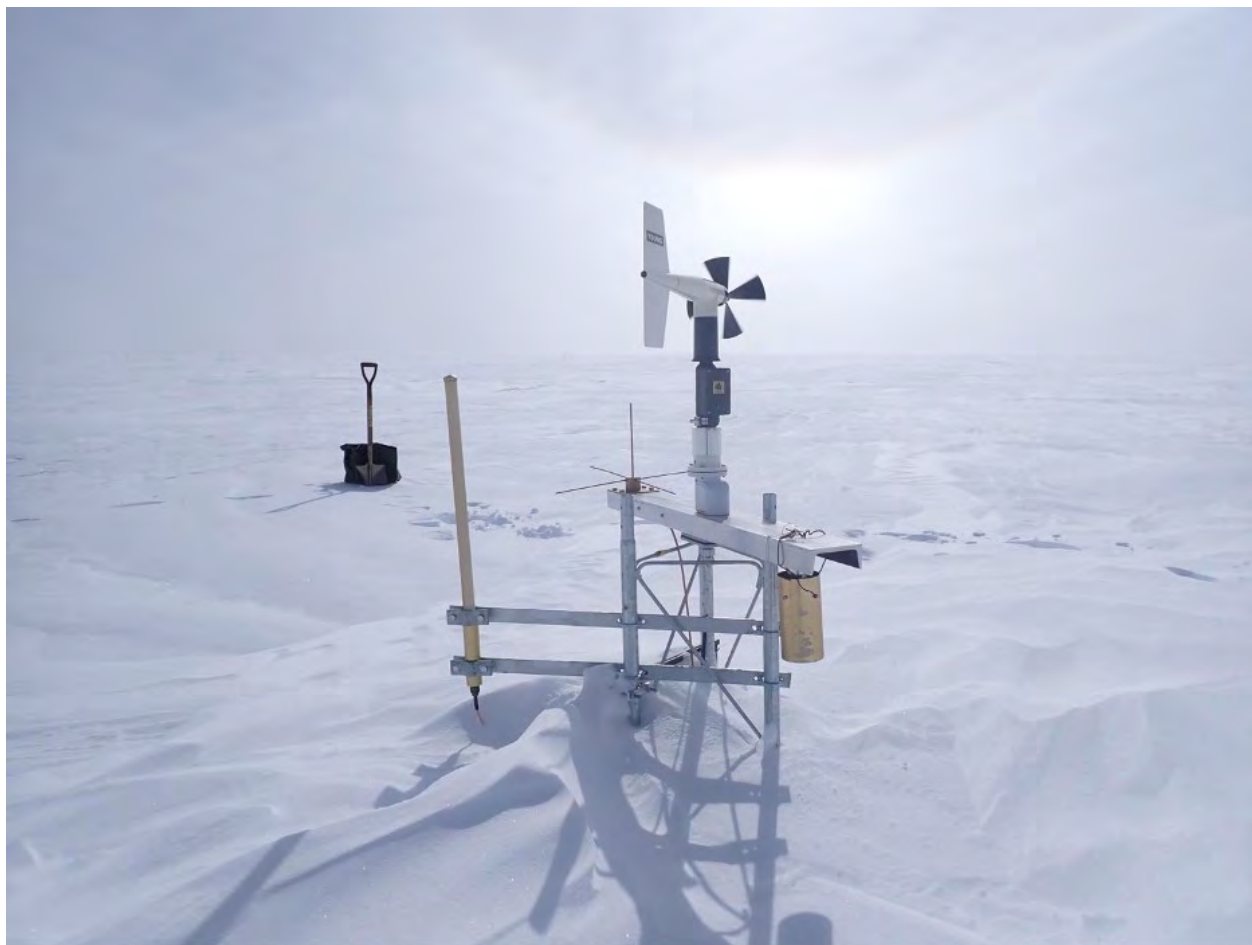
Old Dome Fuji AWS before argos antenna disconnection. Photo courtesy of Prof. Dr. Fumio Nakazawa at NIPR.

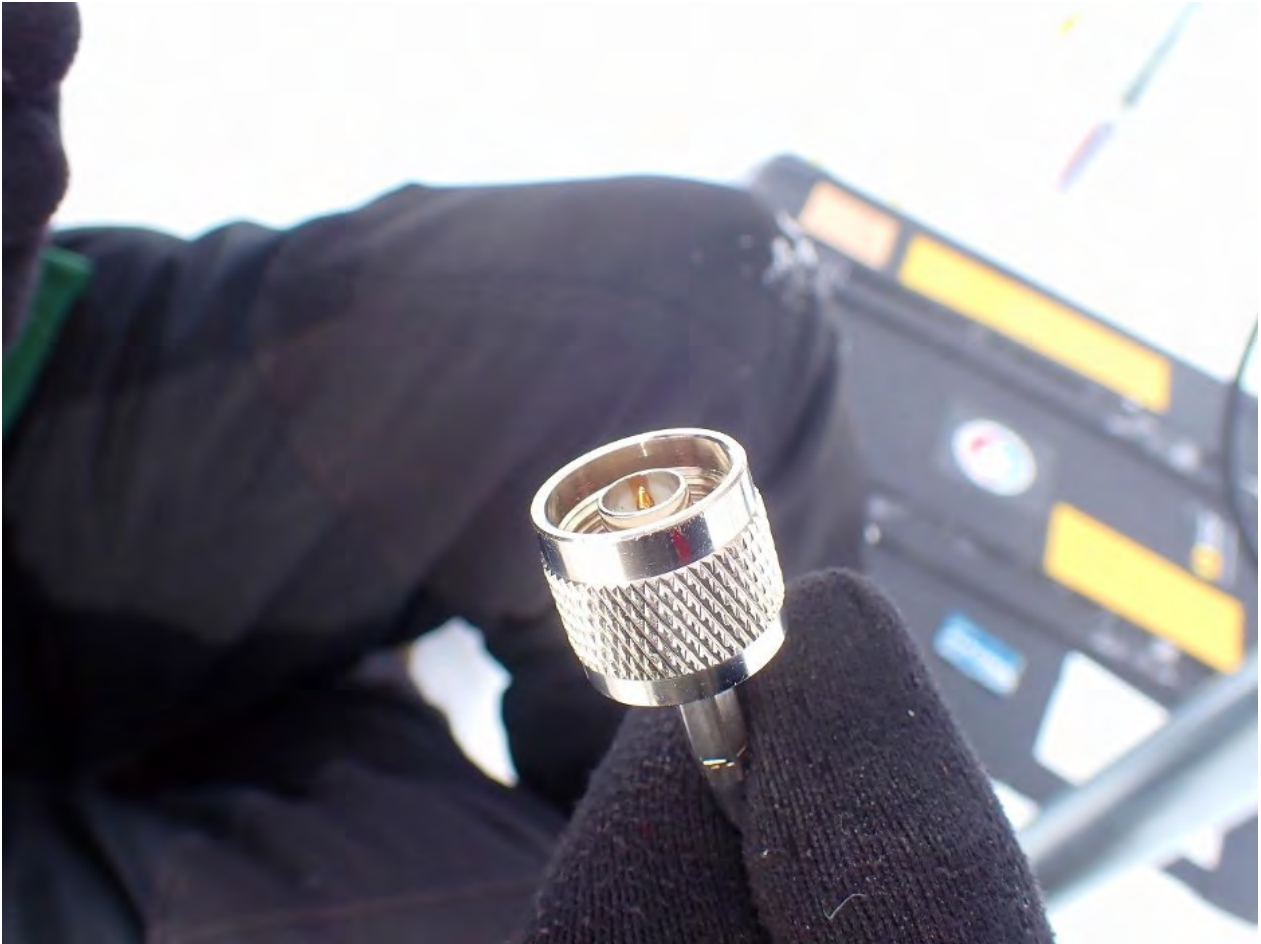
Field Work Notes: Report from Naoyuki Kurita: "[Field team] found that the center contact (center pin) of the N connector was short. The center contact is usually connected to the coax cable using solder. However, it has not been soldered, so it can easily move up and down. We speculate that the center contact was pushed down when the connector was fitted, resulting in an insufficient of power supply to the antenna. The field team member soldered the center contact and coax cable, then reconnected it to the enclosure. We now believe that the poor contact issue has been resolved, and you should be able to receive all transmissions."

The center pin of the N connector on the antenna cable (connecting the antenna to the outside of the enclosure) after soldering in the field. Photo courtesy of Prof. Dr. Fumio Nakazawa at NIPR.

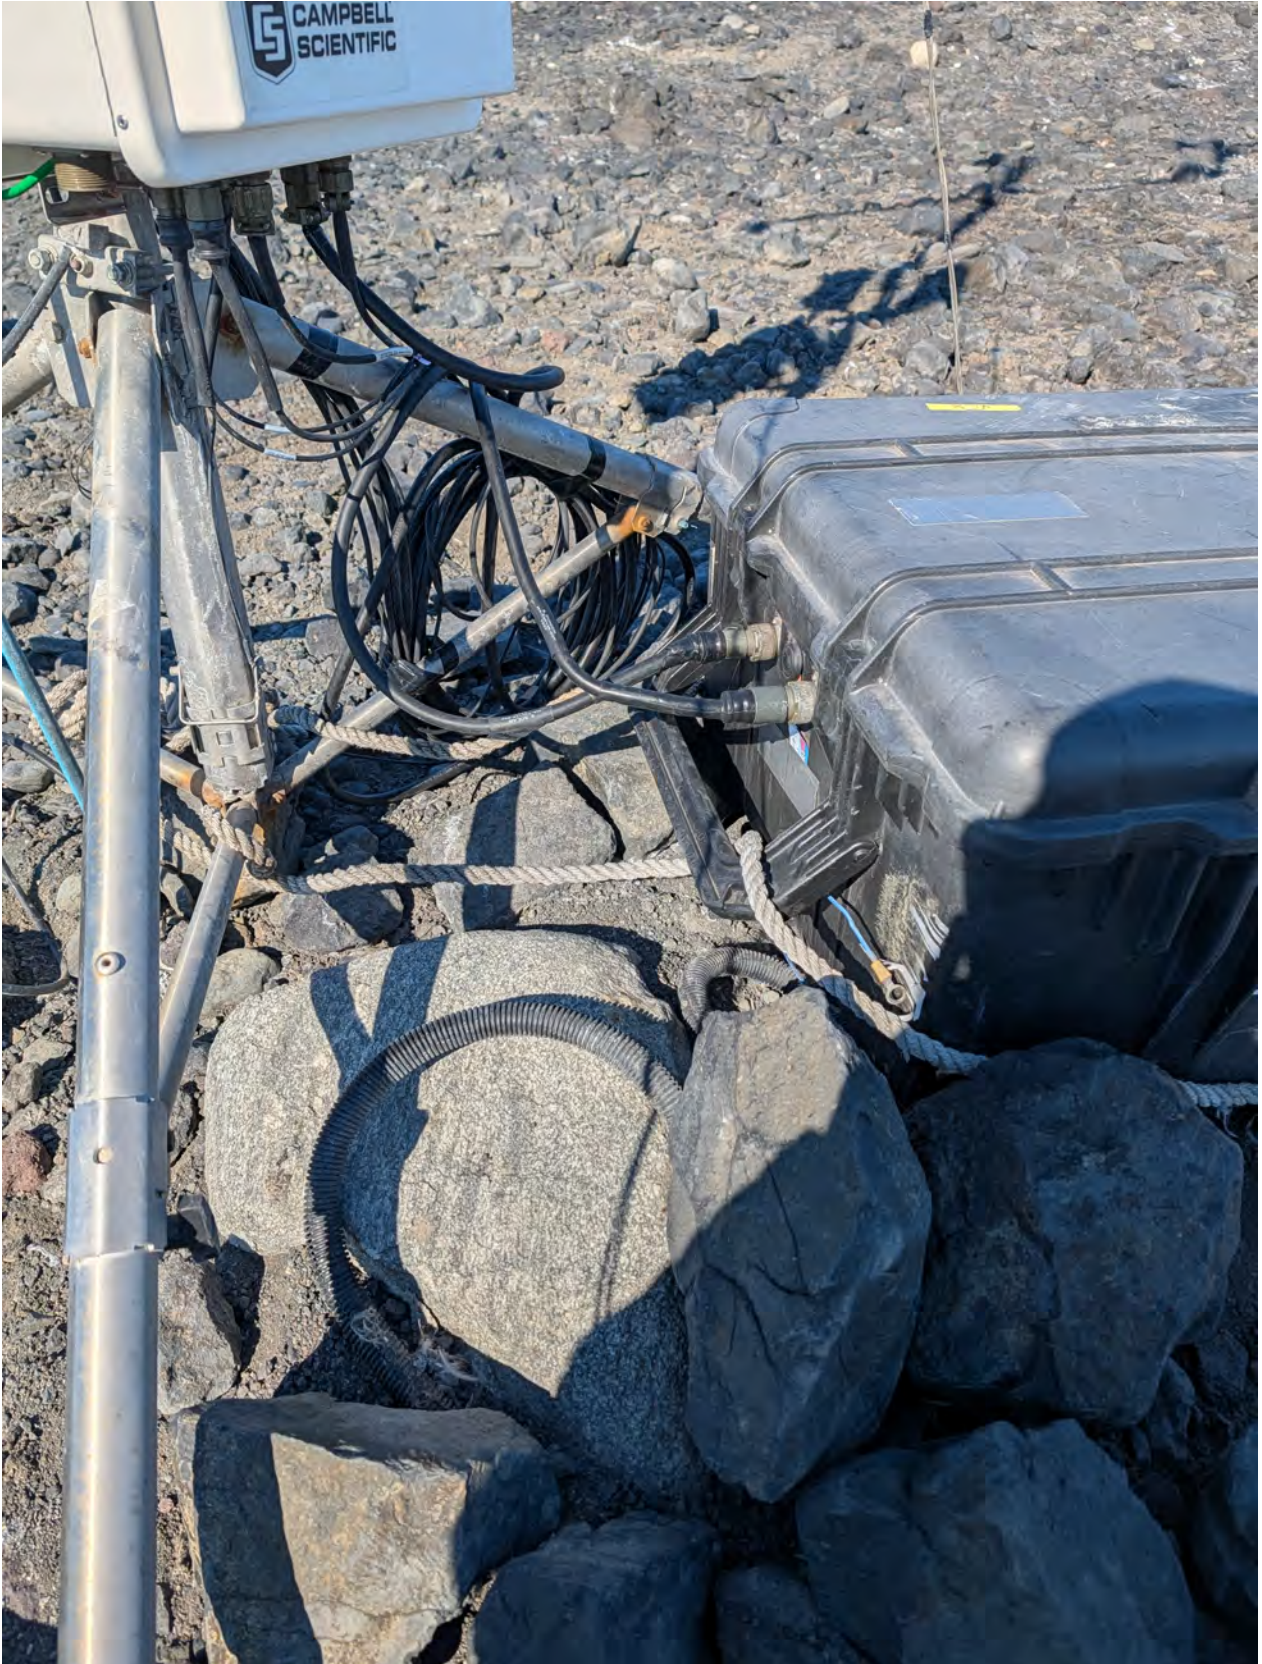
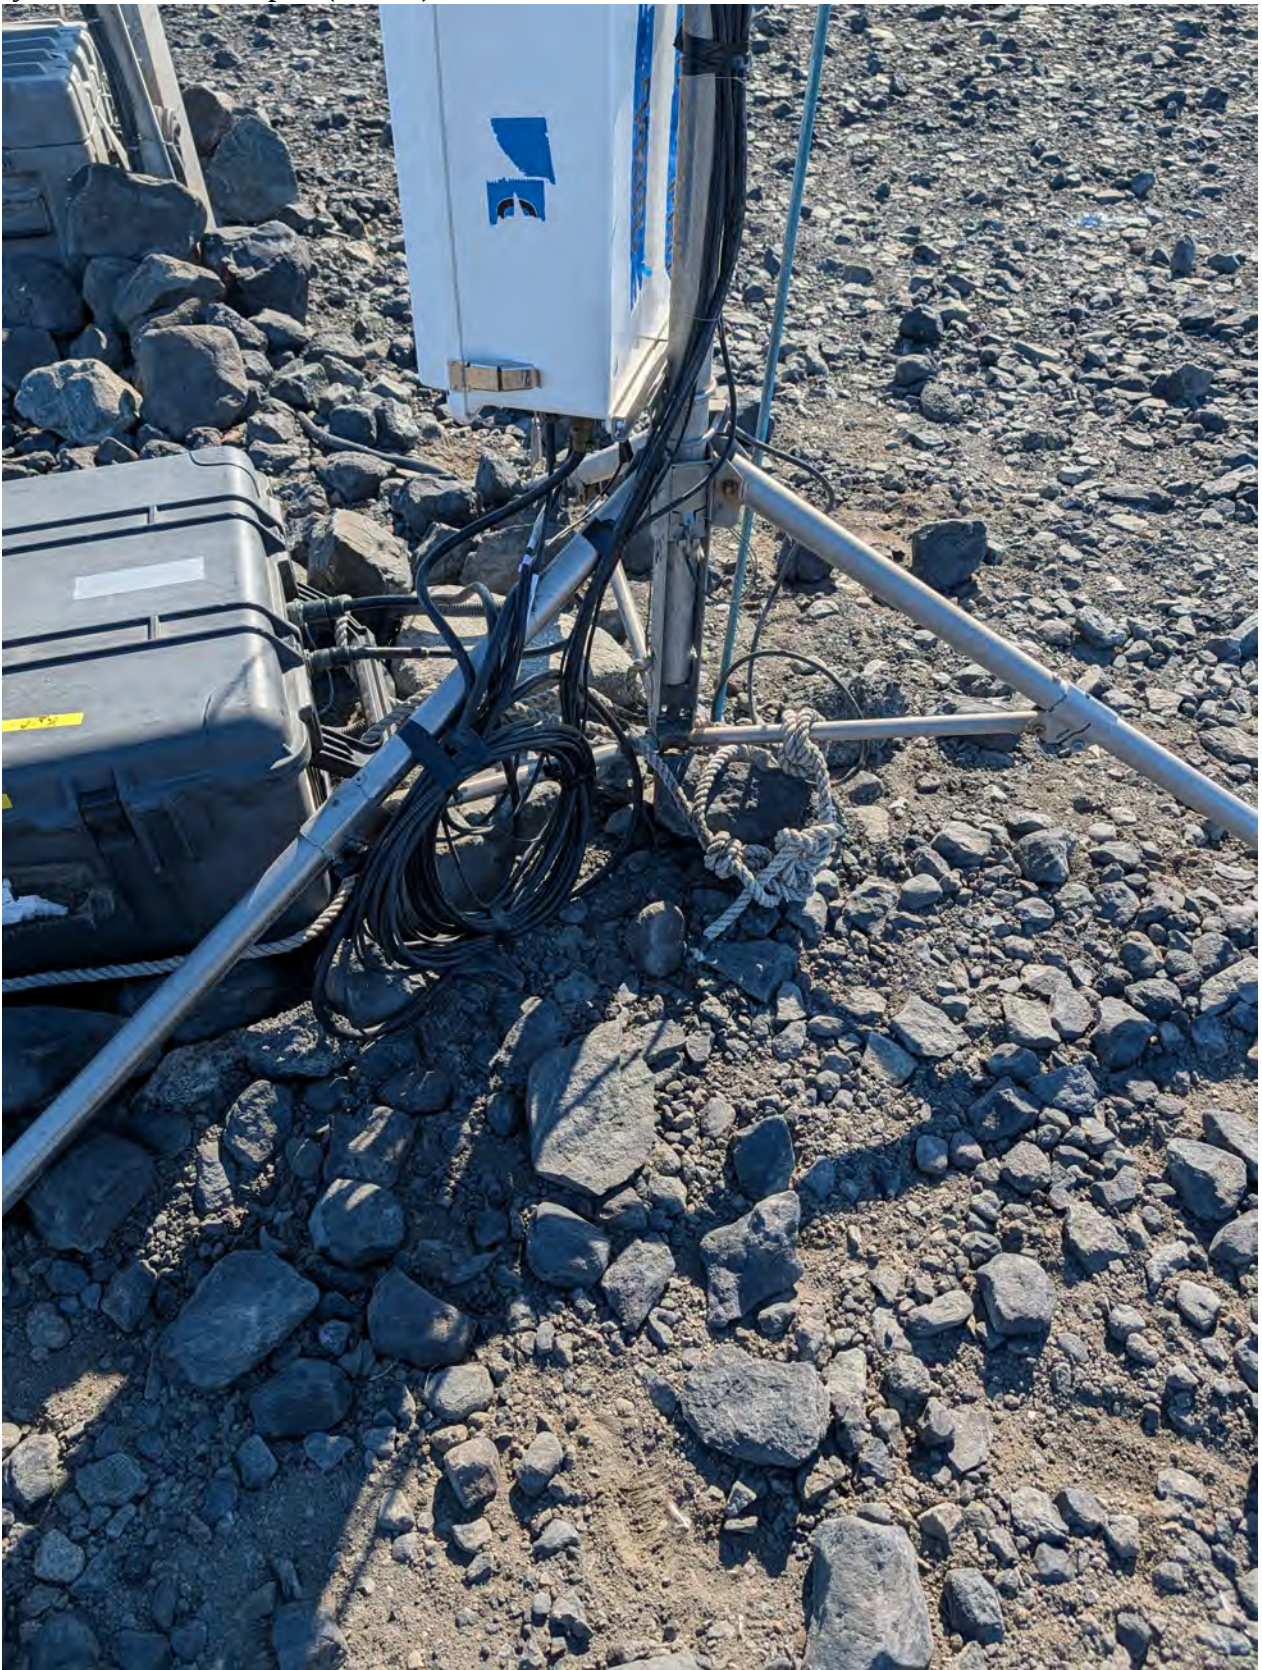
Battery box fastened to tripod (view 1)

Battery box fastened to tripod (view 2)

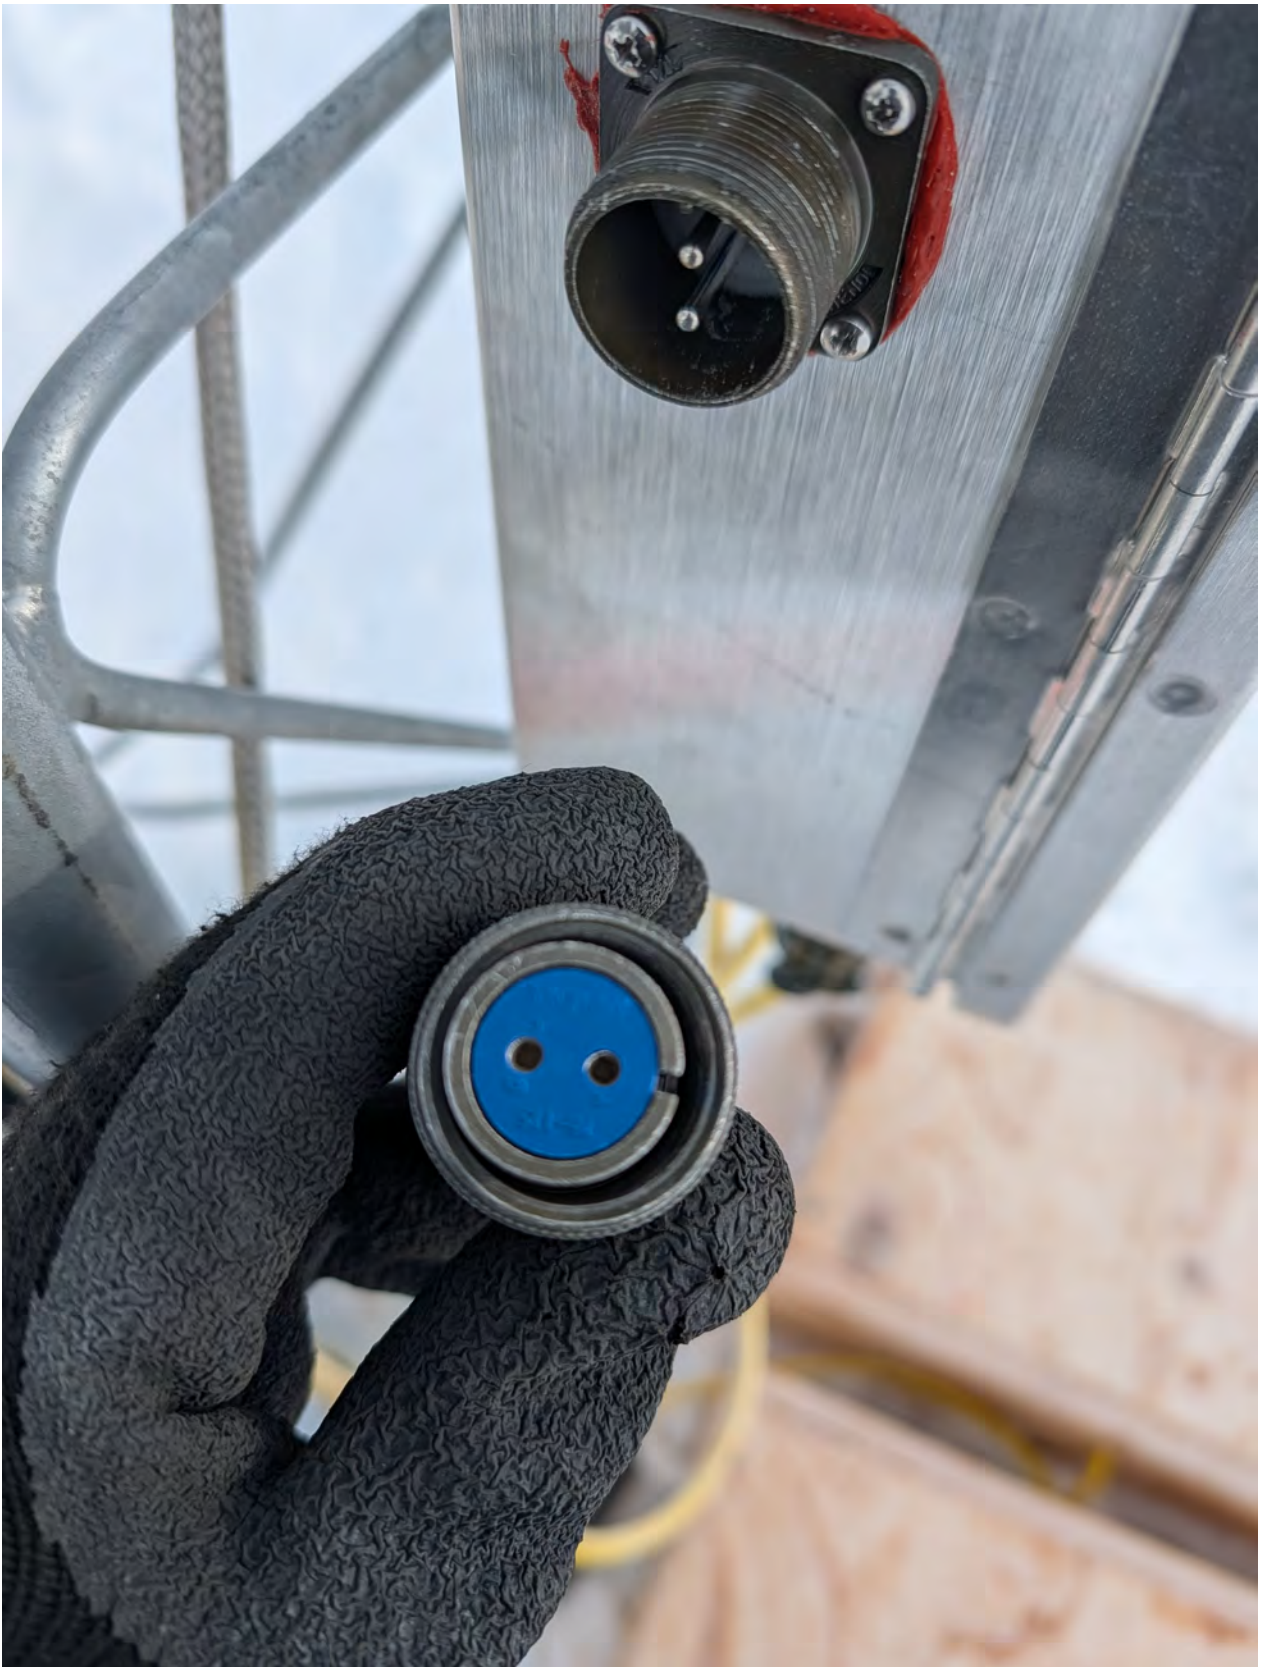
Plug for electronics enclosure: 16-115

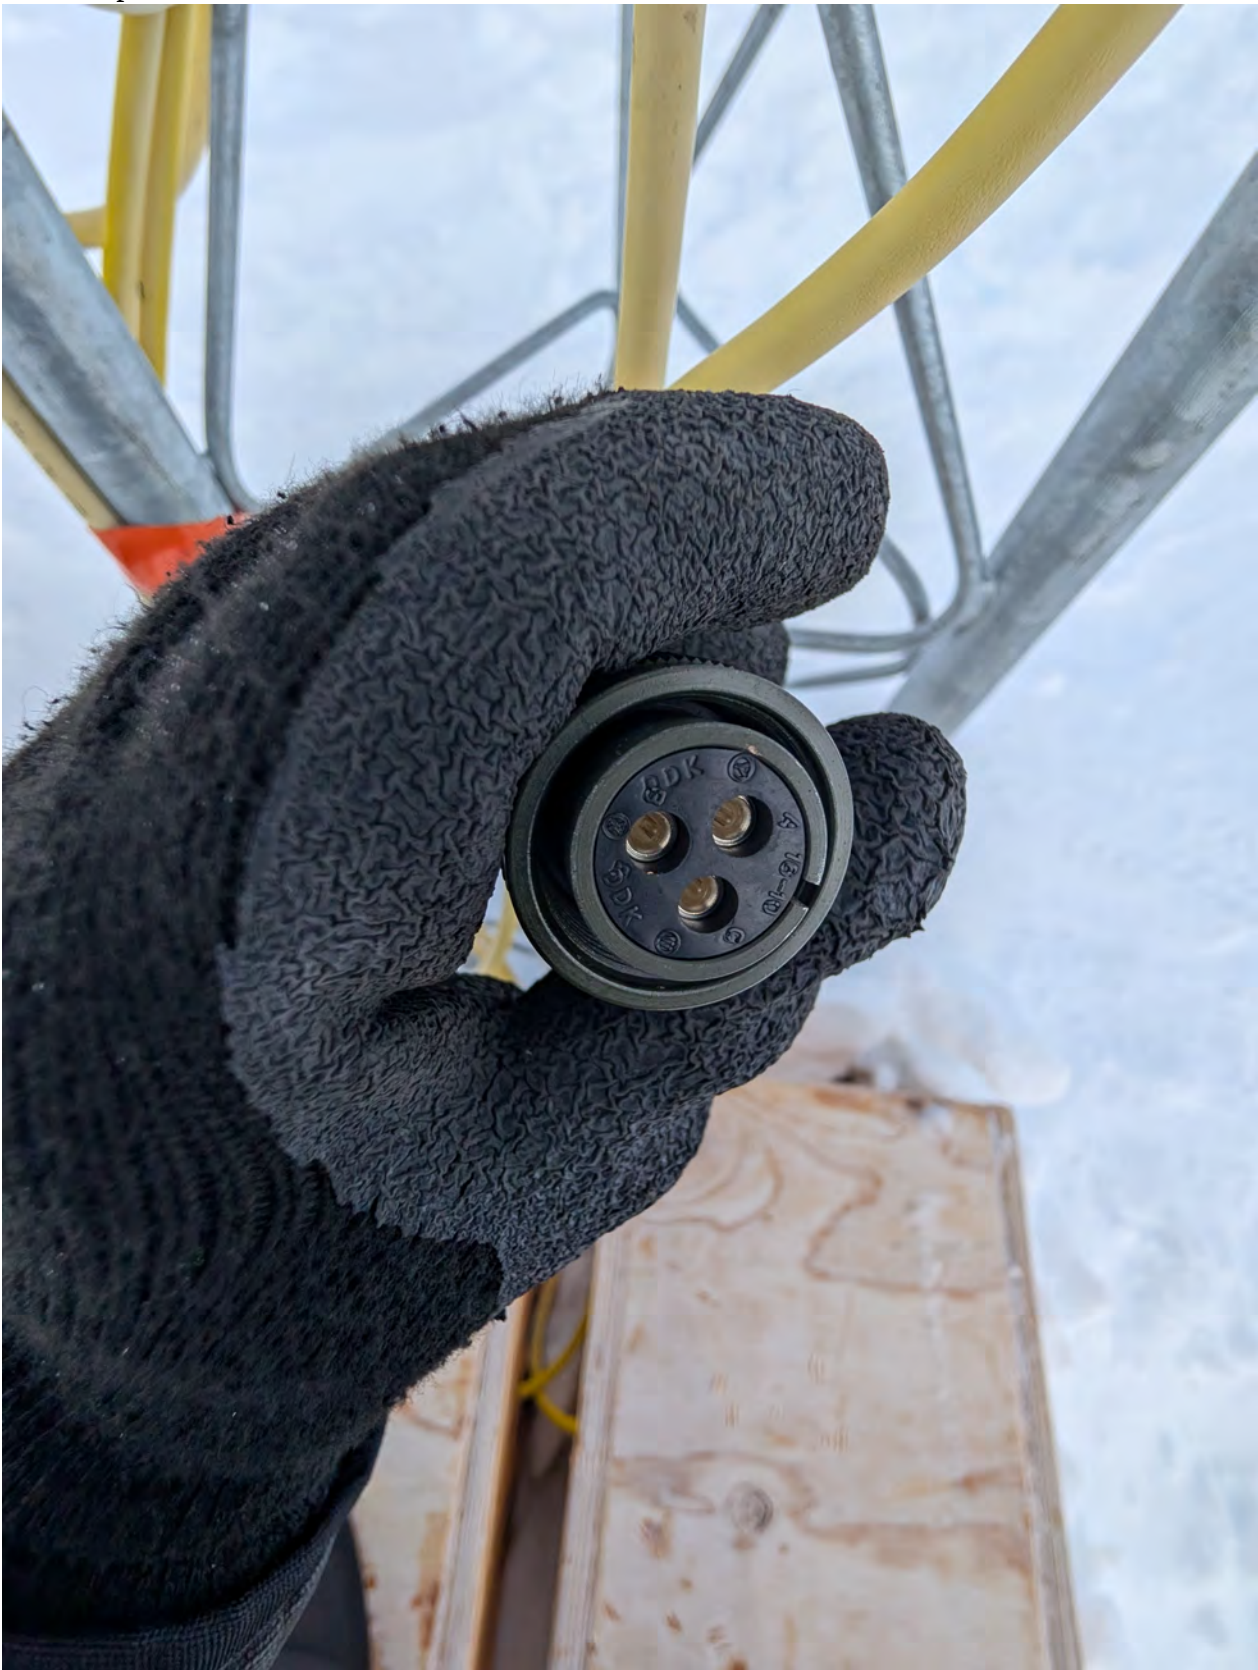
Plug for solar panel: 18-3S

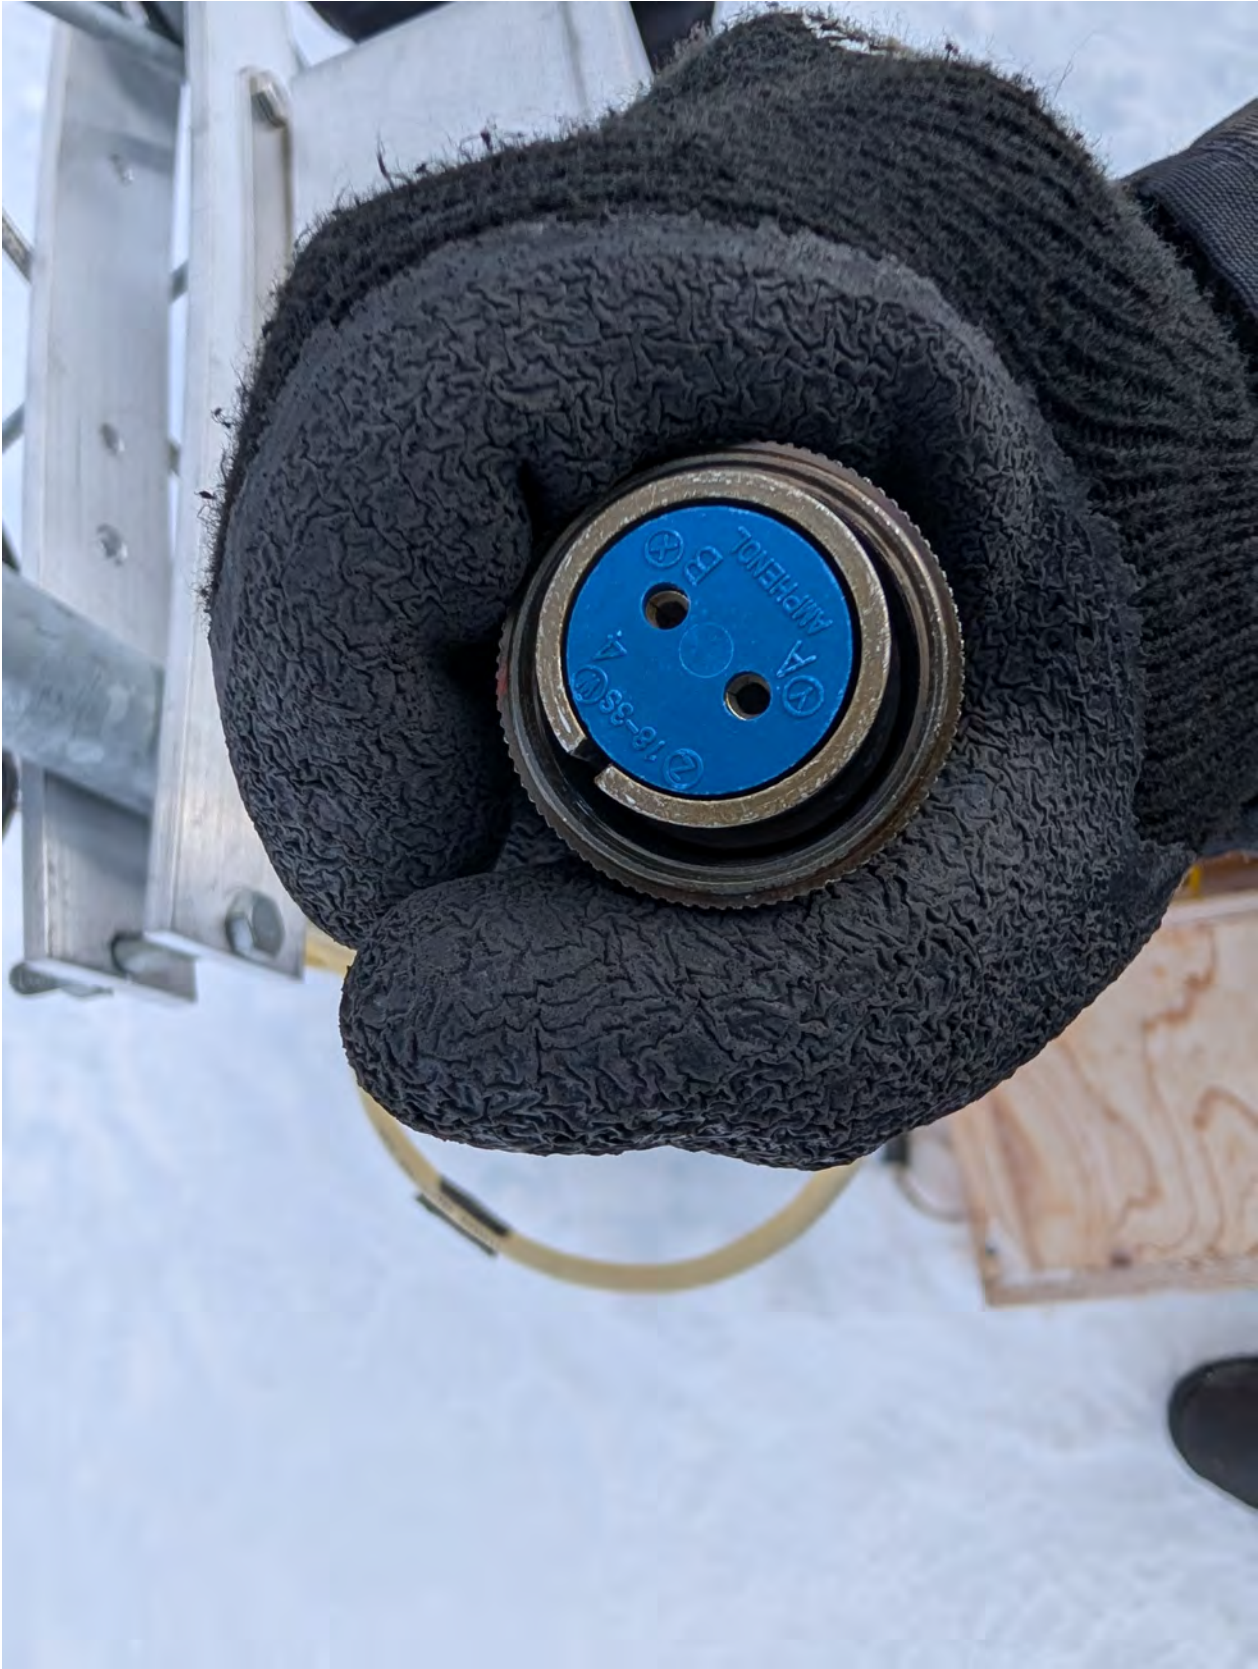
Plug for battery boxes: 16-10

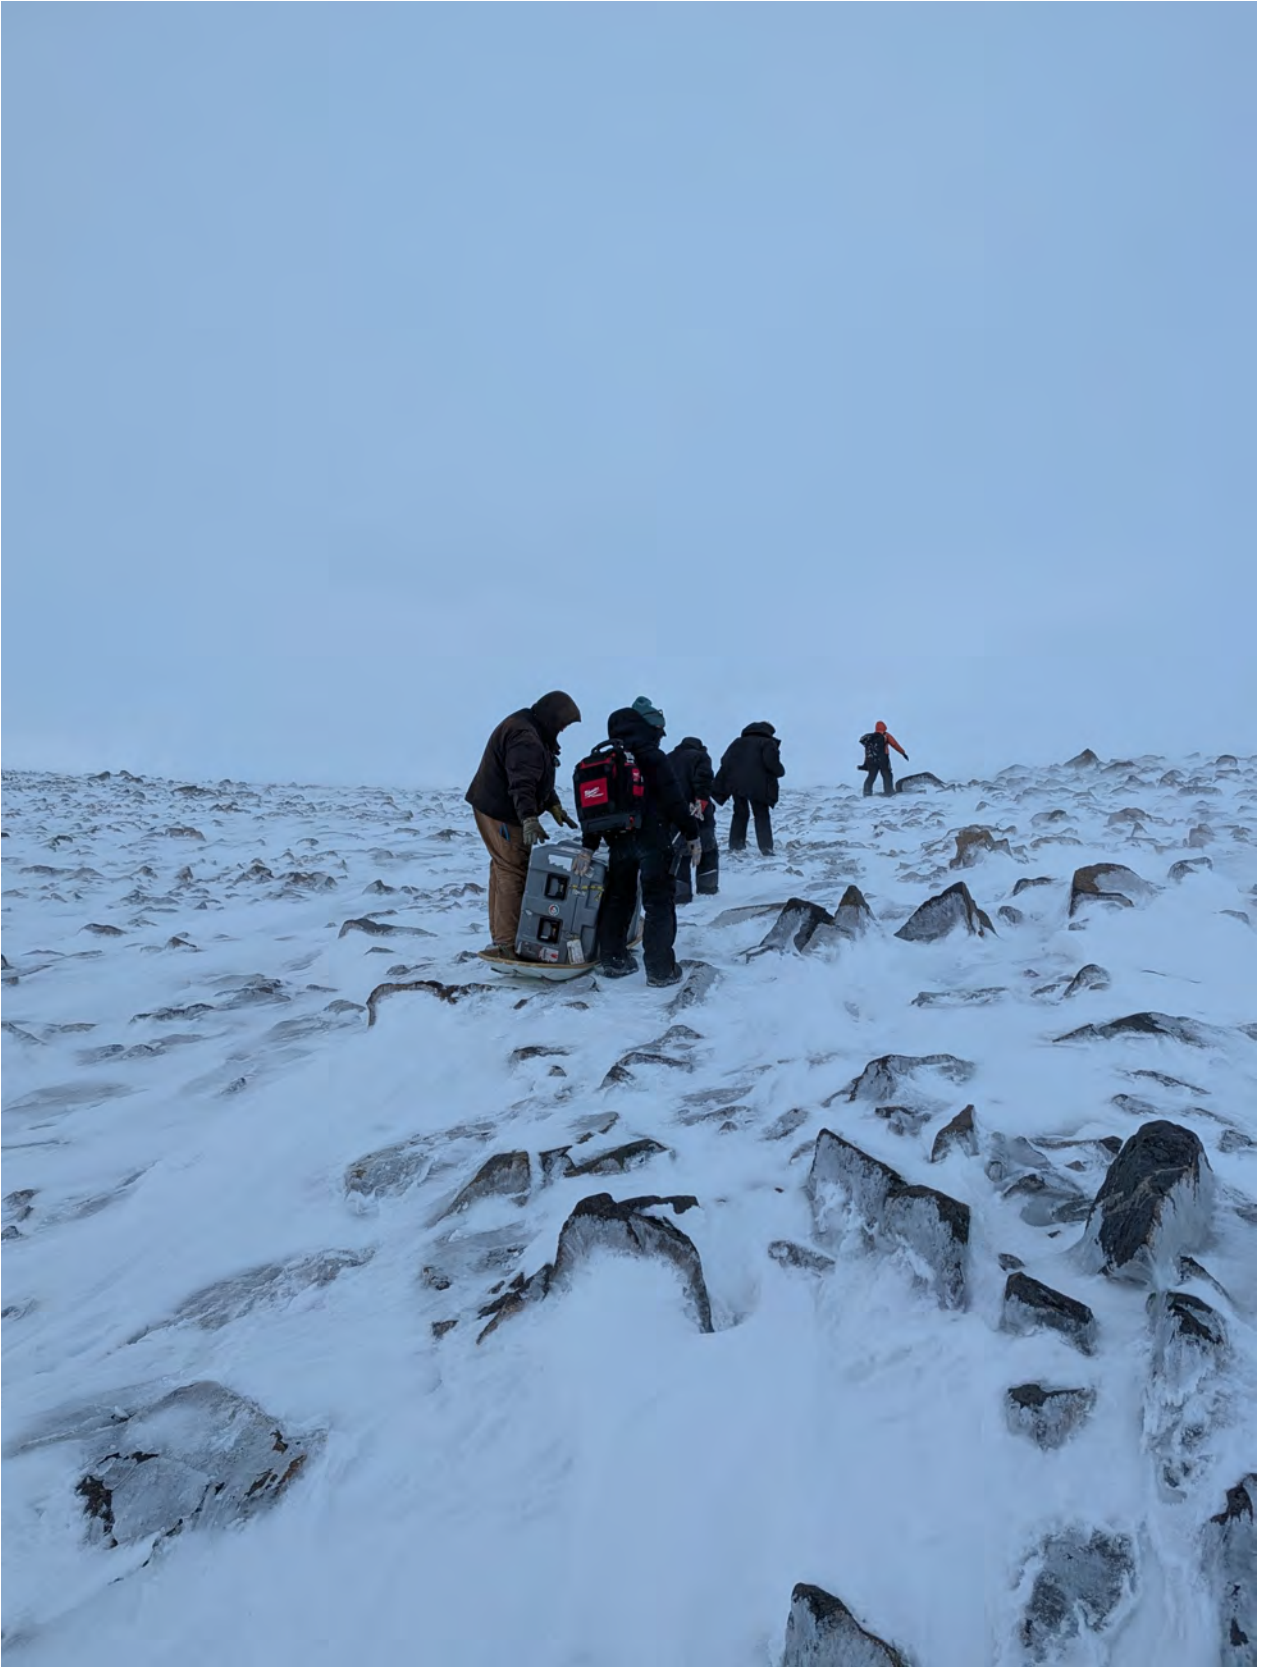
One battery box remains frozen in the ice, battery still inside

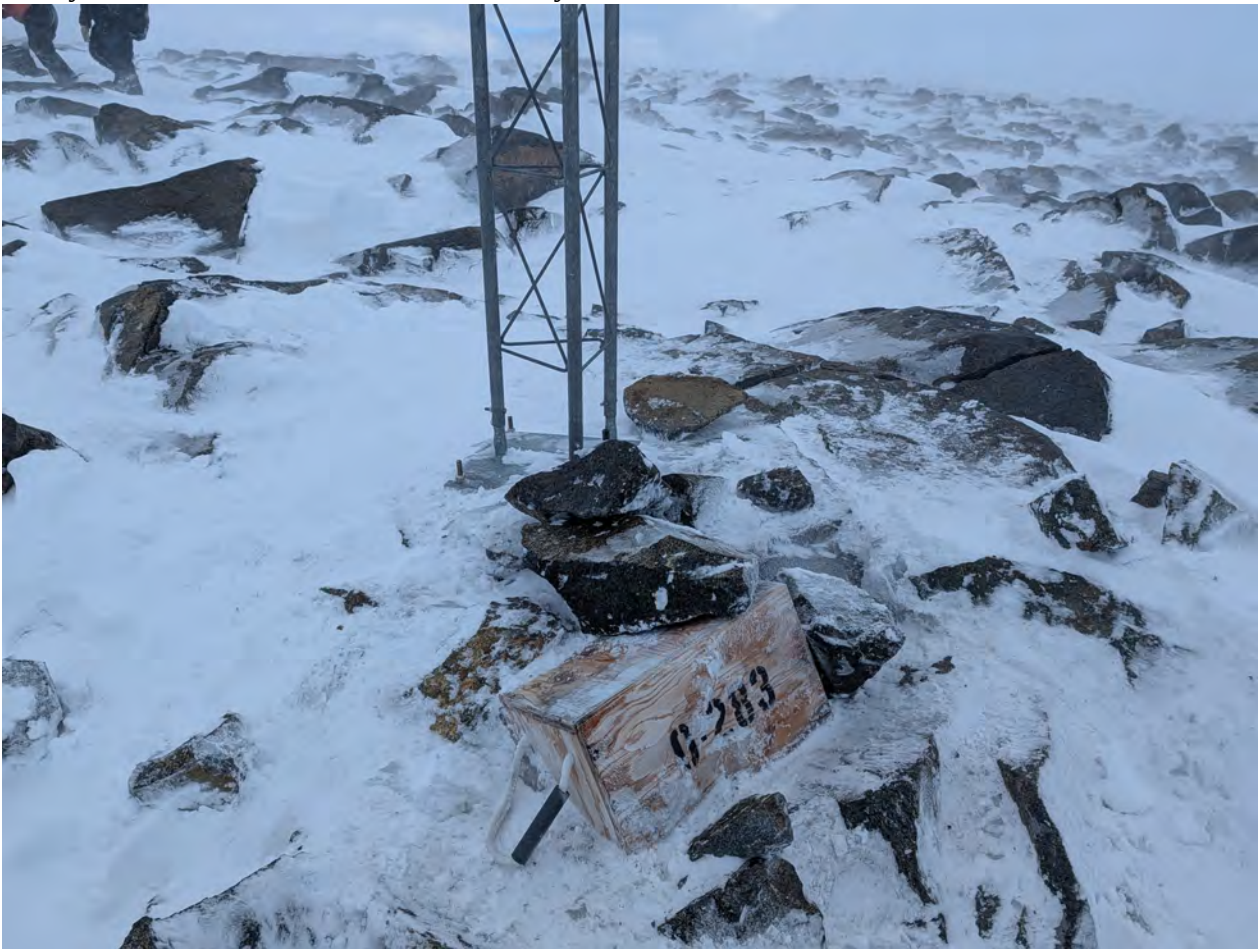
Footing for guy wire drilled into rock

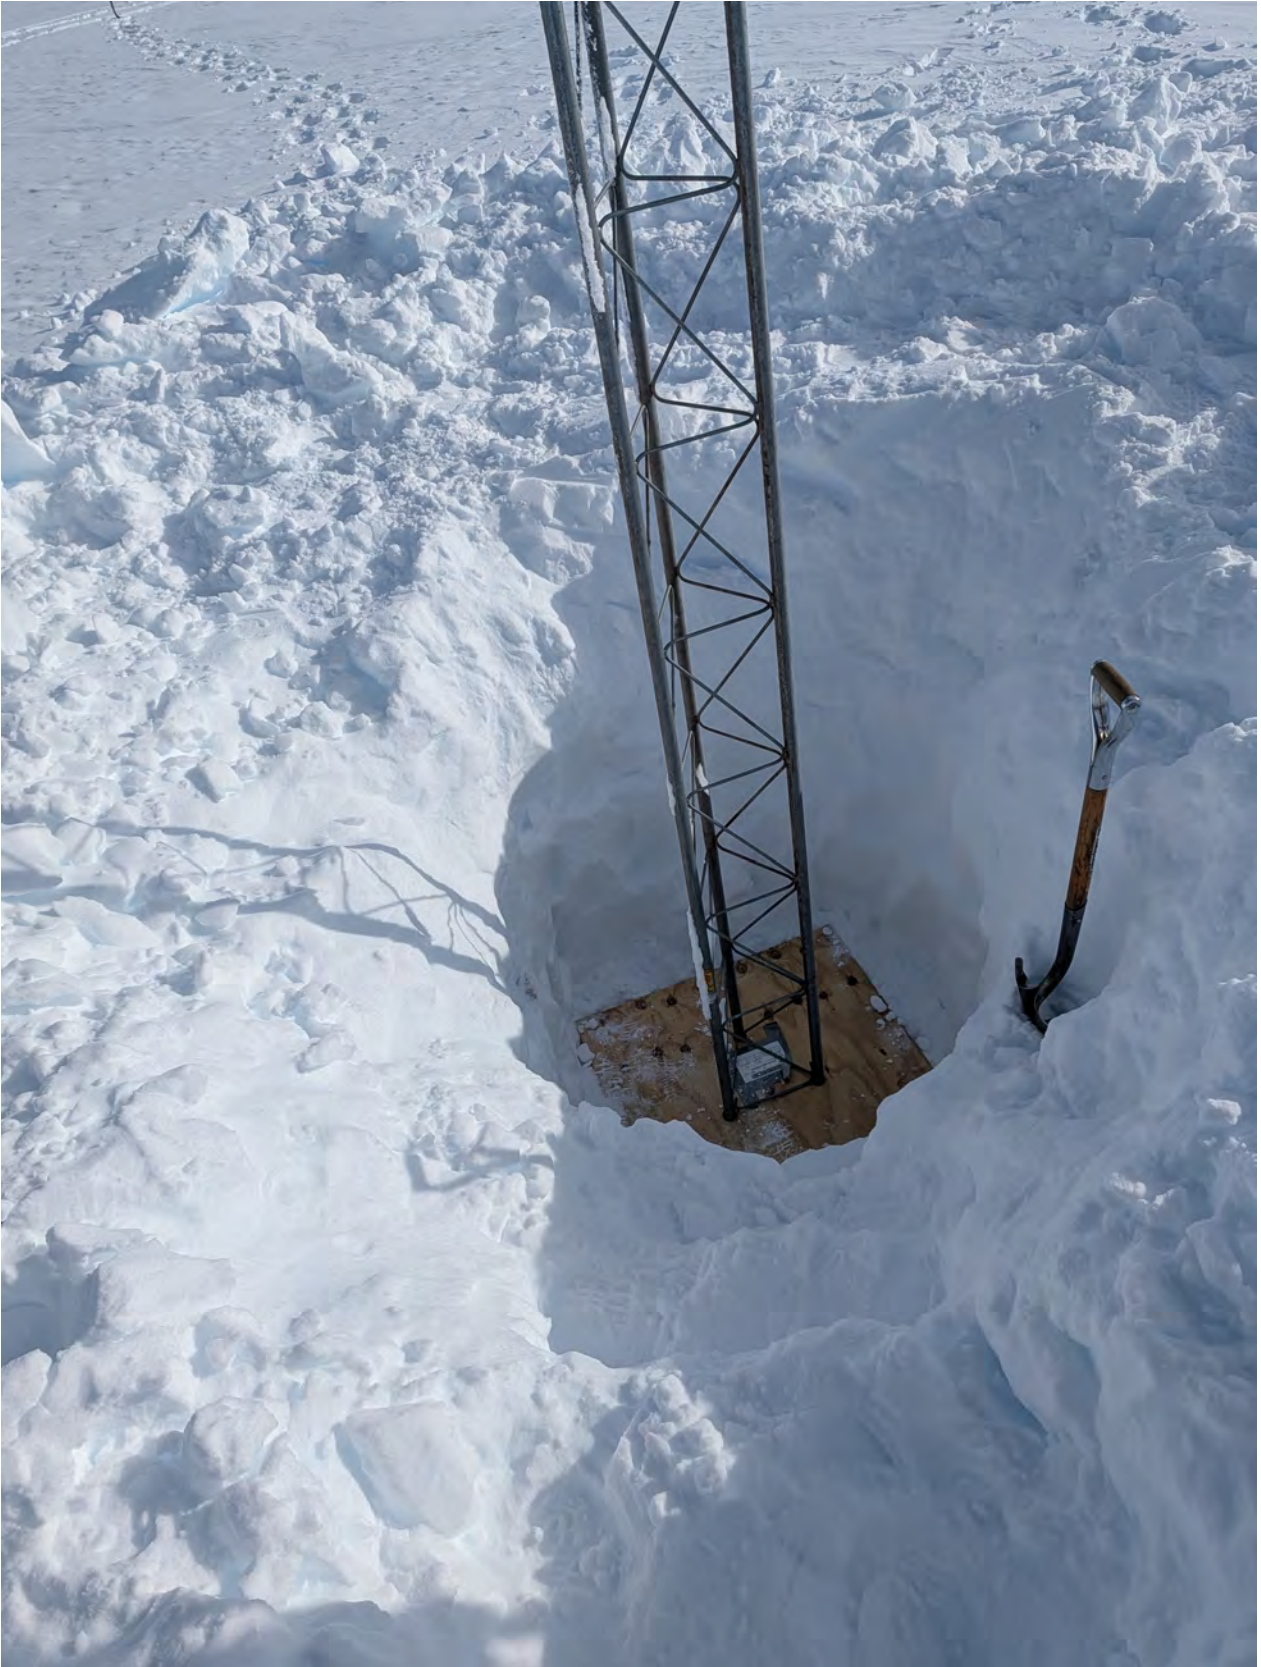
Field Work Notes: Kathie AWS was last visited on 12/29/2017, and was buried beyond recovery - the original tower could not be found. Laura Wert led the effort to install the 10' base section of the tower and the guy wires. Final AWS tower height was around 4.3 meters. All instruments and electronics were installed on the new tower section. Verified Argos transmissions with Lee Welhouse before departure. NOTE: elevation at 1627 meters.

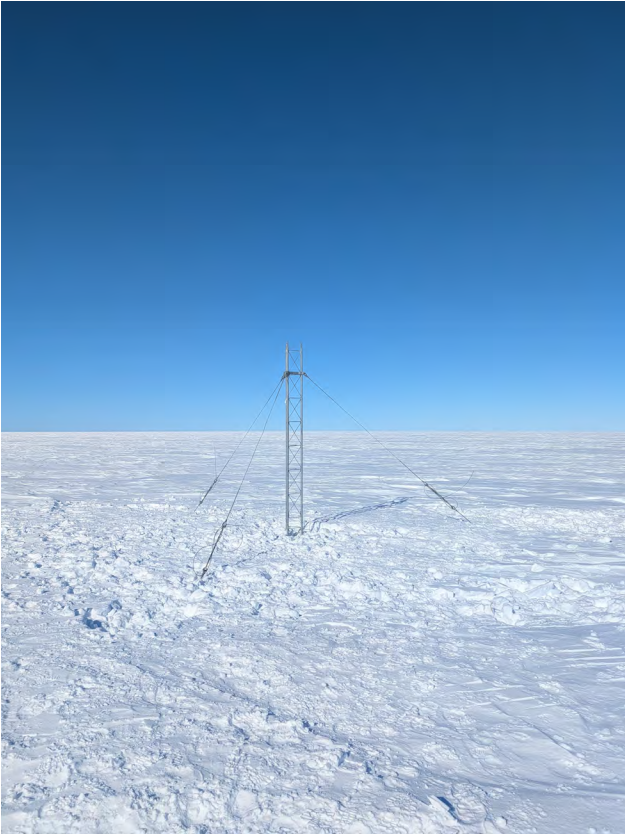
Pointing towards East - Before

Field Work Notes: The AWS site had a naked tower in place from a previous visit on 12/29/2025. All instruments and electronics were installed on the tower. There was a missing bracket for the ADG instrument; a makeshift bracket was fabricated using a spare antenna mount and copper tie wire. The station was not transmitting before departure; will have to revisit to repair/update.
