## **AWS Field Report 2025-26**

**Field Team: Matthew Lazzara, Lee Welhouse, Forbes Filip**

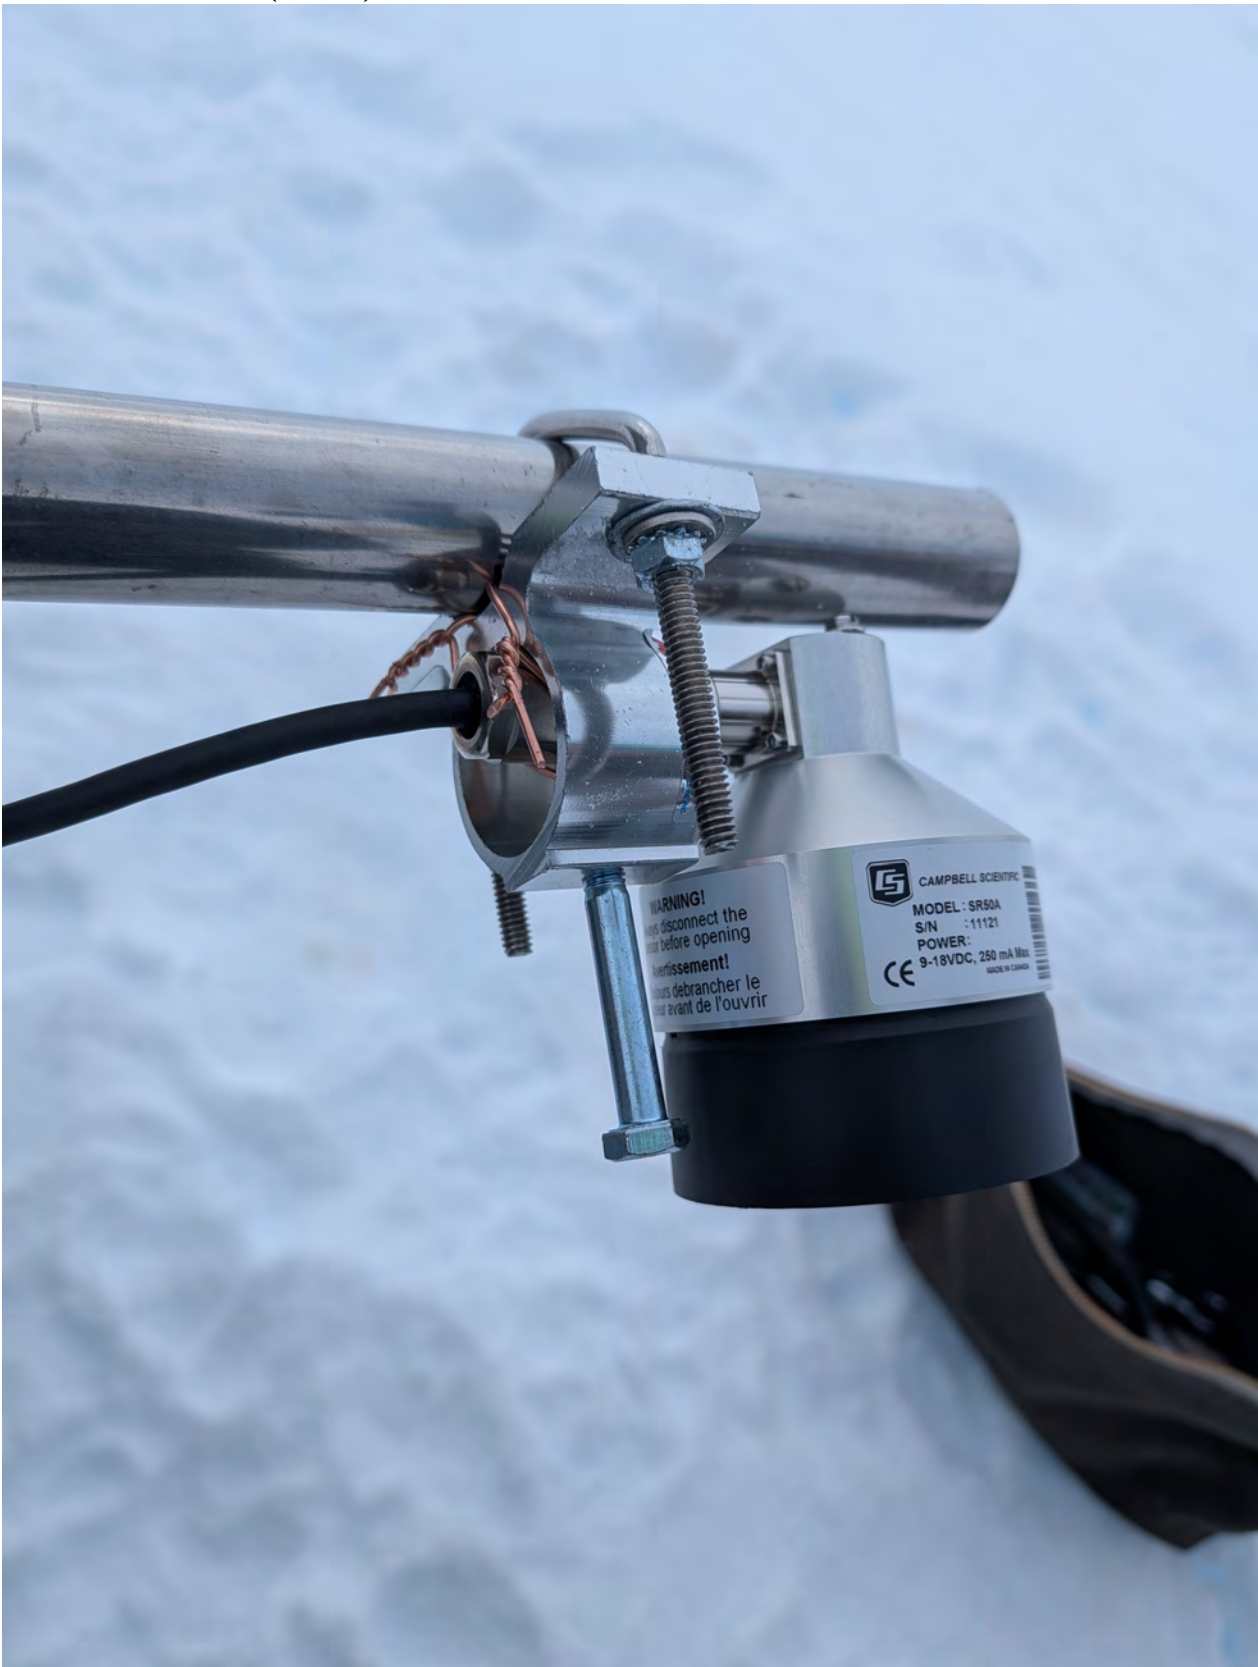
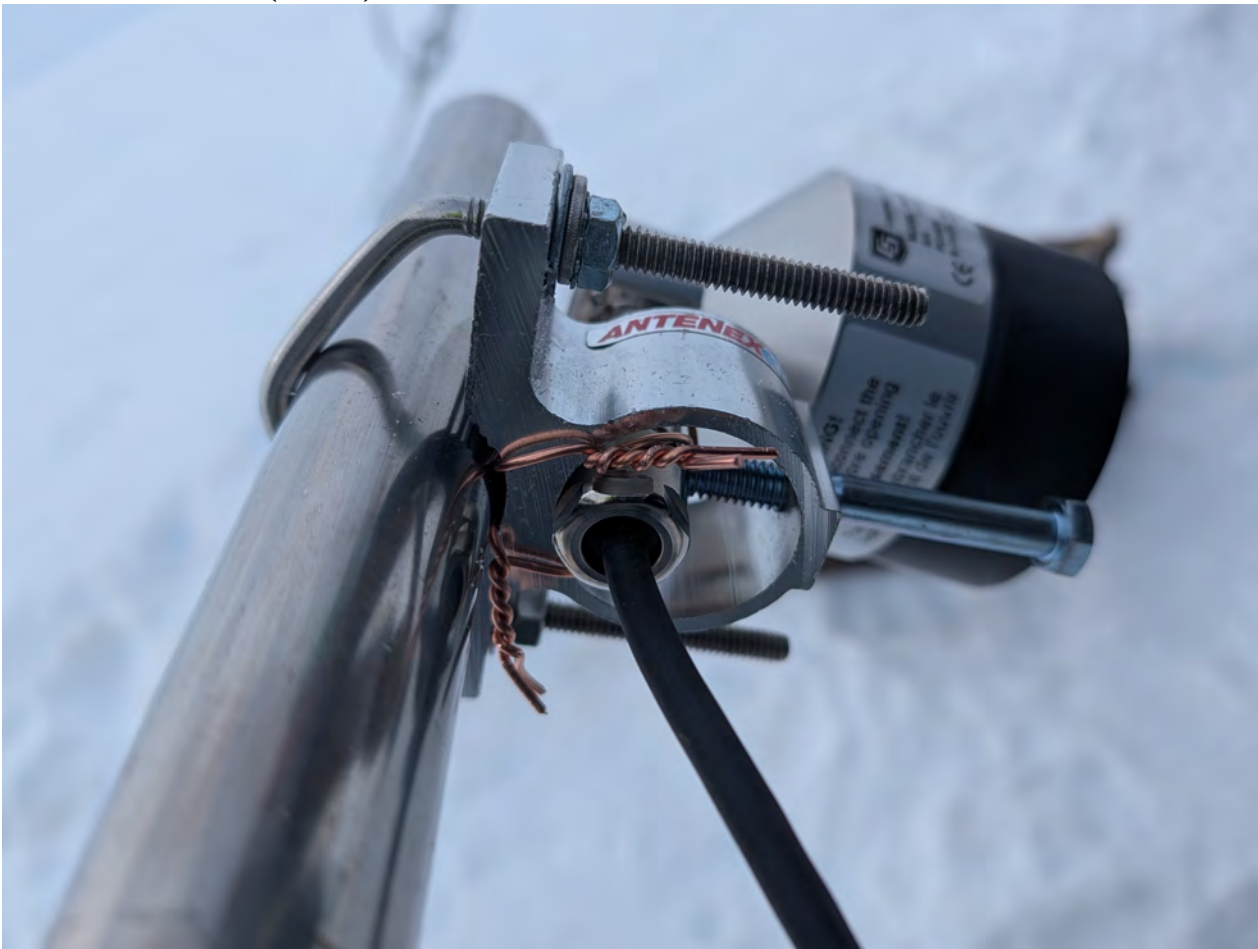
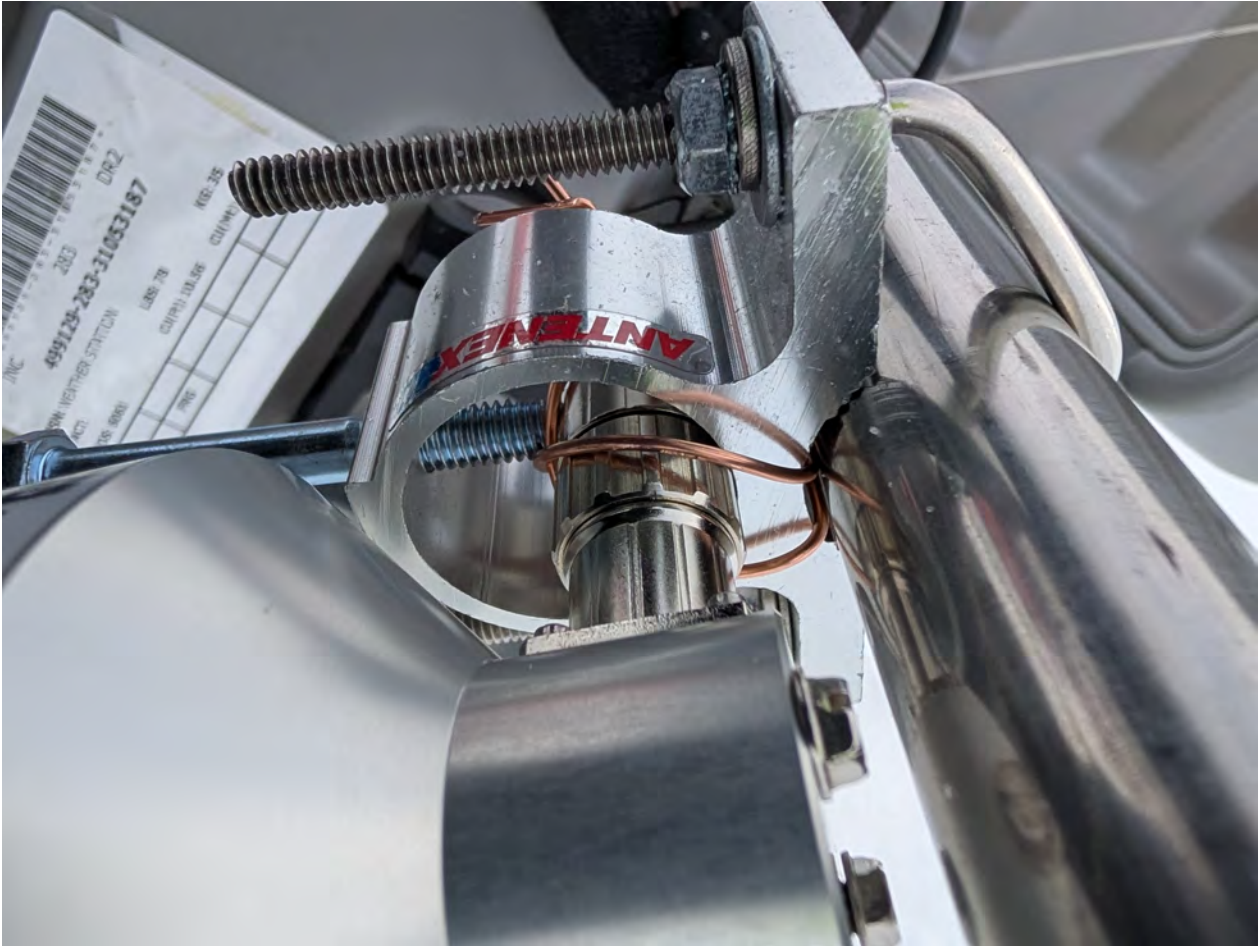
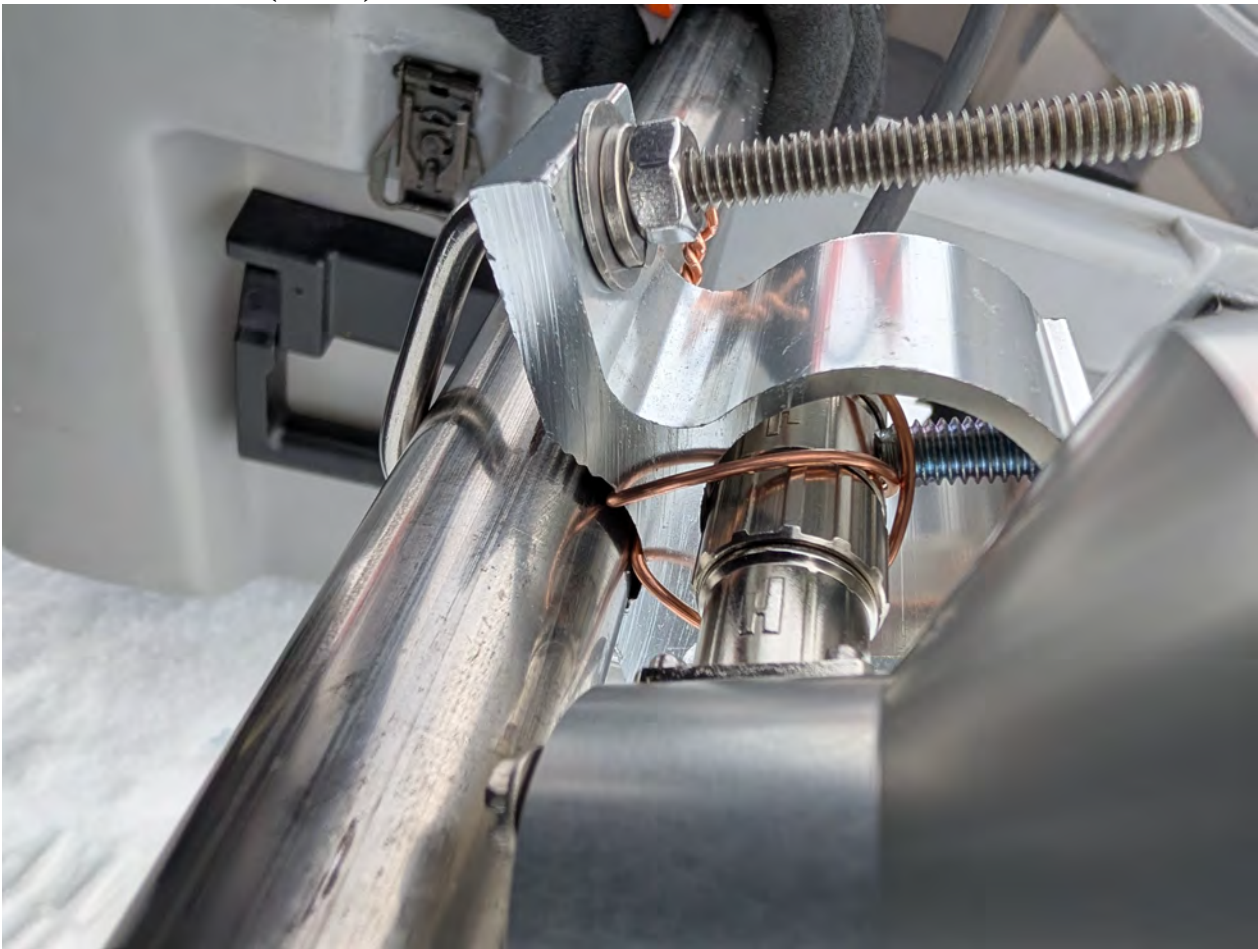
Field Work Notes: The AWS site had a naked tower in place from a previous visit on 12/29/2025. All instruments and electronics were installed on the tower. There was a missing bracket for the ADG instrument; a makeshift bracket was fabricated using a spare antenna mount and copper tie wire. The station was not transmitting before departure; will have to revisit to repair/update.

ADG - makeshift bracket (view 1)

ADG - makeshift bracket (view 3)

ADG - makeshift bracket (view 4)

ADG - makeshift bracket (view 5)

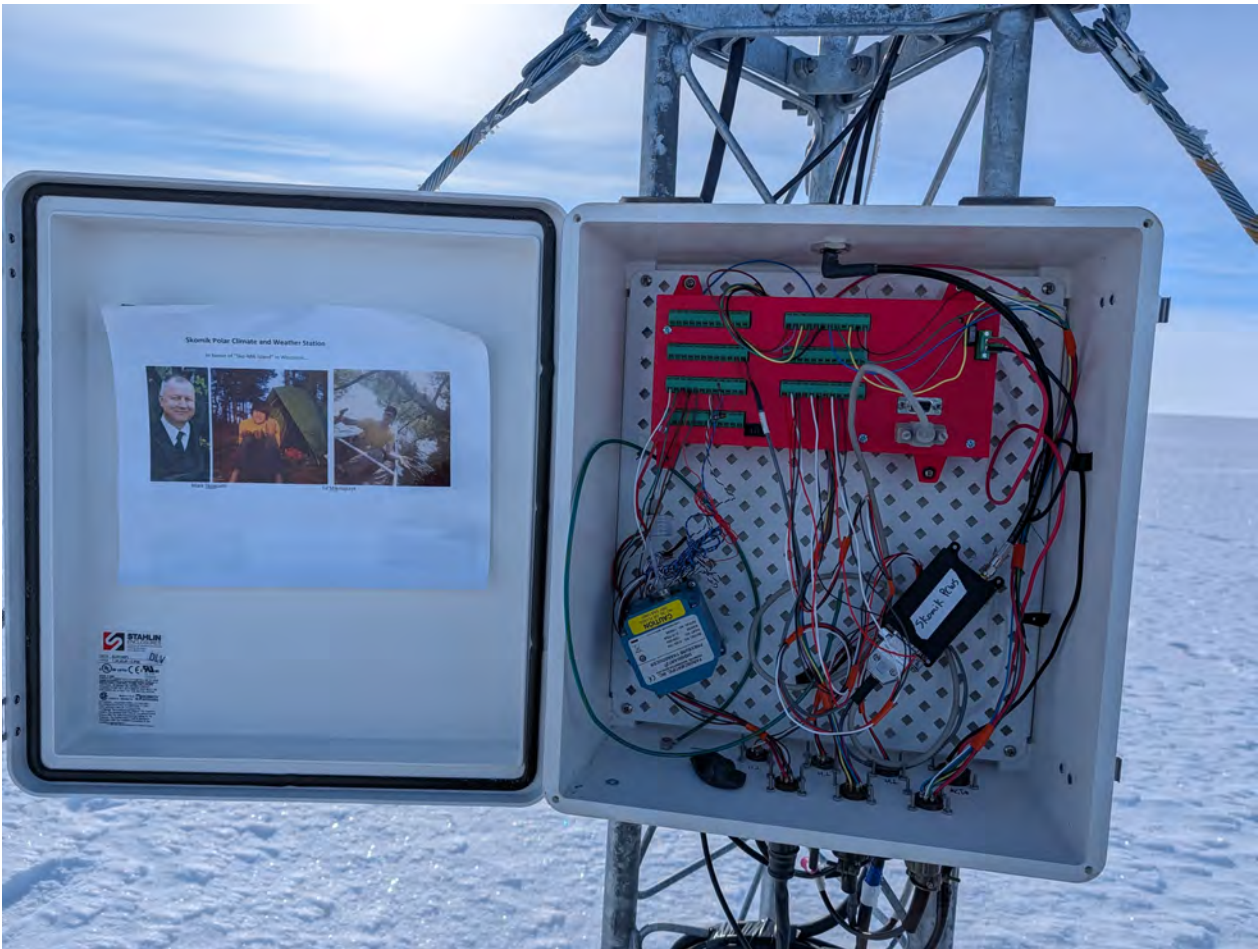
Field Work Notes: Replaced the data logger (M-AWS Logger v2.2) to get more units field tested. There were no adjustments to any instrument heights or the power system. DID NOT Verify Iridium transmissions with Lee Welhouse before departure - my bad; the AWS was in fact transmitting. Unfortunately, there was not sufficient ground time available to conduct a raise on the station. NOTE: no visible external changes to the AWS during this visit.

Skomik M-AWS - inside the enclosure
